Framing Quiz

by Gordon F. Tully

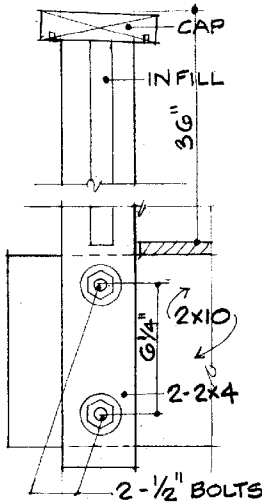
Porch Rail Detail #1

Two alternative designs are shown. One has a pair of 2x4s bolted to each side of a 2x10 joist, with 1/2-inch bolts spaced 6 1/4 inches apart. Notice that both members run past the joint to provide enough clearance between the bolt holes and the ends and edges of the wood members. If you don't do this, the wood might split.

To prevent splitting in this case, the bolt must be a distance of seven bolt diameters from the ends of the 2x4 and the 2x10. And it must be four diameters from the edges of the 2x4, and 1 1/2 diameters from the edges of the 2x10 (measured from the center of the bolt). These limits are determined by whether the bolt is pushing across or along the grain.

Answer: Approximately 16 inches on center (approximately, because readers should check their own railing designs and not treat this one as gospel). The calculations are based on the 50-pounds-per-foot rule. The other criterion—that the rail must resist a 200-pound point load—should be checked.

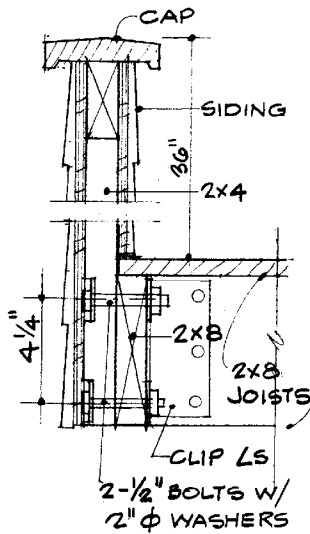
Porch Rail Detail #2

buried in a solid railing and bolted to a 2x8 running along the edge of the deck. It is bolted on with two 1/2-inch bolts equipped with heavy 2-inch-diameter washers spaced 4 1/4 inches apart. The 2x8 is, in turn, attached to the framing with steel clip angles.

Answer: The 2x4s must be spaced about 18 inches apart, as limited by the size of the washers, which distribute the load to prevent crushing the members. But the real problem with this detail is how to get the torque out of the 2x8 and into the perpendicular framing.

The 2x8 will try to roll out at the top, due to the 50-pound-per-foot pressure at the top of the railing and translated into the 2x8 by the bolts. This twisting must be resisted by a clip of some kind. The nails or bolts at the top of the clip must resist a pretty substantial pull: about 350 pounds per running foot of railing.

For example, if you fasten each leg of each clip at the top with a single 16d nail, you will need a joist every 4 1/2 inches! If you double the 2x8 and use two 16d nails on each leg of each clip, you can space the joists about 12 inches on center. If you use 1/2-inch lag screws and are careful how you anchor them into the joists, you might reach a spacing of 24 inches o.c. (The clip angles are assumed to be steel plates, not 16-gauge joist clips.)

In all railing details, the fastening problem goes away if you up-size the joists from 2x8s to 2x10s or 2x12s. The fasteners then act over a longer lever arm (moment arm) and the stress drops.

Another strategy is to brace the railing with buttresses, returns, or angles, and to install a heavy top member as a horizontal beam. Now, new crucial joints occur at the corners, where the stress in the railing has to be transferred to the bracing rail.

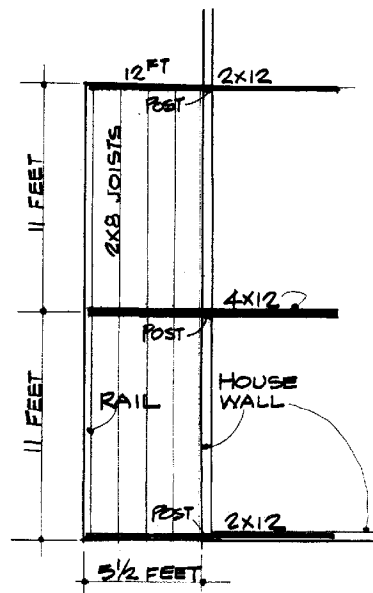
Plan of Porch

While one beam is buried in the right-hand wall, the others run back into closets. The porch cantilevers 5 1/2 feet from the wall, and the beams are 11 feet apart and 12 feet long. Can you spot the problems with this porch?

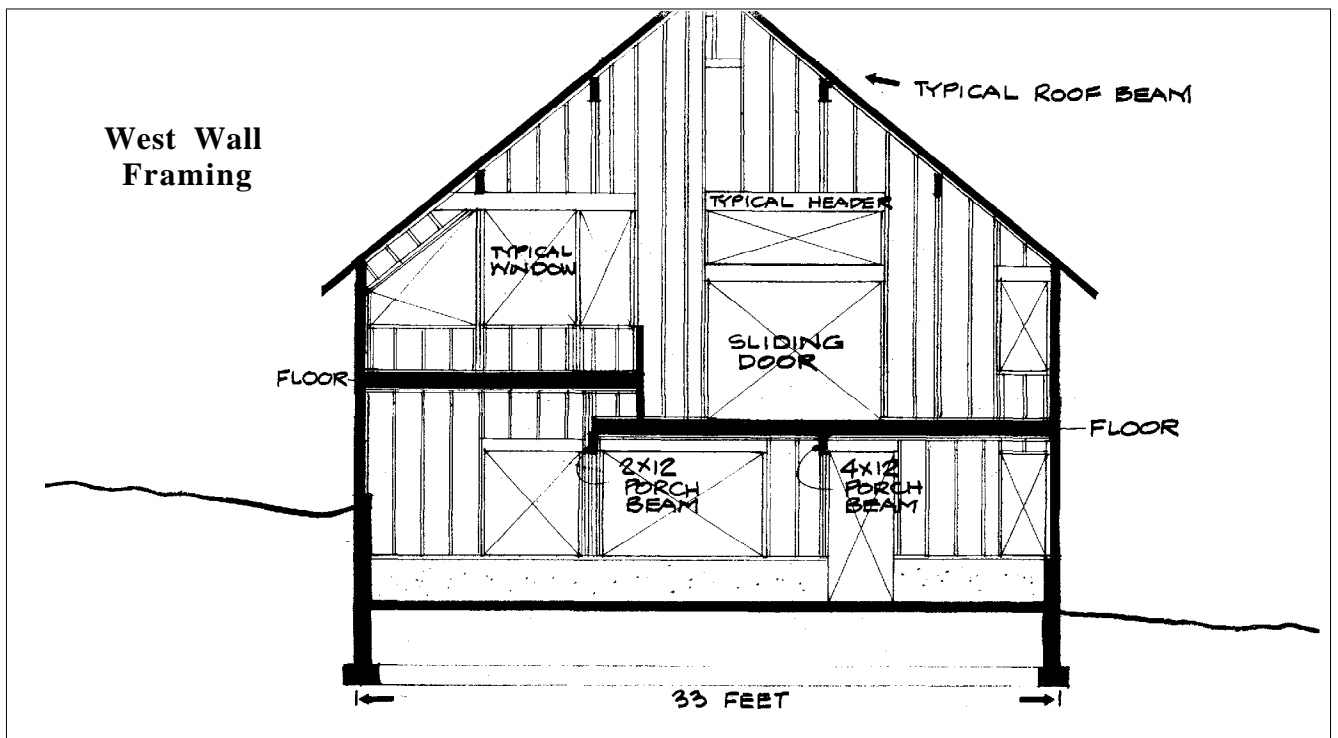
West Wall Framing

foot 2x4s in the center of the wall. These members are simply inadequate to carry such a load. This is a good example of using standard framing where special engineering is called for.

During the first winter, our sharp-eyed tenant noticed that the wall moved like a drumhead during 70-mph winds. He measured a two-inch deflection, and gave us a call.

tie-down to the slab, there simply is not enough weight in the structure to counterbalance the design load of the porch. (There is, unfortunately, no partition above the beams.)

A more serious problem is that the beams are undersized per the BOCA code. Why, then, hasn't the porch fallen down or seriously deflected? Simply because the building code asks you to design for a pretty large live load, and to reach that load there would have to be 51 people on the deck. However, the worst case to

In this case, the post is exactly *half* the size needed, but, again, a problem hasn't arisen because the worst load on the porch so far has been about half the design load of 60 pounds per square foot.

The drawing shows the 2x4 wall framing. All the walls and floors are shown blackened. The floor joists run parallel to the wall, which is 33 feet wide. The ridge of the cathedral ceiling is 20 feet from the lower of the two upper levels. The ceiling is carried on a series of parallel roof beams (shown blackened in), which frame into this west wall.

Answer: The wall was framed up with properly sized headers, plates, and so on. But strong winds from the west are normal at the seashore.

What went unnoticed was the fact that the wind load on the upper-floor windows and sliding door gets concentrated in the three or four 20-

On the west side of the same house is a cantilevered deck, supported by a 2x12 on each side and a 4x12 in the middle. These beams are blackened in on the wall drawing, just below the upper floor.

Answer: One problem is that the beams are not long enough. Although the drawings call for the ends to be

A problem that many might miss is a common one: underestimating the size of a post. The post in question occurs at the cantilever support point. The load on the post is *twice* the total load from the deck on the beam, because both the deck and the tie-down are pressing on the post with equal force.

A small post will have no trouble carrying the load. The problem, however, is that it will crush the wood fibers of the beam above and the wall sill below. The allowable compressive strength *across* the grain for most species is about one-quarter the allowable compressive strength *along* the grain. This cross-grain compression strength governs the size of the post. The end of the post must be big enough to spread the load and

To brace the wall, we added on the inside a carefully engineered, glued and screwed, multilayer, horizontal

plywood diaphragm, which now forms an attractive soffit over the windows and doors. The diaphragm picks up the wind load and transfers it to the two outer roof beams, thereby acting as a horizontal beam.
