Cracking Clapboards

by William A. Lotz

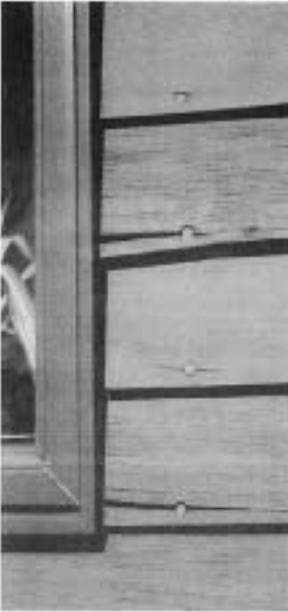
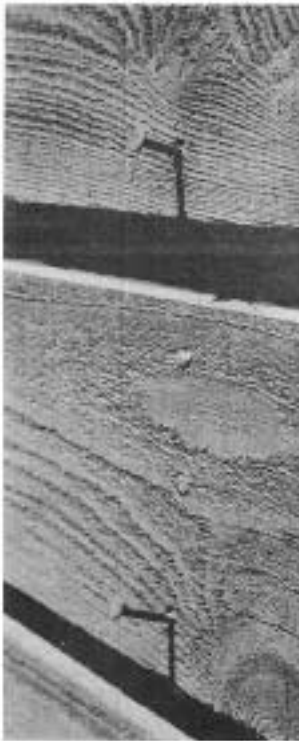
Splitting (above) and nail popping (right) are common on horizontal wood sidings installed directly over foam sheathing. One solution is to put the foam on the inside.

Wood clapboards are hydrophilic—they absorb moisture. Extruded polystyrene is hydrophobic—it does not absorb (much) water.

on the clapboards and they absorb moisture. In the morning, the sun hits the clapboards and quickly warms and dries their exterior surface. But the interior surface of the clapboard is still cool and moist. The polystyrene effectively prevents heat and moisture transfer from the back side of the thin clapboard. The resulting stresses in the thin wood clapboards—cool and moist on the back and warm and dry on the front—cause splitting and warping.

If the carpenter is heavy-handed when nailing the clapboards, the result is localized compression of the foam. Combine this stress with stresses from heat and moisture, and the nails pop out. The manufacturers

In my opinion, the best way to keep out of the middle is easy—don't install wood clapboards nailed to extruded polystyrene.

1. Install the clapboards on 1-by sleepers nailed over the foam. One caution: If the framing is 24 inches on center, don't use hardboard siding or it may warp.
2. Install plywood between the foam and the clapboards. Here, you would still need to use extra-long, ring-shank box nails to get sufficient penetration into the studs.

In either case, you'll need to nail through the foam with 16d nails, which must be done gingerly or the foam will compress unevenly. Neither of these options is likely to please your carpenters.

Foam is an excellent insulating material if used correctly. My preference is to install it on the inside of the wall under the drywall. ■
