CINCHING UP AN OLD SCHOOLHOUSE

Remodelers counteract earth movement with cable compression and a concrete grade beam

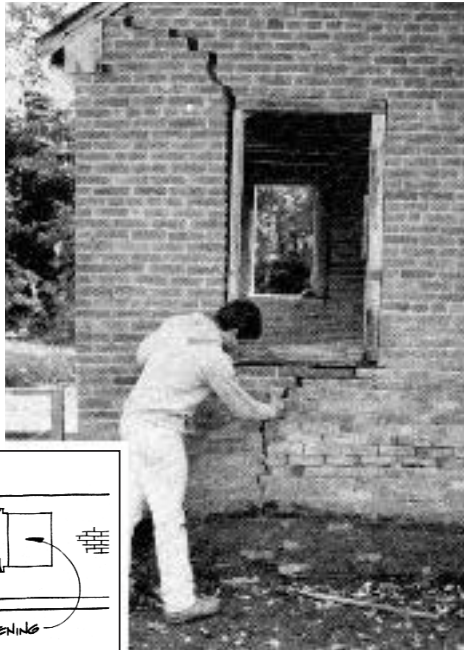
Figure 1. Stepped cracks opened up at the window corners when one corner of the building settled. The inset illustrates how the wall pivoted outwards when the fieldstone foundation sagged.

to fall and the walls to pivot out at the top and in at the bottom. This opened cracks of up to 2 inches in the back wall (see Figure 1).

One goal of the renovation was to preserve as much of the existing structure and appearance as possible. That meant leaving the unmortared fieldstone foundations largely intact. The foundation extended slightly above grade on all sides. The solution was to jack the sagging corner up while squeezing the building together to close up the cracks. A concrete grade beam was then poured on the inside. This beam would spread the load of the brick walls to

resist future settling, and keep the lower part of the walls from pushing in and the upper part of the walls from pivoting out (see inset, Figure 1.)

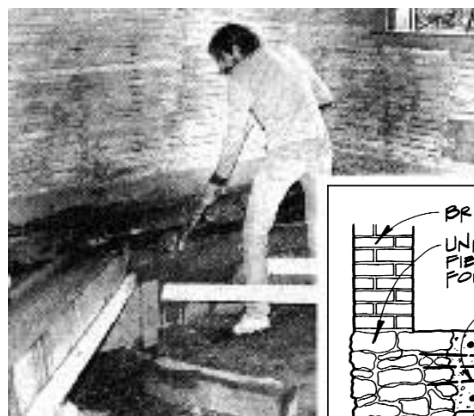
Figure 4. The grade beam was poured on all sides of the perimeter of the building. Rebar tied it to the ground and the fieldstone foundation wall.

The schoolhouse had been missing its one door and six windows for years, so there wasn't much problem getting the concrete chute inside. But an additional wooden trough helped get to the far wall so the truck didn't have to move (see Figure 4). After the concrete cured, missing bricks in the lower section of the walls were replaced and the cables were removed. I guess that old school house got a passing grade beam. ■
