EIFS Performance Review

For a durable EIFS exterior, follow installation details to the letter
and avoid the use of gypsum sheathing

by Richard Piper and Russell Kenney

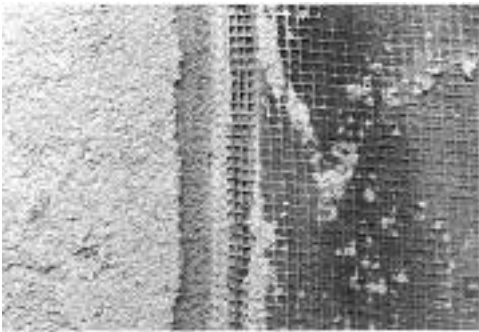
Exposed mesh. Many jobs had exposed mesh at joint edges and at terminations (see Figure 1, next page). We observed mesh on the surface of the base coat on some jobs under construction, and we could see mesh patterns through the finish coat on a few jobs. These are signs of thin base coats and mesh that is not adequately embedded in the base coat.

Mesh that's not fully embedded is exposed to moisture and won't provide good impact resistance. Moisture alone can reduce the tensile strength of reinforcing mesh, and it is well-known that moisture combined with alkalinity (from the cement) speeds the strength reduction of the mesh.

Figure 1. Mesh that's exposed on the surface of the base coat is likely to get wet and lose tensile strength. Once weakened, it will not provide adequate impact resistance.

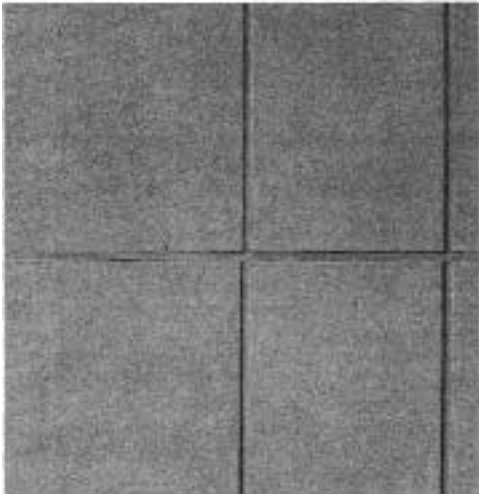
Sealant failure. The majority of projects, including some less than six months old, had some sealant failure. Failures at

EIFS field joints were more common than at perimeter joints (Figure 2, next page). The typical failure was a cohesive failure of the finish coat. This means that the sealant didn't pull away from the finish coat; rather, the finish coat itself pulled apart. This is because some acrylic finish coats soften when kept damp and therefore do not generally provide a durable surface for elastomeric sealants. Nevertheless, most EIFS and sealant manufacturers still either require or allow sealants to be applied to the finish.

Figure 2. The sealant at this control joint failed within six months of installation, allowing water into the system. To prevent this, use a low-modulus sealant and apply it to the base coat, not the finish coat.

- Failed elastomeric sealant joints are a major cause of water entry in EIF systems. To prevent these failures, the sealant must be applied to the primed base coat, not to the finish coat, which can soften when wet. And because EIFS is a relatively weak substrate for elastomeric sealants, you must choose a *low-modulus* sealant that maintains its low-modulus over the life of the sealant. (When a low-modulus sealant stretches, it exerts less stress on a joint.)

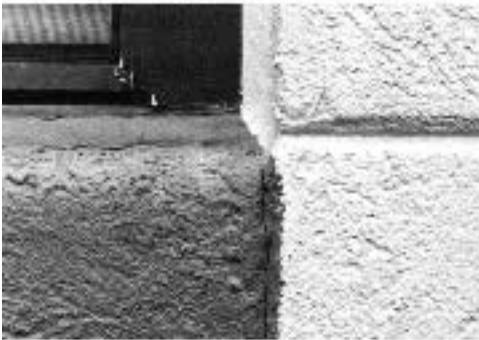
Figure 3. V-grooves, added for decorative effect, should never line up with window or door openings. This one cracked, was recoated with the manufacturer's elastomeric coating, and cracked again within a year.

Cracking in V-grooves. V-grooves are sometimes added for decorative effects. Approximately one half of all projects with V-grooves had some cracking in the grooves sufficient to allow water penetration. Cracking is most common when the V-groove falls on the insulation board joint beneath (see Figure 3).

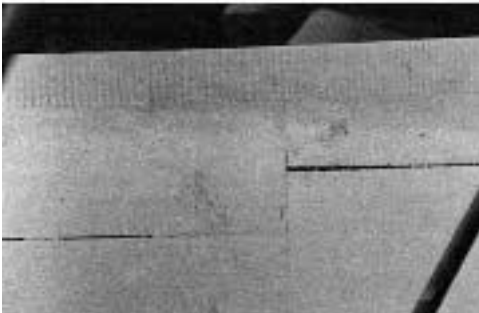
Figure 4. Gaps between EPS insulation boards are a common cause of cracks. To prevent problems, fill any cracks with insulation slivers.

Cracking at board joints. More than 10% of all projects had some cracking not associated with openings or joints. These cracks mostly occur over the gaps between insulation boards (Figure 4) and grow worse as the reinforcing mesh loses tensile strength from exposure to moisture and alkalinity.

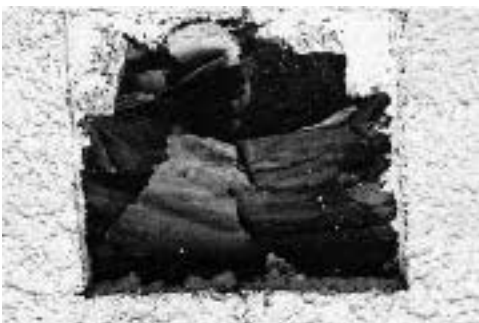
Figure 5. Moderate wetting will cause the facing of gypsum sheathing to delaminate. With increased wetting, the core will deteriorate, as seen in this cut-away section.

Most of the cracks and sealant failures we saw in the survey were sufficient to allow water to enter the EIF system. From our earlier investigations of several hundred EIFS buildings, we know that such leaks can lead to water damage of the gypsum sheathing underneath (Figure 5). When wet, the sheathing is prone to deterioration and delamination. Water also tends to collect at horizontal terminations and joints that are "back-wrapped" with mesh. The water often collects well below the point of entry, and it can cause the gypsum sheathing to delaminate and the sealant joints to fail.

Because EIFS as typically applied often cracks and allows water penetration, we believe that EIFS should not be adhesively applied to gypsum sheathing (ASTM C79). The fact that the current systems continue to be adhesively applied to gypsum sheathing on high-rise buildings in locations exposed to high winds and heavy rains is hard to understand or justify. Projects with masonry, concrete, or cement fiber-board substrates are less vulnerable to water penetration.

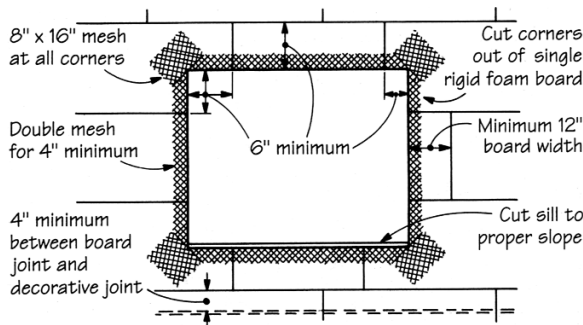
Insulation Board Layout Around Windows

Insulation board joints aligned with door and window openings are a common cause of cracks. To prevent problems, joints must be offset from the openings and the corners reinforced with diagonal mesh. In addition, decorative joints should not align with board joints or openings; board joints should not align with sheathing joints; and laps in the mesh should be offset from the edges of openings, grooves, and corners.

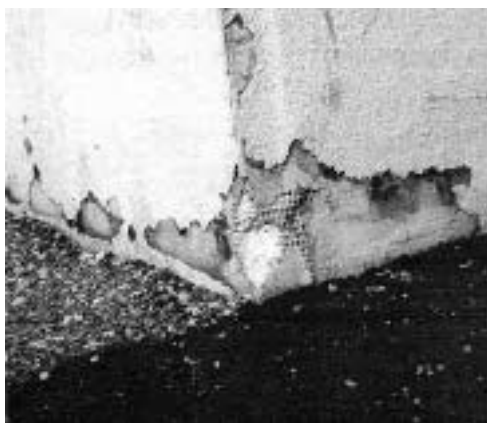
Figure 6. Areas near walkways face greater wear and tear. Use high-impact mesh in these locations.

outside and inside corners. Fully embed the mesh, leaving no mesh ends or mesh pattern visible. Use high-impact (heavy-weight) mesh at all surfaces near grade or near balconies or walkways, where they will face additional wear and tear (see Figure 6).
