# An Ice Dam Analyzed

An engineer's report shows that in snow country, soffit-to-ridge venting is typically the most practical way to prevent ice dams in cathedral ceiling assemblies

by Jeffrey Hoffman, P.E.

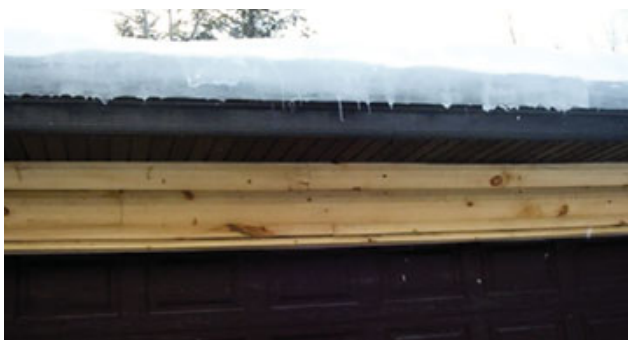
**Figure 1.** Ice dams on this new home in Michigan's Upper Peninsula formed above interior cathedral ceilings, which were insulated with low-density open-cell spray foam and were unvented. The roof sections with no ice are above unheated areas of the home.

I focused my investigation of the ice dams on three areas: the design of the roof, including the unvented cathedral ceiling; the performance of the spray-foam insulation; and the effect that a blanket of snow on top of the roof would have. What I discovered was that the unvented cathedral ceiling coupled with the heavy snowfall during the winter in question were the main factors causing the snow on the roof to melt and create ice dams.

As it turned out, my client — the builder — settled out of court, and the owner and insulation subcontractor agreed to split the cost of a new roof. They planned to strip the shingles and then install 2x4 sleepers to create a vent channel, followed by new sheathing, new shingles, and soffit and ridge vents.

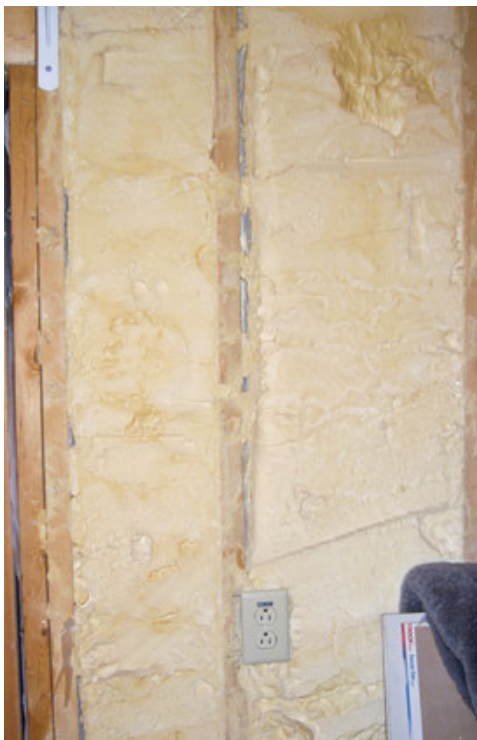
**Insulation R-value.** To measure the insulation's R-value, I used an exterior garage wall. Like the roof, it was insulated with spray foam, and it provided easily accessible surfaces for taking temperature readings on both sides (Figure 2).

I then used heat transfer equations to calculate the R-value of the insulation in the garage wall, which I determined to be 3.2 per inch, with an uncertainty of  $\pm 0.45$ . My result was slightly less than the foam manufacturer's published value of 3.6 per inch, but given the uncertainty, I concluded that the insulation itself was not defective and was performing satisfactorily.

**Figure 2.** By taking surface and air temperature readings on both sides of the foam-insulated garage walls, the author was able to estimate the R-value of the insulation in that location and — by extrapolation — in the cathedral ceiling.

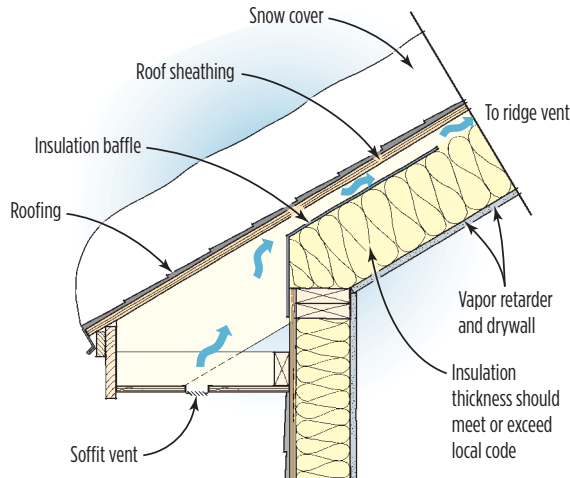
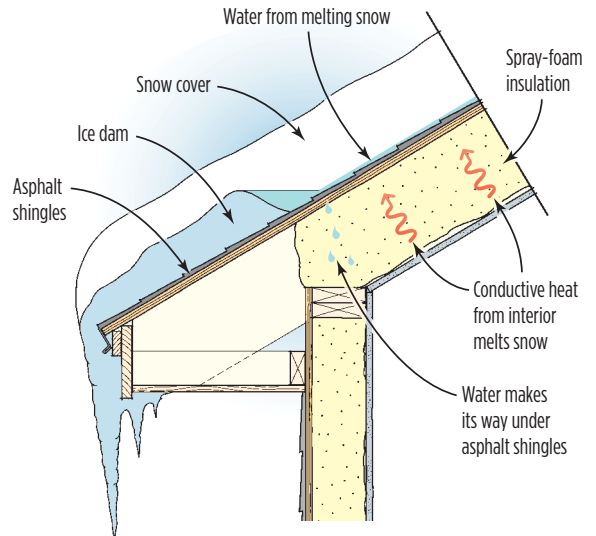
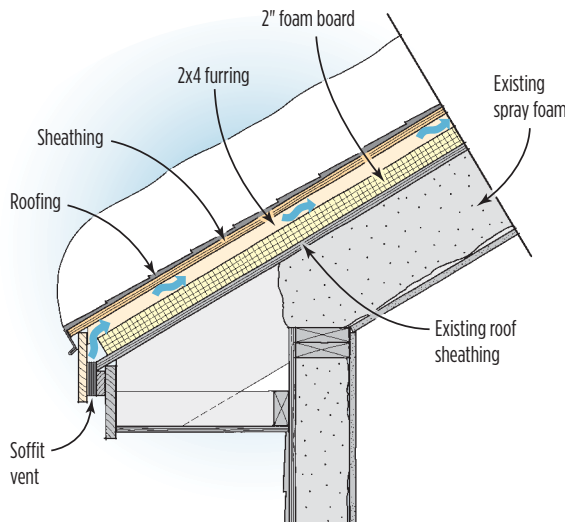
A conventional vented roof slows the melting of the winter snow cover by keeping the sheathing at the outside temperature.

An unvented cathedral ceiling, like the one shown in this article, may cause ice dams as heat from inside the house warms the roof surface.

One fix for an unvented cathedral roof with icing problems is to retrofit a built-up vented assembly. Adding rigid foam insulation increases R-value and slows conductive heat loss through framing members.

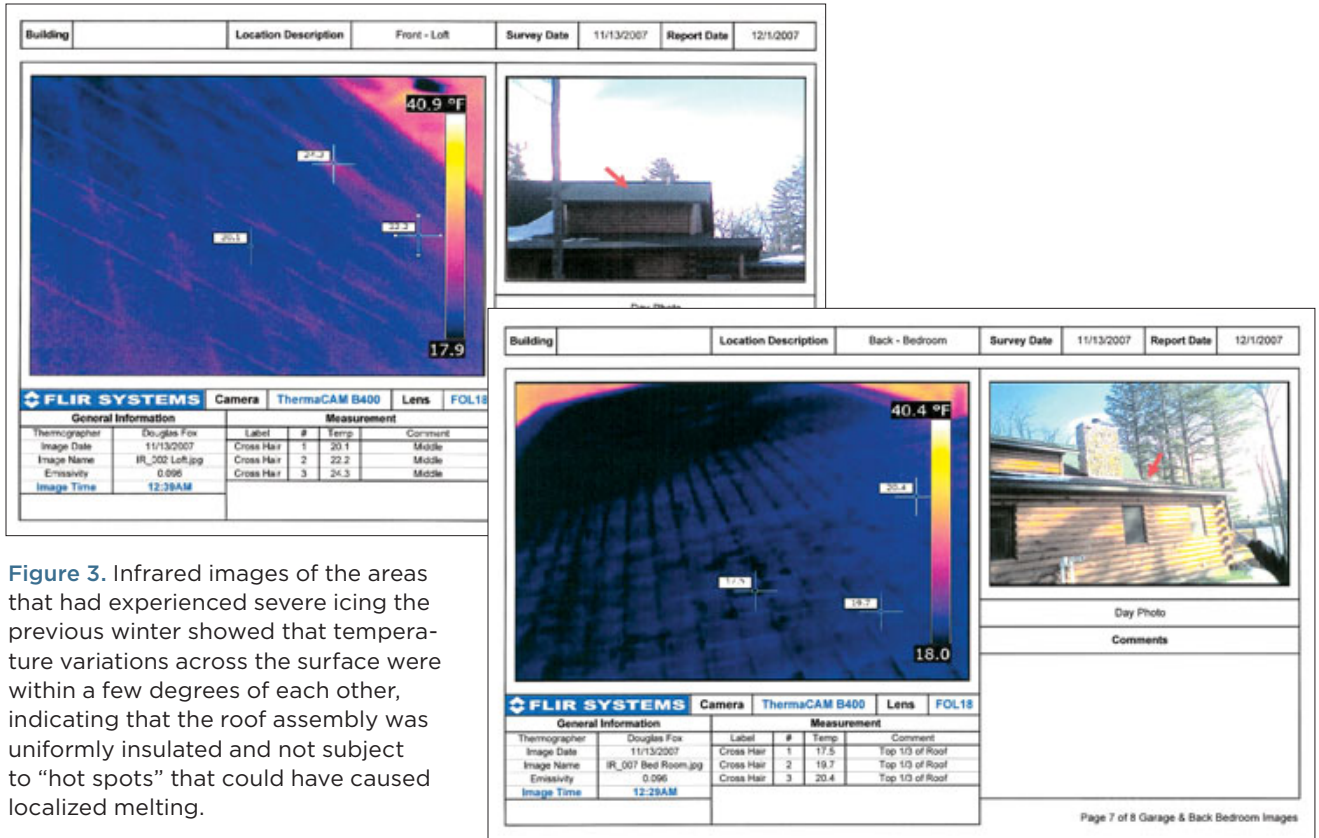
I made a number of thermal images of the roof sections that had experienced icing. The infrared photos showed that the roof surface temperatures were uniform within 3 or 4°F (Figure 3, page 4). This suggests that the roof was uniformly insulated, with no major voids, and that the melting was not the result of local hot spots but was a surface phenomenon.

**Figure 3.** Infrared images of the areas that had experienced severe icing the previous winter showed that temperature variations across the surface were within a few degrees of each other, indicating that the roof assembly was uniformly insulated and not subject to “hot spots” that could have caused localized melting.

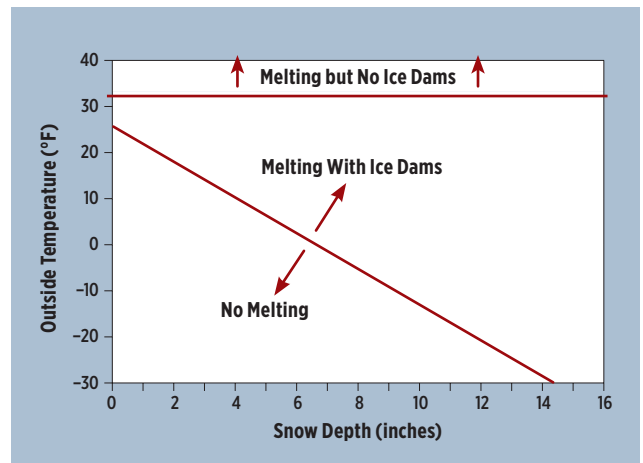
The results of the model are summarized in (Figure 4, page 4). The graph shows that the existing roof assembly would in fact melt snow, given my assumed indoor and outdoor conditions, which are common in Toivola during the winter. For example, with 4 inches of snow

on the roof, melting would occur when the outside temperature climbed above 10°F. The eaves would of course be at the outside ambient temperature, and the liquid water running down the roof surface would refreeze before dripping from the edge, generating ice dams.

**Figure 4.** Given the calculated R-value of the roof and an assumed interior temperature of 74°F, this graph plots melting on the roof surface as a function of snow cover and outside temperature. Below the sloped line, no melting occurs; above it, but below 32°F, melting will occur and ice dams will form at the eaves. Above 32°F (the horizontal line across the top), melting would take place without freezing.

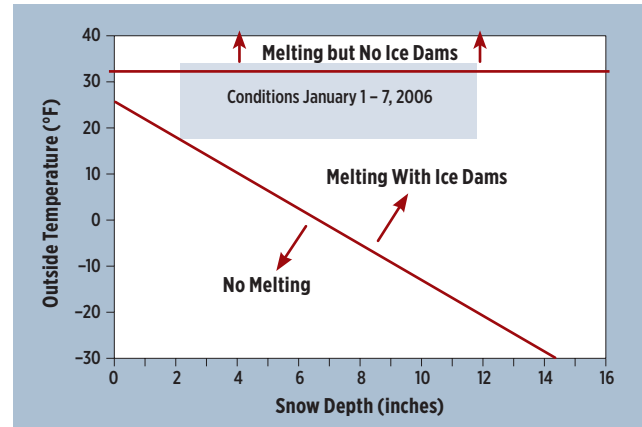
**Figure 5.** The author collected historical weather data for the week before the ice dams were photographed (left), averaged it, and superimposed it on the graph to make the point visually that conditions were ripe for icing at the eaves.

2 to 12 inches, based on an average of the recorded temperatures during the week before the photographs were taken. I superimposed this on the modeled conditions in Figure 4, demonstrating that weather conditions during that week were conducive to ice damming on this roof, as predicted by the heat transfer model.

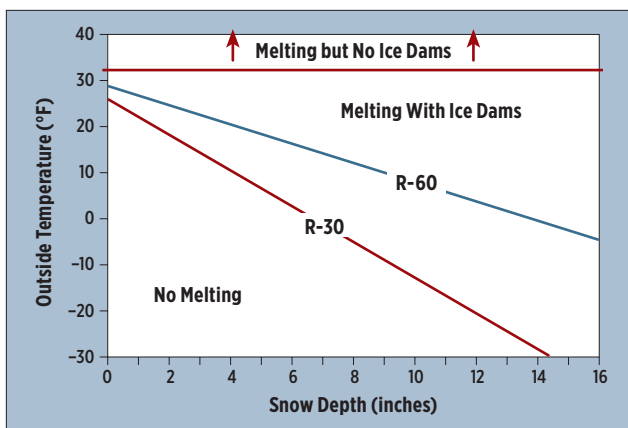
In my report, I concluded that had the builder stuck to the original plans for the house, which showed a fully vented cathedral ceiling, severe ice dams would have been unlikely. In fact, in our region, where it is not uncommon to get 200 inches of snow in the course of a winter, a vented roof assembly is always the safest precaution. As the graph in Figure 6 shows, even if the levels of insulation in the ceiling assembly were increased, normal weather conditions for the region would likely lead to ice dams on an unvented roof.

**Figure 6.** Even with ceiling R-values up to 60, the normal range of winter temperatures would still lead to ice dams, given a blanket of snow on the roof.
