BY KYLE DIAMOND

## Fixing a Poorly Flashed Cupola

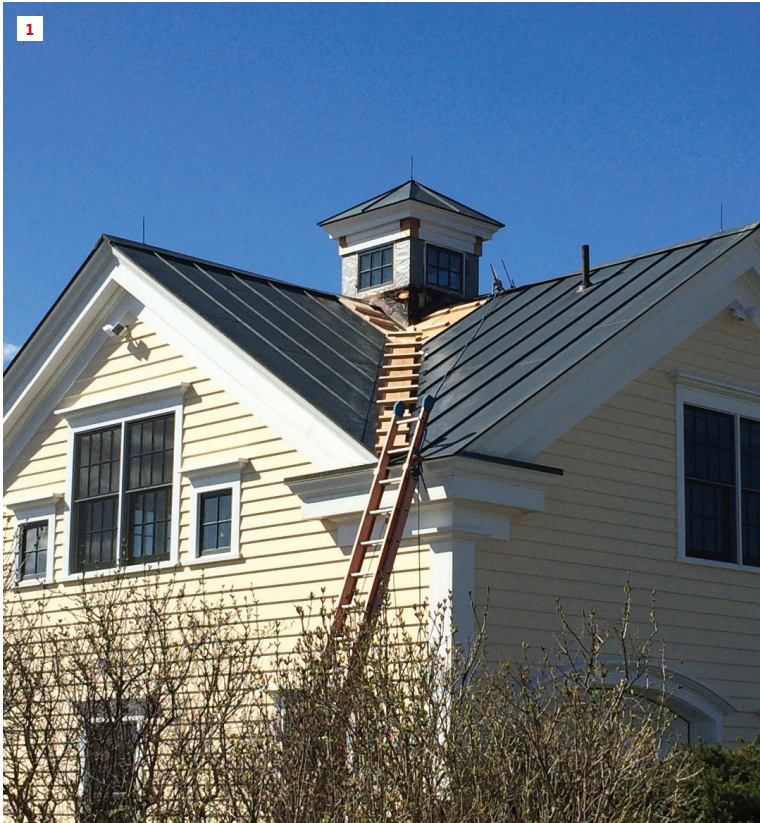
**Last fall, my company was asked** to investigate a roof leak originating from a cupola atop an attached carriage-house garage (1). From the exterior, nothing appeared to be wrong with the cupola or the surrounding roof. But the inside was a different story. The house was fairly new, approximately 10 years old. Above the garage was a guest bedroom with a cathedral ceiling that reflected the roof's four valleys. At the peak, the cupola, with its four awning windows, served as a light well. According to the homeowners, there had been gradual, periodic leaking around the interior light well since the home's initial construction. After a particularly bad storm last summer, the water staining worsened, prompting them to remove the damaged

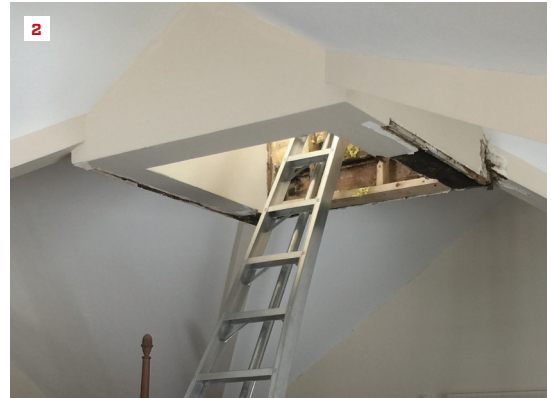
drywall—exposing open-cell-foam-filled stud bays and water damage to the framed enclosure (2). That's when they called us.

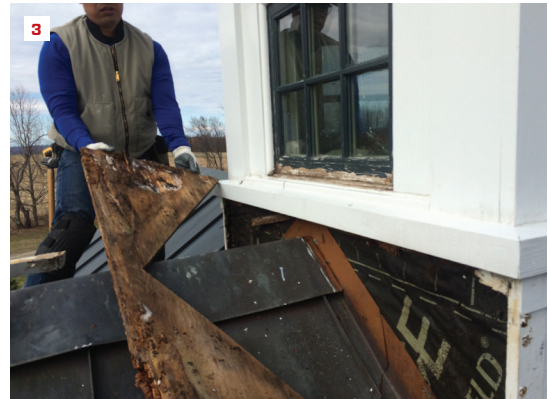
We began our investigation by removing the outer, plywood-clad finish base of the cupola (3). The copper roof-to-wall flashing had been reverse-flashed, with the copper placed on the outer surface of peel-and-stick—the previous builder had omitted the housewrap, which could have easily lapped the vertical leg of the roof-to-wall flashing. Another red flag was that sheathing behind the peel-and-stick at the top of the base felt spongy, which led us to remove the cedar corner boards and wrap-around sill (4). We then discovered that where the cupola's upper portion transitioned to its wider, lower base, there was no flashing; the upper portion's Tytar drainage plane dumped onto the 2-inch-wide, exposed plywood strip at the stepped-out base (5).

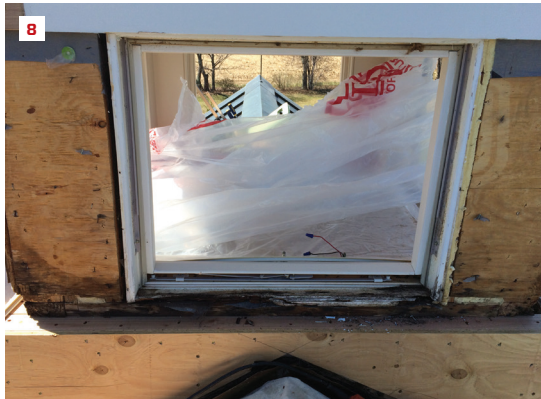
them to rot, while most of the framed sill, which concealed the awning's operable hardware, was not damaged (8). This saved us from having to do any interior trim or drywall work. We managed to remove the rotted portion of the sill, then pulled the sashes and began waterproofing the base.
