RESILIENT BUILDINGS

A Texas Tornado: Lessons Learned Stronger Connections Could Have Saved Homes

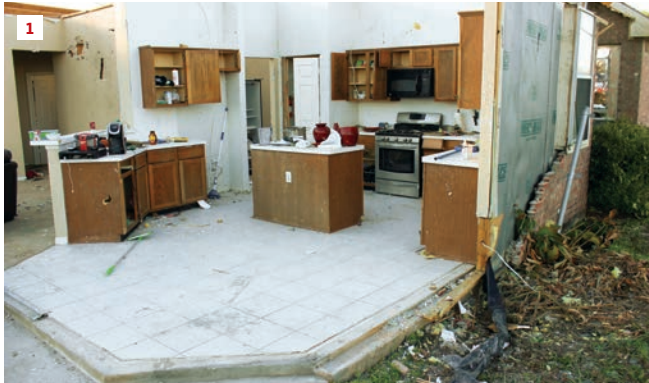
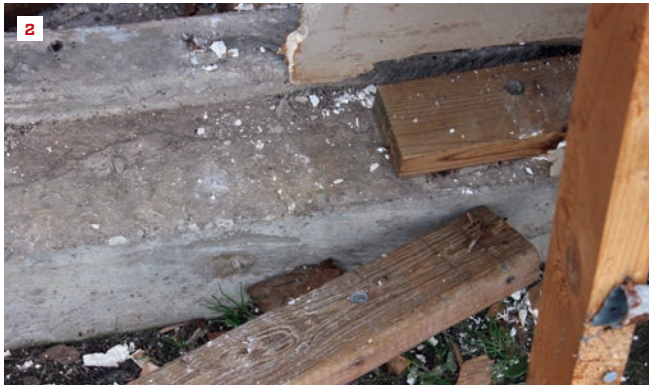
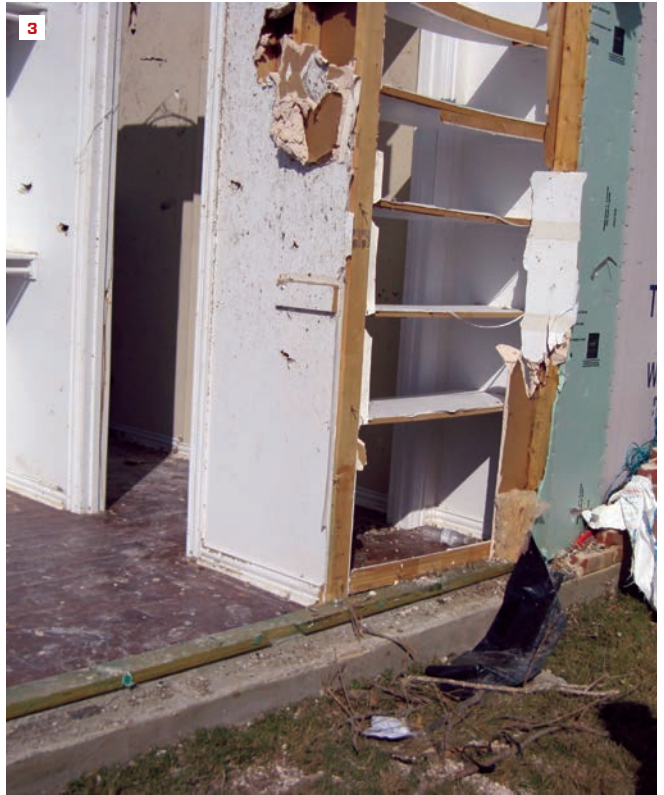
Above are three examples where the wind ripped lower-story walls away from their slab foundations. This kitchen wall (1) was not fastened down with anchor bolts, but only with powder-actuated nails. Nails used to fasten another detached wall plate (2) do not appear to have penetrated the concrete when the plate was installed. In photo (3), the wall plate stayed in place, but the wall above it came loose; the fastening of laminated fiber or foam sheathing was insufficient to hold the wall studs in place.

The 3-inch washers, Uher explains, help to prevent cross-grain bending of the sill plate, as well as preventing the sill plate from lifting off the foundation. In Texas, however, the APA team found many examples where anchor bolts weren’t even used—just powder-actuated nails (which didn’t always penetrate the concrete).

But even where sill plates were firmly attached to the foundation, says Uher, carpenters often neglected to nail the wall sheathing to the plate. That step is important, Uher says: “It really finalizes that connection.”

APA’s 2015 design guide, “Building for High Wind Resistance in Light Frame Wood Construction,” recommends that wall sills be attached to foundations using anchor bolts spaced at 32 inches to 48 inches o.c., connected with nuts over 3-inch washers. The guide calls for walls to be fully sheathed with wood structural panels (OSB or plywood), attached with 8d nails at 6 inches o.c. in the field and at 4 inches o.c. on the edges (including at the sill plate).

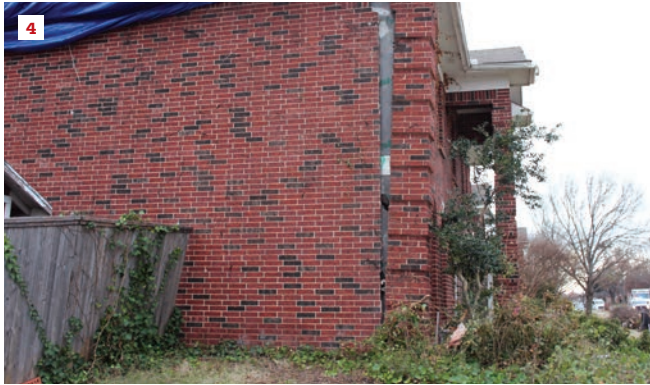
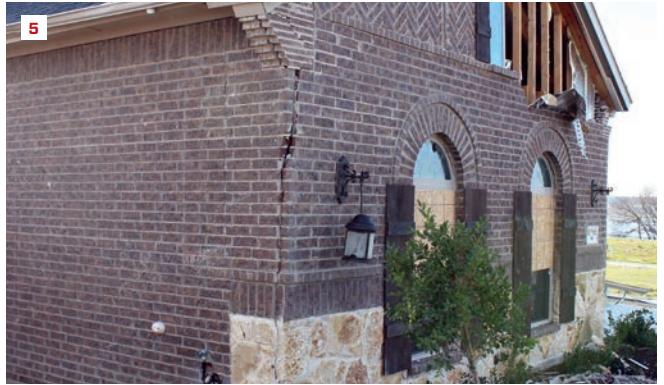
Failure of brick veneer exposed to relatively moderate wind speeds was common on the fringes of the tornado's track. Vertical cracking in the brick at the corners of buildings (4, 5) was a typical failure—the result of lateral displacement, or “drift,” of stud walls built without sufficient bracing. In one case (6), brick veneer and foil-faced foam sheathing were both blown off the gable wall—possibly after the wind breached the garage door. In another example (7), portions of a brick wall collapsed. “Lateral flexibility within these structures is incompatible with rigid and brittle brick-veneer wall coverings,” notes the APA report.

Images 4 and 5 (above) show big cracks at wall corners. “We saw this repeated over and over again in Texas,” says Uher. “We think

that it is due to lateral displacement. Brick is really brittle, and the lack of flexibility of brick can be a problem in these high wind speeds.” Structural wall bracing is important to maintain stiffness so that inflexible components such as brick cladding, doors, and windows will not be damaged by “drift” of the wall structure.

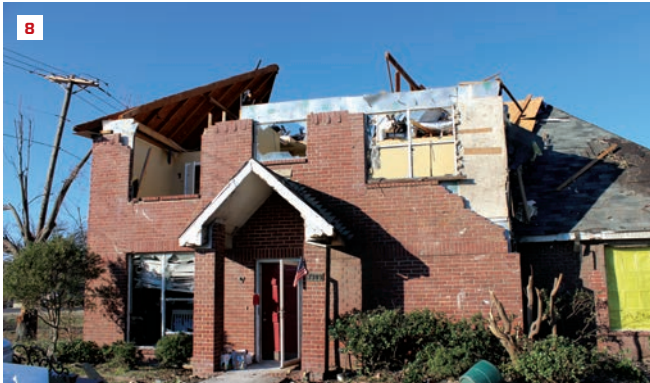
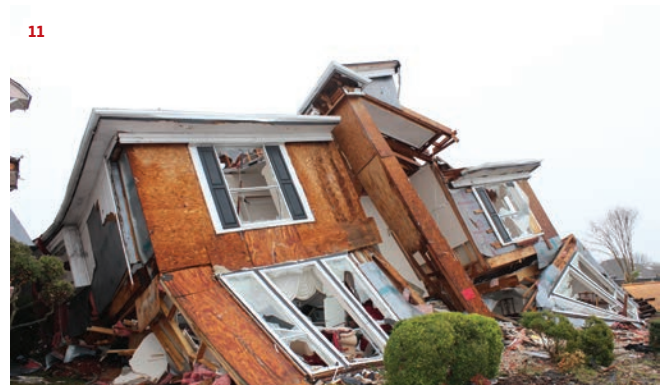
Perfecting the wind uplift load path requires tying roofs to the tops of walls and tying upper-story wall systems to lower-story walls. In the Garland-Rowlett tornado, homes suffered complete loss of the roof structure because wall plates weren't tied to walls with well-nailed structural sheathing, or roof members weren't securely fastened to wall plates (8). In other cases, inadequate connections between upper and lower stories resulted in the destruction of upper stories (9). Inadequate bracing of tall walls (10) and lower-story walls with multiple openings (11) also resulted in structural failures.

In the Garland-Rowlett tornado, that wind force pulled some roofs off their walls. Touring the damage zone, APA engineers noticed that the connection of walls to roof was often insufficient. Roof framing wasn't typically tied down to wall plates with metal connectors, and wall sheathing often didn't overlap wall top plates.

In high-wind events, the roof-to-wall connection is subject to shear as well as uplift loads, notes the "Building for High Wind Resistance" manual. APA recommends framing connectors that can handle both kinds of loading, attached on the outside of the wall. Sheathing should overlap the plate, with nails at 4 inches o.c.

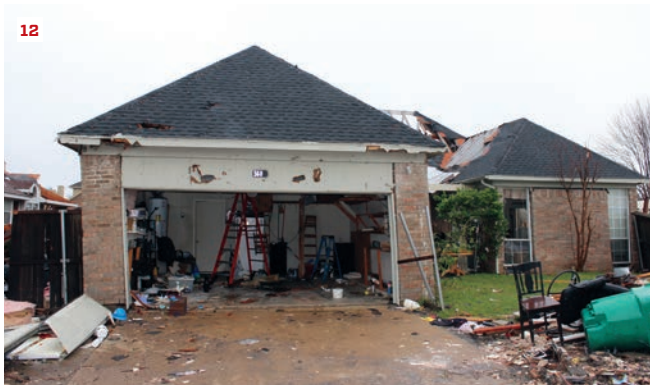
This garage door opening (12) shows a classic racking failure that is also commonly seen in earthquakes. Image (13) shows similar racking of another garage door frame, plus catastrophic failure of the adjacent walls and roof—likely a result of the sudden pressurization of the building when the garage door was lost. In images (14) and (15), pressurization of the garage apparently contributed sufficient force to cause the loss of roof sheathing in nearby areas of the main house roof.

One code-allowed solution is to use a “portal frame” as prescribed in the International Residential Code (IRC), with a continuous header across the large opening, and heavily nailed wood structural panels tying the wall framing to the header—plus metal anchors tying the wall base to the foundation.

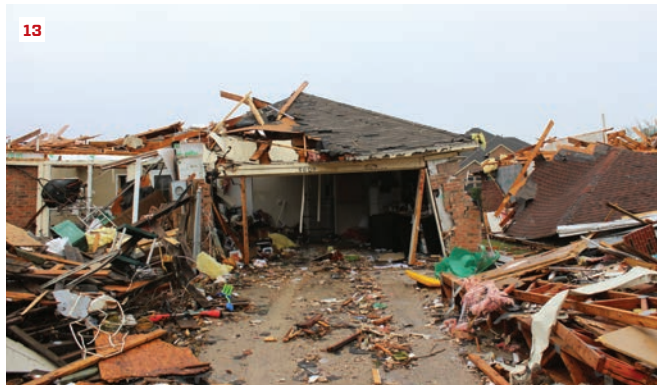
But the garage door itself can also be a weak point. “Failure of a garage door pressurizes the inside of the house,” explains Uher. “Once the garage doors go, the wind is now not only on the outside of your house, but inside. You have suction on the roof, plus pressure from underneath. The pressures double, essentially—and then it’s typically a sudden failure of the roof.” One weak link can be the connection of the wall to the roof. “If that fails,” Uher says, “it allows both your walls to fall out and your roof to blow off.”
