## Resurrecting a Sagging Roof

BY JAKE LEWANDOWSKI

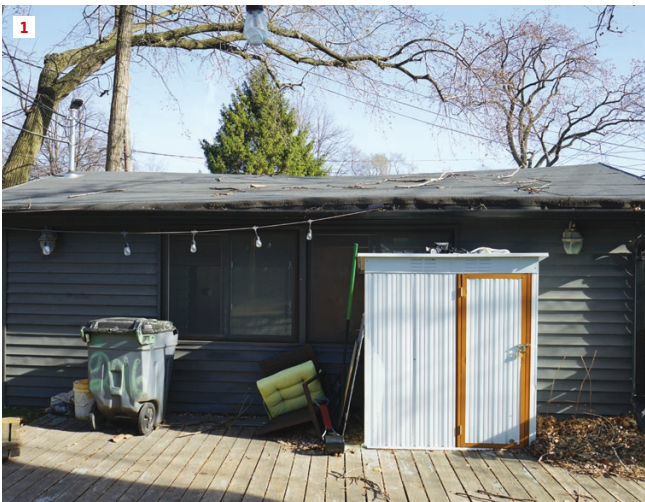
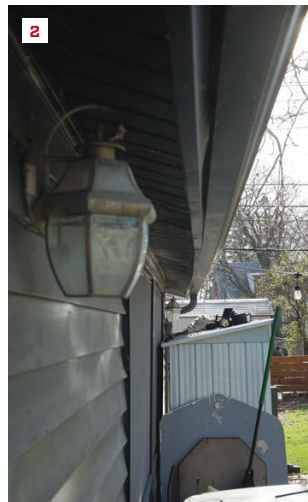
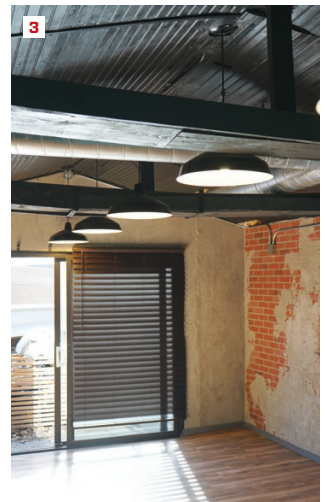
**On a recent job**, we were called in to repair a garage that had been converted to the primary bedroom of a home near Chicago. It was visually apparent that the roof had some deficiencies. The ridge had a substantial sag, which in turn pushed the exterior wall out of plumb upward of 3<sup>1</sup>/<sub>2</sub> inches at its worst location.

The roof structure was insulated and had been finished with wood paneling. It also included widely spaced tie beams that were more cosmetic than structural. Cathedral ceiling areas like this one require a structural ridge beam to support the roof loads, or adequate rafter ties or ceiling joists to resist the outward thrust of the roof loads. This building lacked both.

**Before.** The structural problems of a small primary bedroom addition were immediately apparent to the author: The ridge sagged (1) and the bearing walls had been pushed out of plumb, causing the top plate to bow outward (2). The cathedral ceiling had only widely spaced ties that were boxed-in to look massive but were more cosmetic than structural (3).

turally sound state. Working with a local engineer, we determined the most cost-effective approach was reinforcing the 2x4 rafters with modified 2x6s and adding rafter ties along with intermittent collar ties.

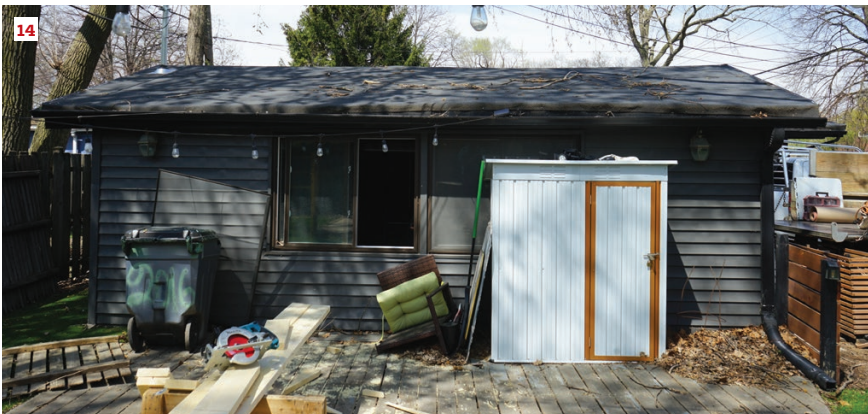
**After.** When the job was completed, the sag in the ridge (14) and the bow in the outer wall were vastly improved.
