# Brick Veneer & Steel Studs: Performance Questions

Some researchers question the durability of this popular building system, particularly in damp climates

by Jim Cowie  
and Mike Wilson

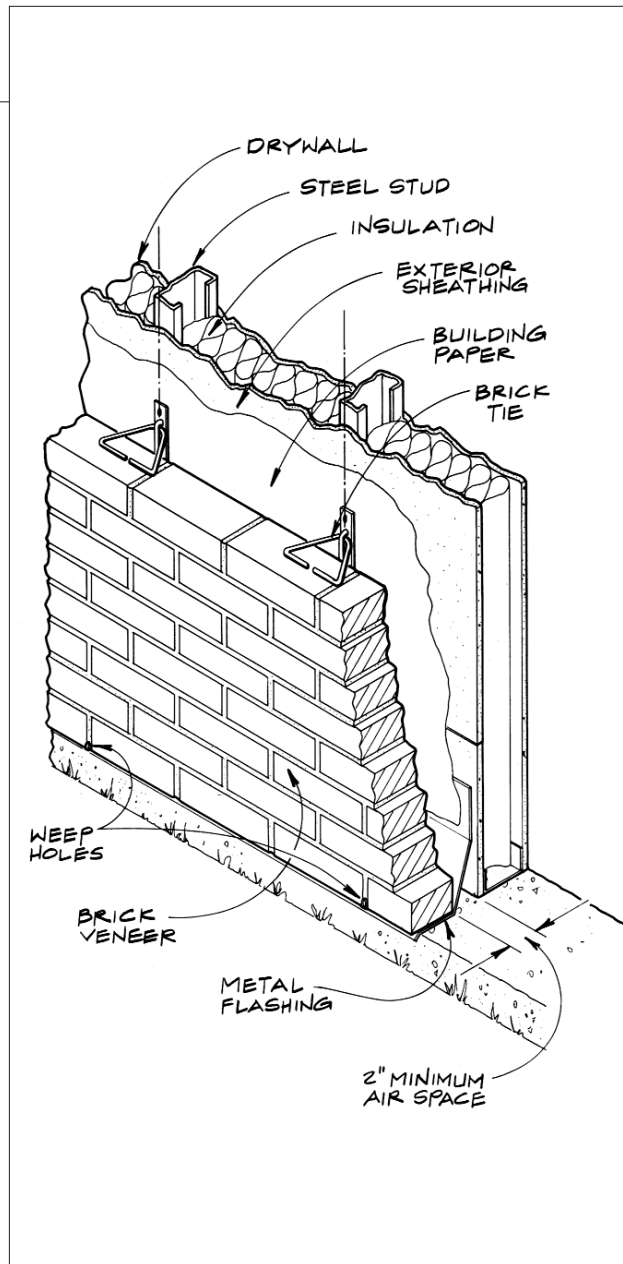
**Figure 1.** For the brick-veneer/steel-stud system to perform properly, special attention must be given to flashing shelves and openings. A minimum of 2 inches must be maintained between the brick and the stud wall. Bricklayers must be careful not to allow mortar droppings to clog the cavity.

The brick veneer is connected to the studs with brick ties leaving, ideally, 2 inches of unobstructed air space between the sheathing and the brick. Until recently, the recommended cavity was only 1 inch. But tests, as well as real life examples, have shown that a cavity that narrow is prone to clogging from mortar droppings, leaving no escape route for rainwater that penetrates the veneer.

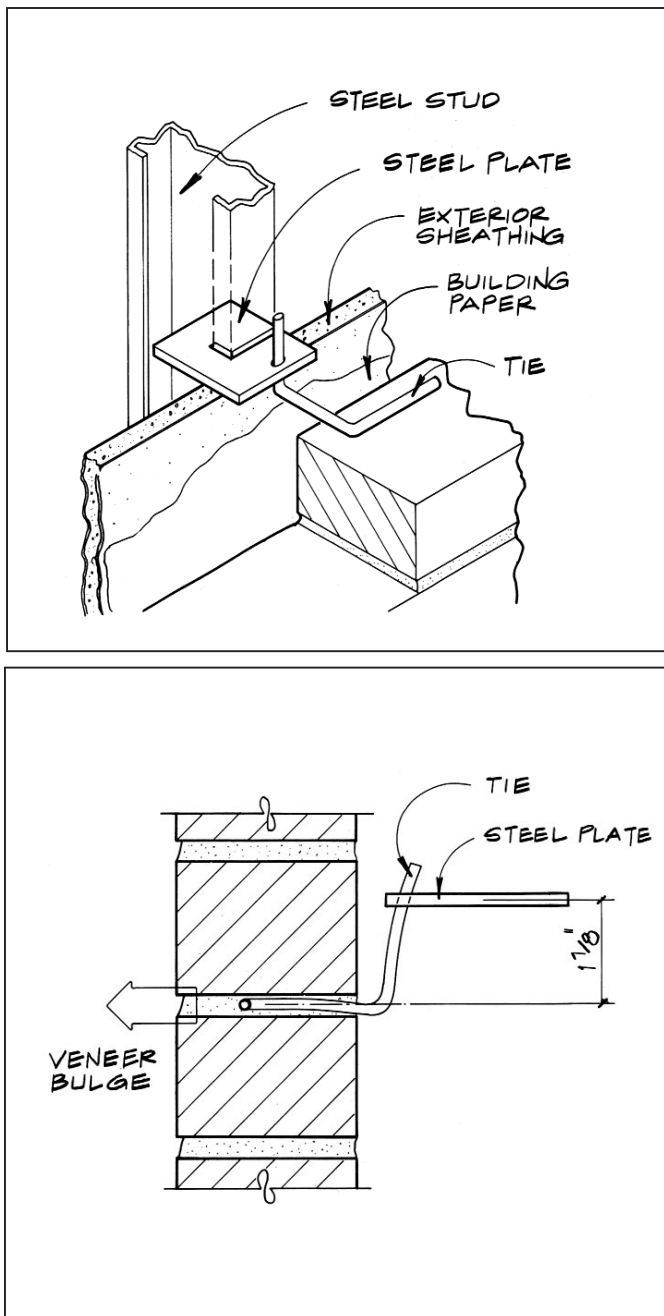
**Figure 2.** Many brick veneer problems are related to the ties. This type of tie (top) uses a steel plate that penetrates both the building paper and sheathing, allowing moisture to enter. The placement of the plate is critical. If it is placed near the top of the wire tie (above) it offers little support to the brick veneer, allowing it to bulge and lean.

Using ties that incorporate steel plates (Figure 2), which require slicing the building wrap as well as the exterior sheathing, is particularly disastrous. It is next to impossible to adequately seal these slices. As a result, the ties create a bridge between the veneer and the studs, providing leakage paths for water

To compound problems, the ties were incorrectly installed with variances of as much as 17/8 inches in vertical distance from the bed joint to the horizontal steel plate. The angled wire gave little or no support to the brick veneer, allowing it to bulge and lean.

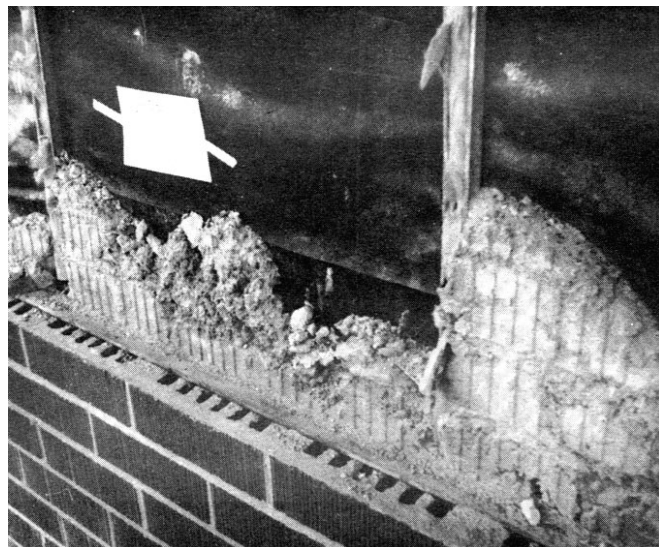
**Figure 3.** The cavity behind the brick veneer is clogged with mortar, trapping moisture and holding it against the stud wall.

- The wall cavity was bridged with mortar droppings, clogging the

weepholes and allowing rainwater to come in contact with the backup wall (see Figure 3, previous page).

construction. Stiffer, custom-designed brick ties were locally fabricated for use in the restoration. To prevent clogging the flow of water to the weepholes, a net cavity width of not less than 2 inches was maintained. Most importantly, we provided continuous on-site inspection, insuring good workmanship.

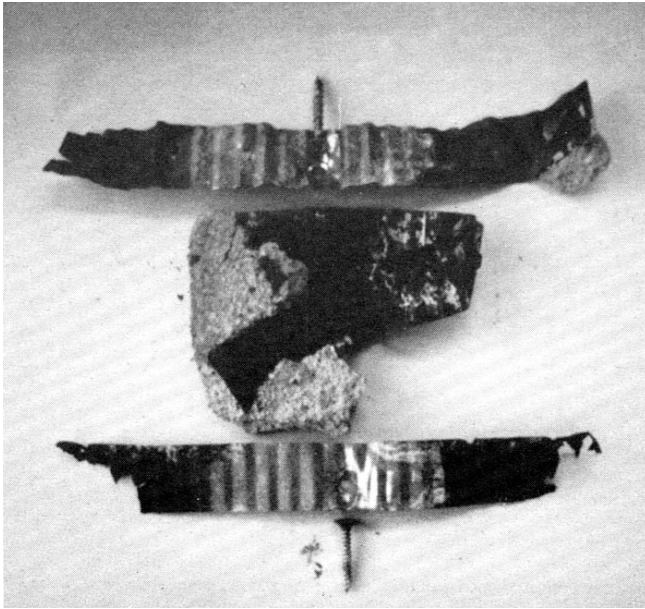
**Figure 4.** These severely rusted ties provided little support to the brick veneer. Better corrosion resistance is required.

- No movement joints were installed below the shelf angles, forcing the veneer to bulge and crack.
- Flashings were either improperly installed or missing altogether.
- The brick ties that were used lacked adequate strength, stiffness, and corrosion resistance. Many were severely rusted (see Figure 4).
