# Classic Porch Revival

A mix of original and new materials refreshes an old porch

by Emanuel Silva

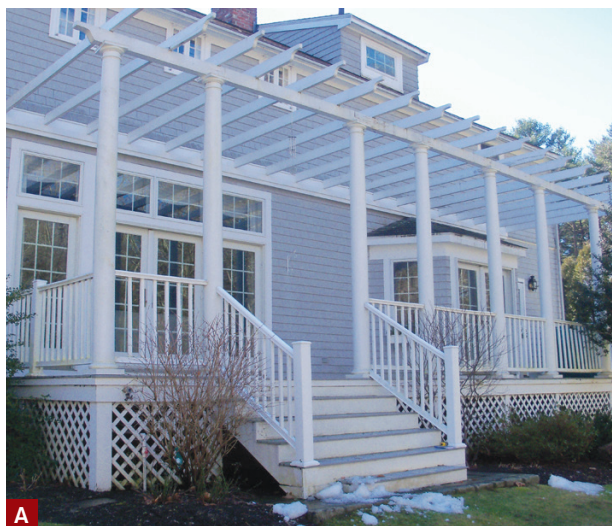
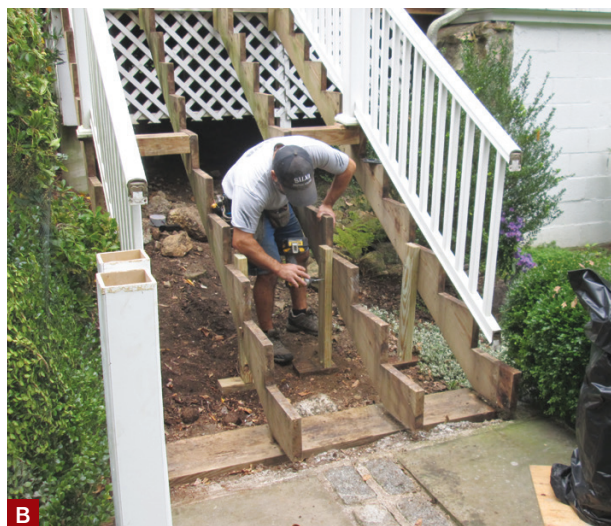
Though the porch framing was 18 years old, it was in excellent condition thanks to the CCA-treated lumber that had been used to build it. Even the ledger was well-flashed and securely fastened to the house framing. I would have preferred to replace the railings, which had been assembled from a prefabricated composite kit, but they were still serviceable, and the owner wanted to retain them.

**Figure 1.** While the original porch framing was sound, the worn and weathered decking needed replacement (A). Part of the repair strategy was to retain the stringers for one set of stairs but pour a new landing pad to support them (B).

After removing their treads and risers, I discovered that the key element missing from both sets of stairs was adequate support at ground level.

The stringers for the long flight of stairs off the side of the porch were simply bearing on a 2x12 that was on the edge of—but not fully bearing on—a small concrete slab landing topped with stone pavers. After temporarily supporting the stringers midspan, I formed and poured a new steel-reinforced concrete landing pad. With solid support, the old stringers simply needed new treads and risers.

too weak. In either case, it often comes down to the stringers—should they be kept or replaced? In this case, the answer was both; the owner agreed with me that the stringers for the shorter, front flight of stairs should be replaced, while the stringers for the longer, side flight could be retained (**Figure 1**).

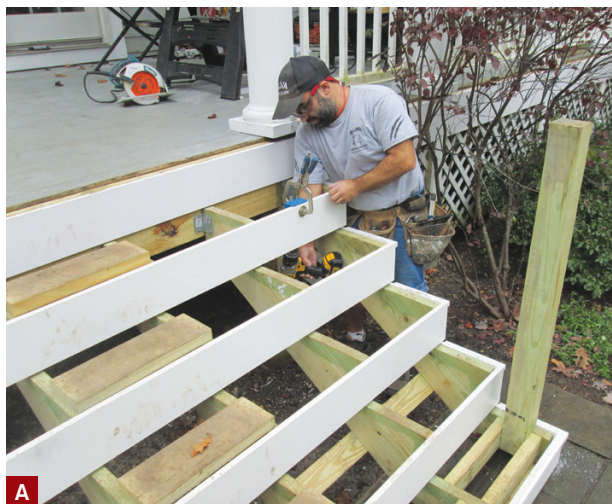
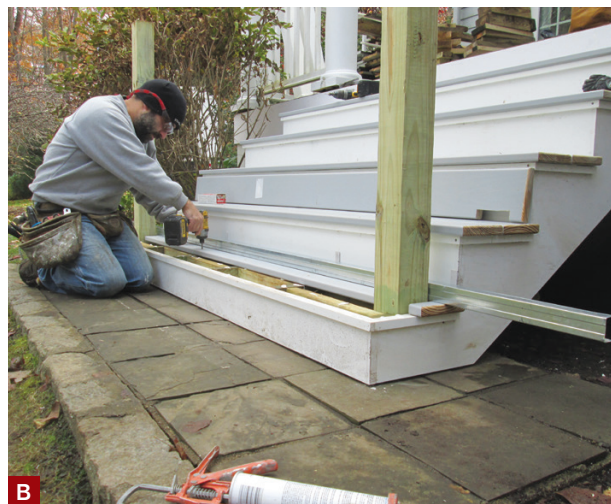
**Figure 2.** The author reframed the front stairs, cutting new stringers and installing a new dropped header to help support them (A). New 5/4x6 deck boards were face-screwed to the framing after the PVC skirts and risers were installed (B).

different length to account for the uneven stone paver landing, but there were only five stringers, while the span table for this particular type of  $\frac{5}{4}$  decking on this width of stairs called for six. I also wanted to improve the header detail so that the tops of the stringers would have a better connection to the deck framing.

Finally, when I removed the posts underneath the composite post sleeves that formed part of the railing system, I discovered substantial rot where the posts connected to the stringers. The owner agreed with my assessment that the stair framing should be replaced prior to installing new treads and risers (Figure 2).

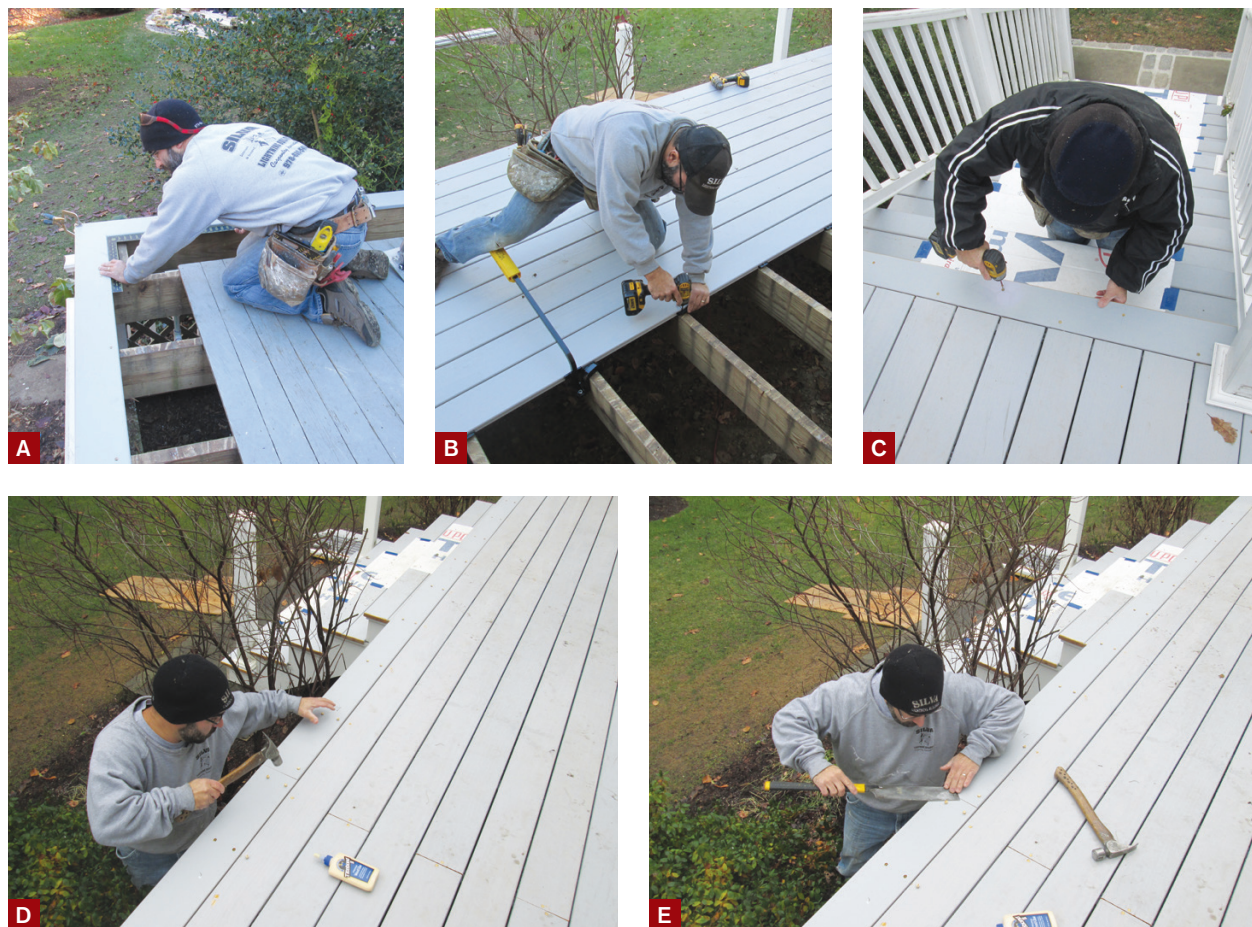
**Figure 3.** Working from the old decking, the author installed the picture-frame border using  $\frac{5}{4} \times 6$  square-edged decking (A). The field decking was grooved for hidden fasteners (B). After face-screwing the border and treads to the framing (C), the author filled the countersunk holes with plugs cut from the same material (D). Then he flush-cut the plugs (E), sanded them smooth, and used a touch-up paint to color-match the plugs to the rest of the decking.

The only hiccup that I encountered with the decking was trying to color-match the cut ends and plugs to the decking. The manufacturer-supplied touch-up coating was supposed to be opaque, but it applied like a translucent stain, even after vigorous mixing and multiple coats.

For the treads and picture-frame border, I had specified square-edge  $\frac{5}{4} \times 6$  boards, while the field decking was grooved for hidden fasteners, which were supplied with the decking (Figure 3). Because the wood was prefinished, the manufacturer also supplied a quart of matching sealer/finish.

The decking was straight, flat, and free of defects, and installing it was a treat. In the field, I used hidden fasteners, while I face-fastened the picture-frame border and treads. I counter-bored the  $\frac{3}{8}$ -inch-diameter holes for the stainless-steel screws I used to fasten the decking to the framing, and I filled the holes with custom-cut plugs.

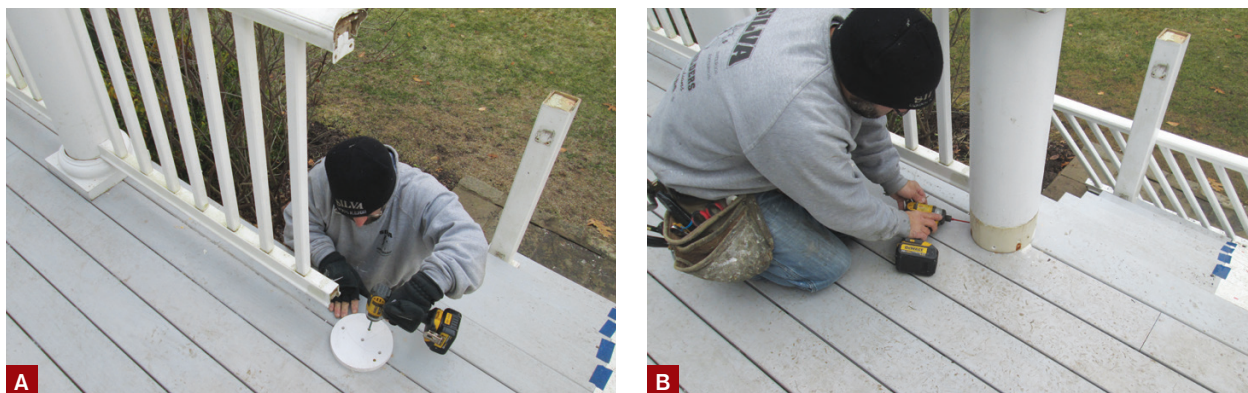
The porch had a pergola supported by PermaCast columns. Because the tops of the columns hadn't been capped when they were originally installed, water had gotten inside them, causing damage to the decking underneath. Otherwise, the composite columns were in good shape, although the pergola they supported was

**Figure 4.** The author cut PVC plugs sized to fit inside the bases of the columns and screwed them to the decking (A). This ensured that the columns would be reinstalled in their original locations (B) and that the railings could be reused.

My solution was to cut round plugs out of 2-by PVC stock that could be inserted into the base of each column. I screwed the plugs in place on top of the decking according to my map, and then slid each column into place over a plug for a perfect fit. A few screws driven through the sides of the columns into the plugs secured them to the decking as I reinstalled each rail section (**Figure 4**).

I wanted to keep water out of the columns, so I also cut round PVC plugs for their tops. I capped the columns with the plugs and a bead of sealant before installing the 4x6 red-cedar beam,

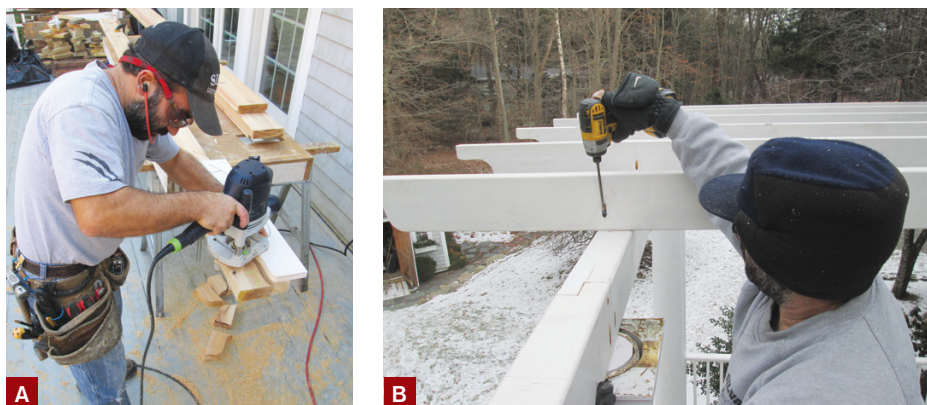
not. Built with common framing-grade material, the beams and rafters were overdue for replacement.

**Figure 5.** After pattern routing the rafter tail profiles (A), the author primed and painted the 2x6 red-cedar rafters and fastened them to the house ledger and 4x6 beam with structural pocket screws (B).

To duplicate the profile that had been cut on the tails of the original rafters, I made a pattern to clamp to the ends of the new 2x6 red-cedar rafters and use as a template. I cut the rafter tails with a bearing-guided flush bit, and then I primed and painted the rafters. Prior to installation, I used a Kreg jig to cut pocket holes at the house ends of the rafters and in the faces of the rafters where they bear on the beam. Installation was simply a matter of driving coated structural screws through the holes into the ledger at the house and into the beam (**Figure 5**). ♦
