A Study in Broken Load Paths Repairing the havoc wrought by sloppy prior work

BY JAKE LEWANDOWSKI

A STUDY IN BROKEN LOAD PATHS

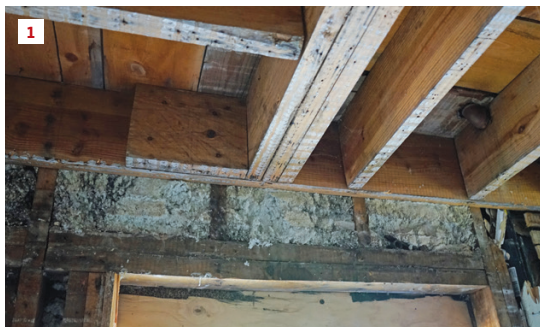
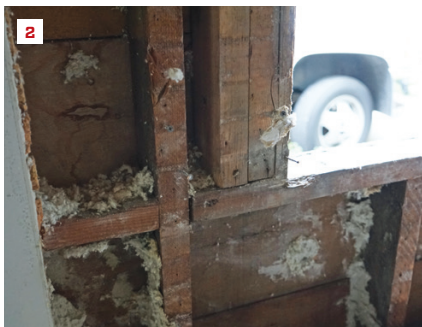
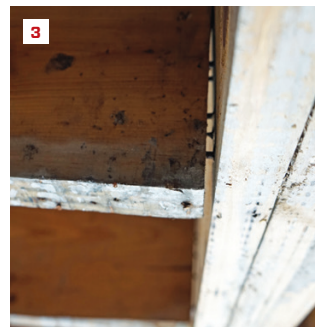
This flush beam in the second floor had no bearing on one end, only nails loaded in shear into a ledger **(1)**. The ledger was partly carried by cripple studs, but the header supporting these cripples had no support **(2)**. No joist hangers supported the joists carried by the flush beam **(3)**, and the end nails had pulled away as the beam, which was overloaded on one side, had rolled.

2) A flush beam in the second floor had no bearing at one end. It was simply toenailed into a ledger that was nailed to cripple studs, and the window header that picked up the loads on these cripples had no support

extending to the foundation. In addition, this beam was overloaded on one side and had rolled. The framing predated joist hangers, and the end nails securing the joists to this beam had pulled away.

Toby and Ernesto erect shoring on one side of the old flush beam (23). After removing it, they cut through the ledger so the new flush beam will extend over the window (24). They use shoring to lift the beam into place (25). With the beam raised, the joists are secured with joist hangers (26), and a new LVL header is installed with full-length jacks (27).

At one end of the flush beam, the load path from beam to window header to full-height jacks is complete (28). At the other end, the flush beam has full bearing on a corner column (29) that bears directly on the new steel beam that spans the girders in the basement. To complete the job of reinforcing the floor system, the joists hacked up by plumbers are headed off (30, 31).

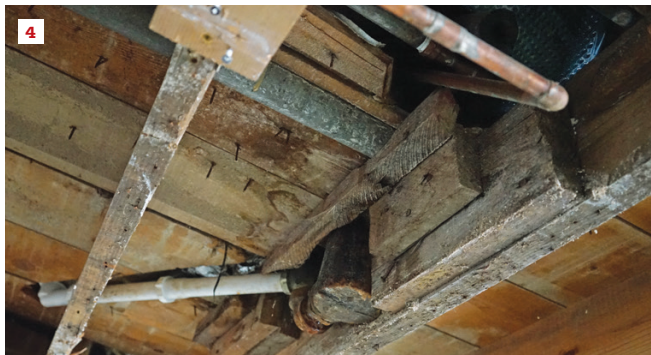
Plumbers over the century had done a good job of carving up floor joists **(4)**. The span and width of this undermount header **(5)** required a double LVL, but the remodelers who installed it to open up the room to the kitchen had used a double 2x12 instead.

1) Undersized floor joists on the second floor had sagged. In addition, an area of this framing below a second-floor bathroom had been severely chopped up by plumbers.

Once the main floor elevation was established, we could install a new flush beam (four LVL plies) and new undermount beam (two LVL plies), as well as rebuild the floor where the plumbers had hacked it up. This required adding headers across joists to carry the loads around the plumbing so we could remove the cut-up joists. It was painstaking work, as it's difficult to screw off framing hardware in such tight spaces. Nevertheless, it's critical to follow through with tight joints and all holes in the hardware filled with screws.

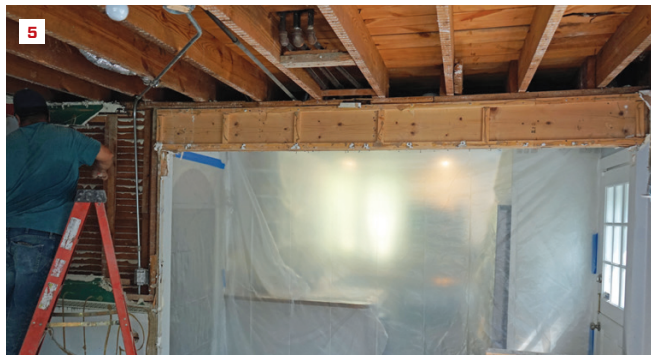
4) An undermount header that had been retrofit to enlarge a door opening into the kitchen was undersized and unsupported. This beam was in line with the flush beam. For its span and depth, the engineer said it needed to be LVL, but the remodelers who installed it had used dimensional lumber, and one end column did not have bearing that transferred to the basement girders.

Prior to removing the old undermount beam, the crew erects shoring on each side of the opening (19). The author joins two LVLs with structural screws and planes the top to flush up the two plies to get good bearing on both (20). The beam is lifted into place (21). It extends beyond the corner so the end column (22) bears directly on the new basement beam.

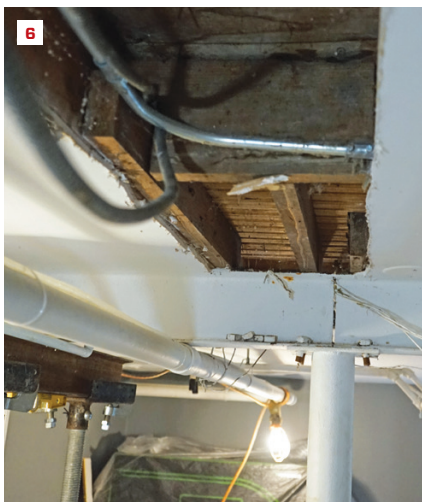
In this joist bay **(6)**, a new steel beam will be installed perpendicular to this basement girder. (It will span to another girder that runs parallel to it). The column supporting this girder had almost no footing **(7)**.

Before lifting, we installed a new steel beam spanning between the two existing basement girders. This new steel beam was positioned directly under the previously unsupported wall section; it would support the corner column at one end of the flush beam as well as the column at one end of the undermount beam. Jacking up this new beam to level straightened the wall plates and lifted the reinforced second floor as well.

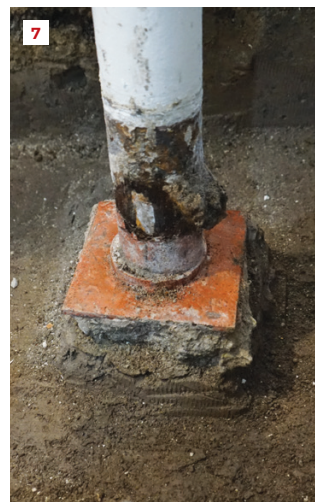
5) A steel column that supported one of the basement girders was failing because it had almost no footing.

At the top of the wall section described above, the pencil line **(13)** shows the position of a laser before the beam is jacked into position in the basement **(14)**. When the beam is level, the wall has been raised more than an inch **(15)**. Steel shims are placed between the new beam and the old basement girders **(16)**. A new footing is prepped **(17)** and poured **(18)** for the new column.

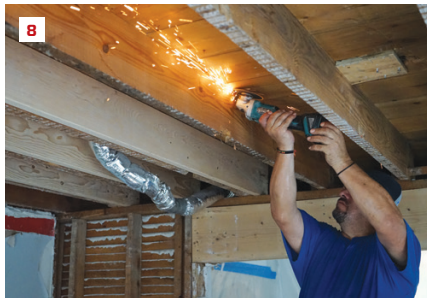
Ernesto Bonilla cuts flooring nails **(8)** so sister joists will fit tight to the existing ones. He and Toby Bonilla roll in sister joists **(9)**; a screw and hammer help pull the sisters flush to the bottom edge of the existing joists **(10)**. Blocking is key to stiffening the floor **(11)**. The studs in this critical wall section **(12)** had bowed and are reinforced before any jacking is done.

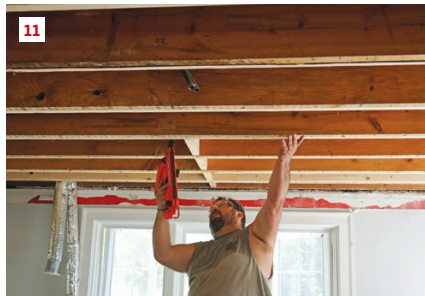
3) An unsupported bearing wall was failing. It was carrying the other end of the flush beam, as well as a section of the underbuilt second floor, but it had no bearing in the first floor that transferred directly to the two steel girders in the basement.

We also strengthened the unsupported bearing wall section mentioned above. The top and bottom wall plates had sagged at each stud, and the studs themselves were bowed. By reinforcing the wall with additional, plumb studs, we could reliably lift from below, knowing that everything would stay straight and the lifting force would be effectively transferred, raising the structure as a whole.
