BY DOUG HORGAN

Getting to the Bottom of a Stone-Veneer Leak

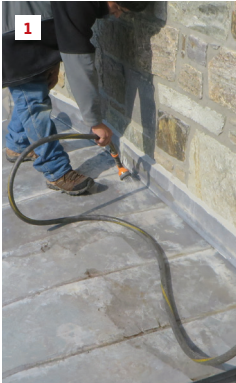
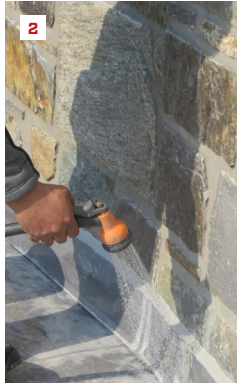
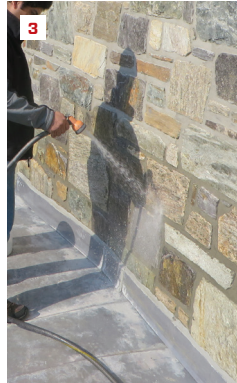
Located on the first floor, the 4-foot-by-10-foot bumped-out bay had a soldered metal roof that appeared to be in good condition. We water-tested the roof and found no leaks **(1)**. We didn't want to test the whole structure at once; we wanted to start at the bottom and work our way up so we could locate the issue. So next we moved our gentle water spray up onto the flashing, aiming the water downward to avoid wetting areas above the flashing. The flashing itself didn't leak, so we moved a bit higher, to the sealant joint at the top of the flashing **(2)**. This too didn't seem to leak.

We then started spraying the stone wall above the flashing **(3)**. While roofing and flashings often leak within a few minutes, our experience with masonry is it can take 10 minutes or longer for water to leak all the way through and appear inside. Sure enough, after about 10 minutes, a steady drip started off the bottom edge of some building felt that terminated at steel angle shelf **(4)**.

The roof over a bump-out abutted the second floor's stone-veneered wall. Water-testing progressed upward: First, the soldered metal roof was water-tested **(1)**, then the counterflashing and the sealant joint just above the roof **(2)**, and last, the stone wall above the flashing **(3)**.

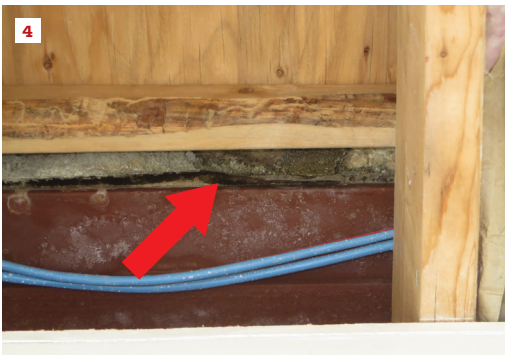
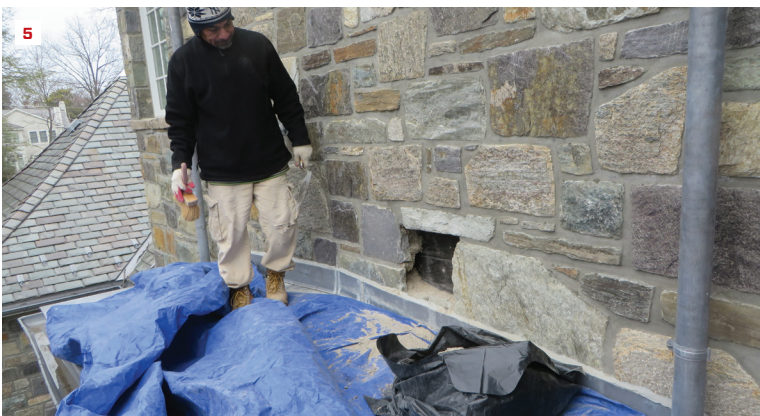
At this point, we were pretty sure the masonry was missing a through-flashing that would direct water out of the wall above the roof, a common and easily avoided problem we find fairly often in our area. To confirm, we removed some stone above the roof to see how it had been built **(5, 6)**.

After 10 minutes, water appeared inside the house at the bottom edge of the felt WRB, which terminated at steel angle shelf **(4)**. Removal of a stone confirmed that through-wall flashing had not been installed **(5)**.

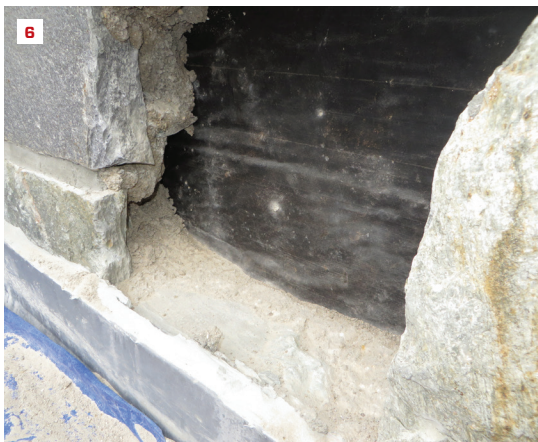
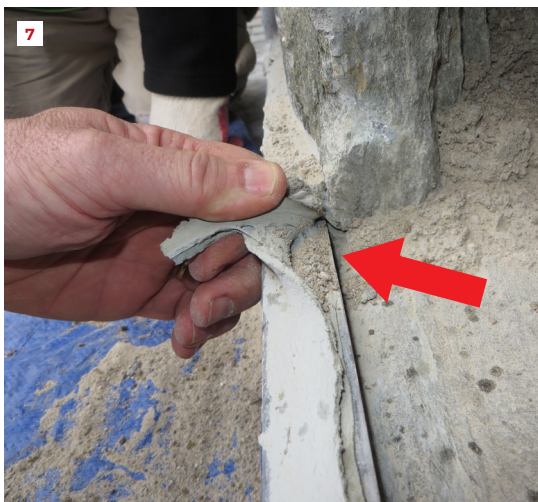
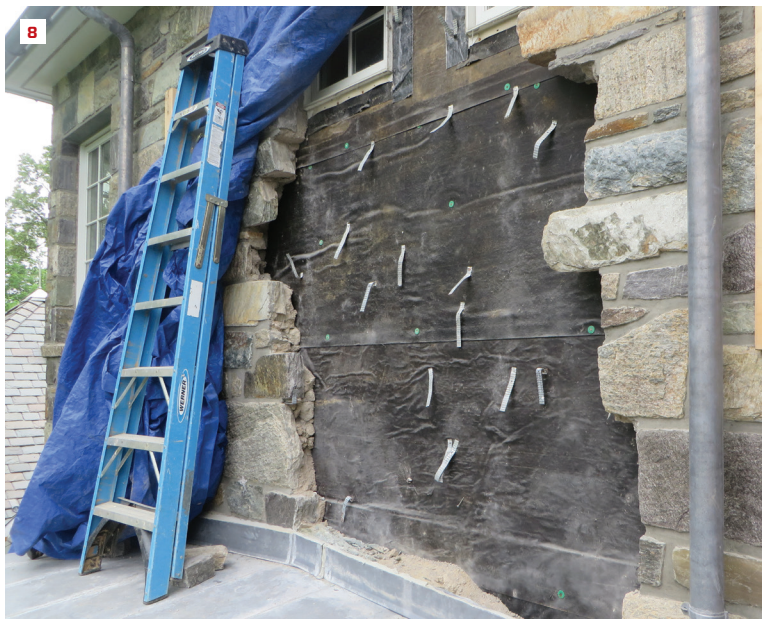
We discovered the roof flashing was cut into the face of the stone and went in only about 1/2 inch **(7)**. Any water draining down within or behind the stone veneer would simply run down past the roof into the ceiling inside the house (see "Leak at Stone Veneer," next page).

The roof counterflashing was inserted into the face of the stone (6) about 1/2 inch (7). The continuous bead of sealant at the saw-cut-in flashing may have helped keep bulk water outside during lighter rain events, but when it rained long and hard enough, water draining down behind the stone veneer would simply run down past the roof and into the ceiling below (see illustration, right). The existing mortar had been mixed up dry on site and so was very loose and porous. The stone had been laid up without an air space, which was code-legal for a brief while in the vicinity where the author works. Though it was common practice, it was not ideal from a water-management perspective. Installing proper through-wall flashing entailed having to remove the granitic stone veneer (8).

A multilayered solution. We removed the stone down to a block starter course **(8)**. The existing double WRB layer, which consisted of 30-lb. asphalt felt over a layer of Tyvek, was also removed. (Ultimately, we discovered enough problems with the stone veneer that we ended up removing all of the stone on the addition portion of the home.)

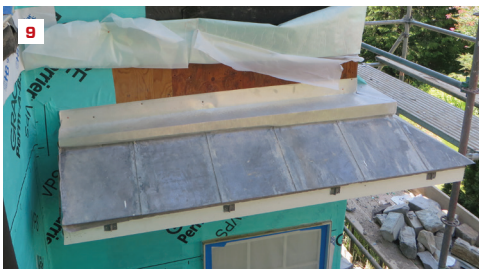
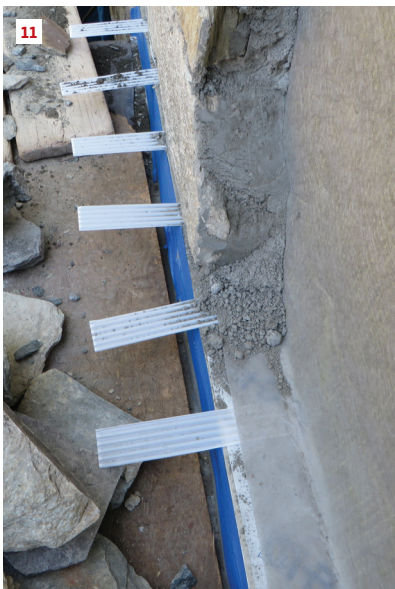
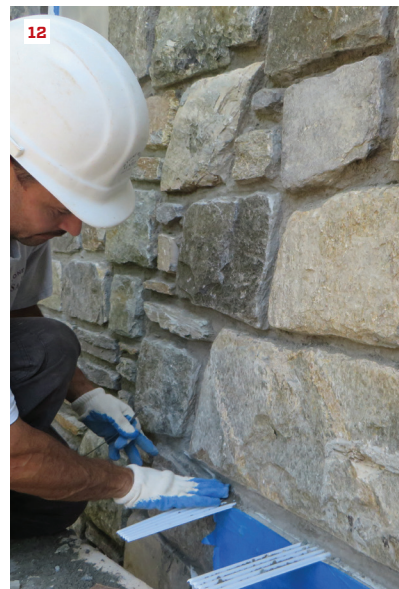
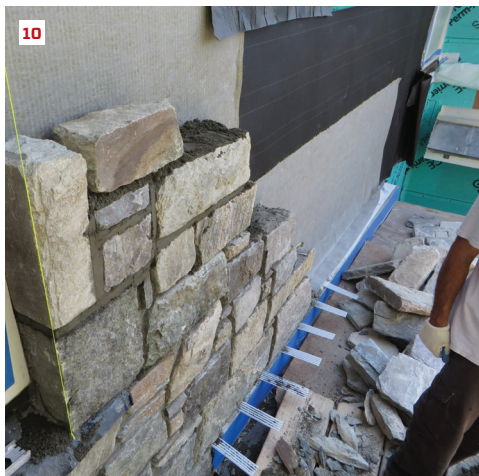
After the self-adhering membrane backup flashing was installed, the metal through-wall flashing was installed over it (seen here on an adjacent roof) **(9)**. The exposed face of coated copper flashing was protected with blue tape, then the water management layers were installed on the wall **(10)**. Self-spaced corrugated plastic weeps provided enhanced draining **(11, 12)**.

At roof-to-wall junctures, we typically install a two-piece through-wall flashing, which allows the roof to be repaired more easily later on **(9)**. The first, “through-wall” piece is fabricated with a 1-inch-tall vertical leg with a hook strip on the outside edge. The second piece, run vertically between the flashing’s horizontal leg and the roofing, is clipped into the hook strip (this second piece can be removed and reinstalled as needed). (See “Through-Wall Flashing,” right).

We installed the water-management layers on the wall so they landed on the through-flashing; any water entering the stone now is directed out onto the roof by the through-flashing. In this case, we used a self-adhered WRB—because of the multiple existing nail holes in the sheathing—added a layer of building paper and a masonry drain-mesh material, and re-installed the stone veneer **(10, 11, 12)**.
