# STRUCTURE

## Deep Structural Retrofit Rotted framing called for a complete rework of the load path

BY JAKE LEWANDOWSKI

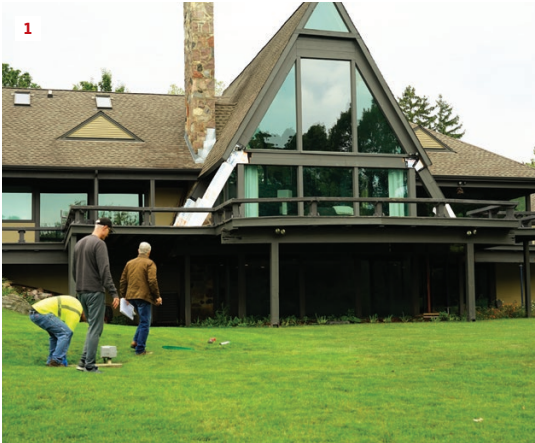
Our company, which specializes in structural repairs, was recently called to an expensive residence outside of Chicago. A number of contractors had been to this house to bid on replacing a large wrap-around deck, but they had concerns; extensive rot of the ledger board signaled deeper structural problems that exceeded their expertise. Our inspection revealed numerous places where poor flashing had led to extensive water intrusion problems. The worst was at the base of large banks of windows on the A-frame-style wing that the deck wrapped around. Water running off the large expanses of glass had leaked for years through the base of the window walls, jeopardizing not just the deck ledger but the entire floor-system supports, which

This photo (1) shows the deck wrapping the A-frame-style wing of the house during the initial investigation by the author's company. Excavation in preparation for drilling helical piers was done by hand to carefully work around utilities (2, 3, 4). A lumber extension attached to a rafter revealed that a waste line was in the exact location where a pier needed to be drilled (5).

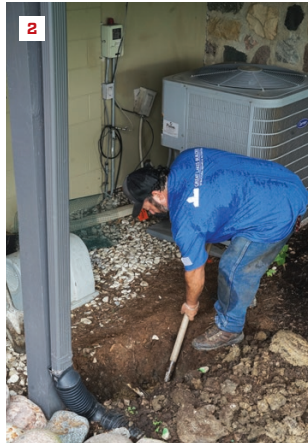
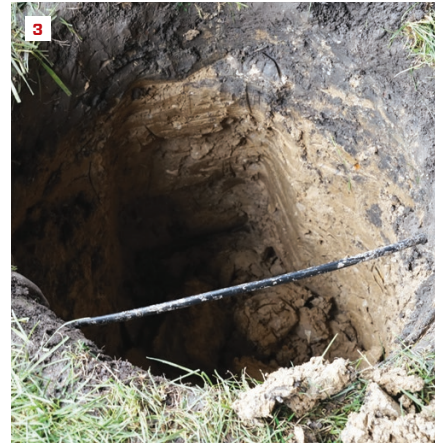
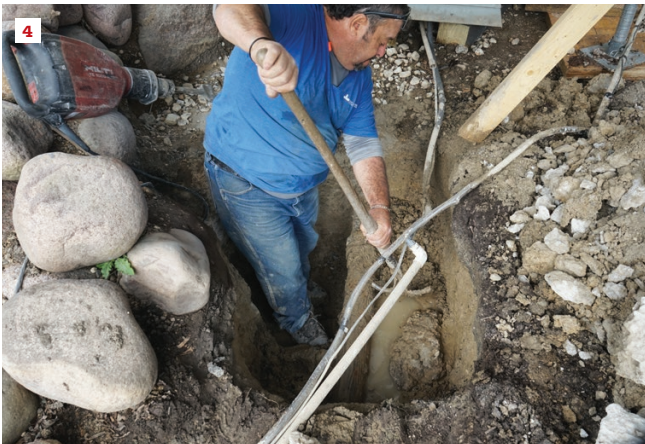
Like many jobs on existing homes, our repair work touched a lot of the building systems. As seen in the photos above, several of the initial excavations for the helical piers had cable and electric lines crossing them, and one had a waste line that was directly in the path of the helical pier. A section of this pipe had to be removed to set the pier and then replaced once the pier was installed.

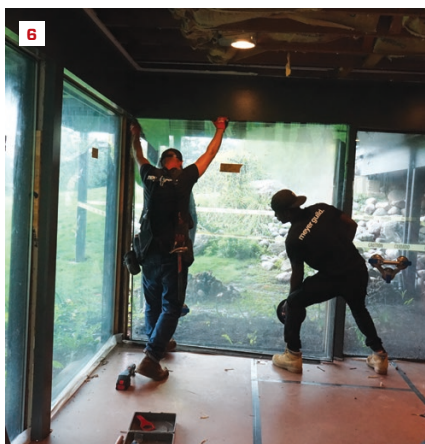
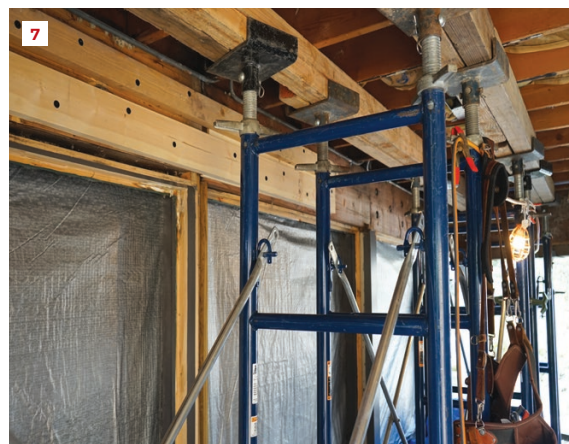
After protecting the floor below the A-frame wing, subcontractors from the window company removed the lower windows (6), and shoring was erected to support the floor during demolition (7). Additional shoring was erected to the left and right of the A-frame gable end to support the roof extending over the deck (shown in photo 10 below).

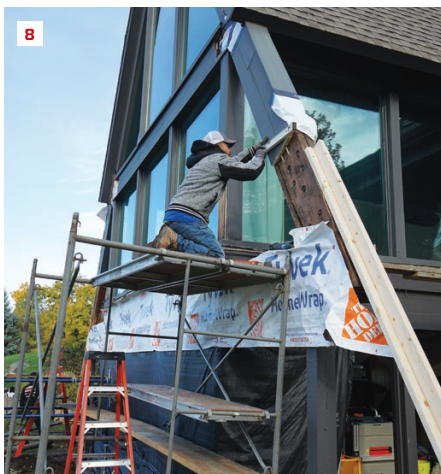
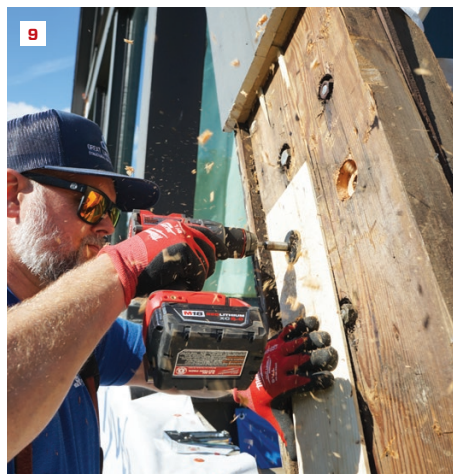
A worker stripped the trim off the face of the gable end to expose bolts holding an existing flitch plate that was spliced into the end of an outermost rafter (8). The author used a plywood template to position a Forstner bit while drilling countersunk holes for larger bolts (9). All the bolts holding the flitch beam were replaced and additional bolts added, per the engineer's specifications. Photo 10, below, shows the temporary LVL beam installed to prevent the roof from spreading during the repair work.

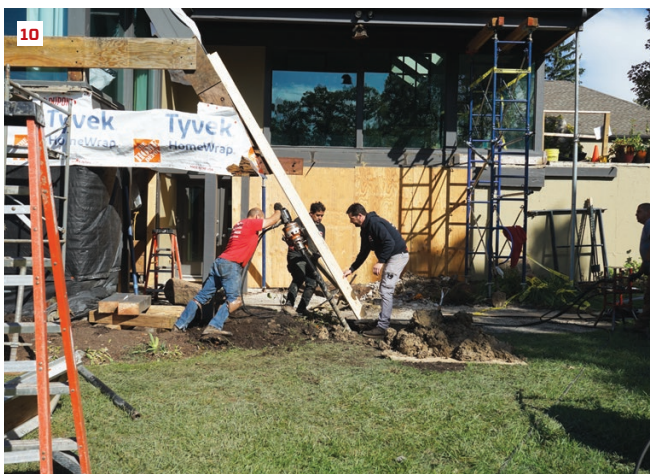
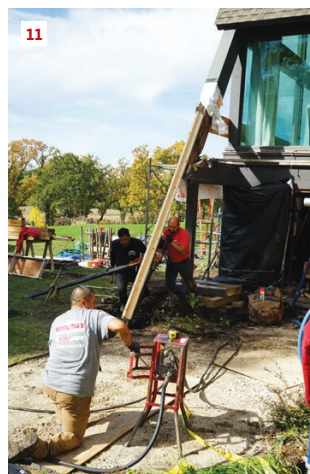
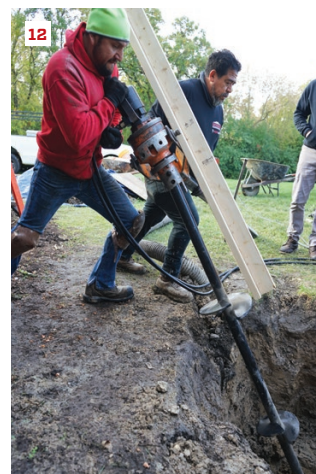
Two-by lumber extensions (nailed in an "L" shape to keep them straight and stiff) projected the line of the rafters to guide the installation of the helical piers, which were drilled at the same angle as the pitch of the roof (10, 11, 12). A total of four helical piers were drilled, two on each side of the A-frame gable.

once the wood rotted out, the integrity of the bolted assembly was severely compromised. Rather than try to reproduce this triangular load path, we worked with our engineer on a repair that redefined the load path: By driving helical piers at the same angle as the slope of the roof, the thrust of the rafters would be supported in-line with the rafters. We also supported the floor system with laminated veneer lumber (LVL) beams and completely reframed the supporting walls to create a robust structure with redundant support paths.

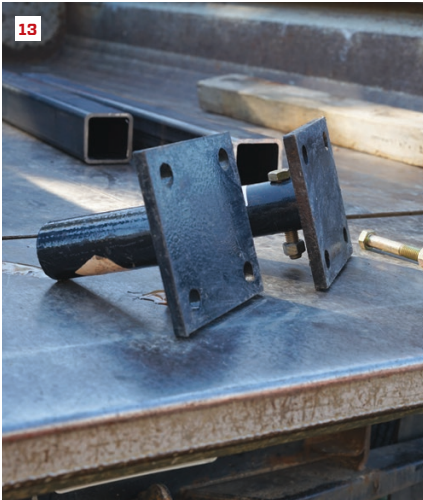
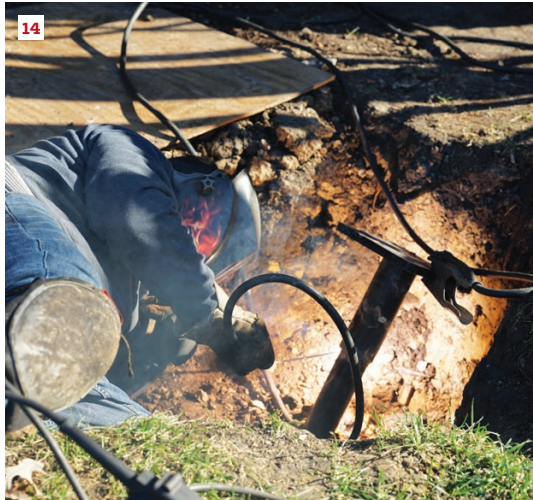
These end caps (13) were fabricated for the ends of the helical piers. The author's crew were then able to connect steel columns that spliced onto the existing flitch plates at the rafter ends. Each end cap was field welded (14) to the end of a helical pier, once the pier had been firmly driven into place.

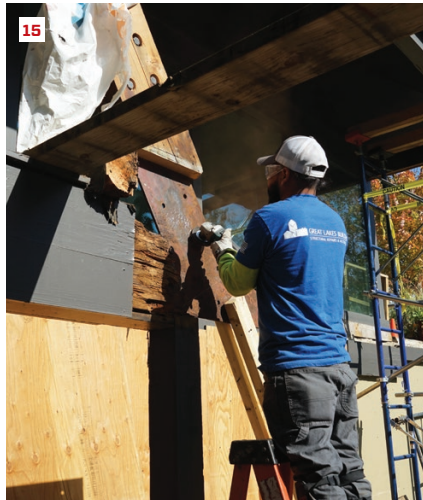
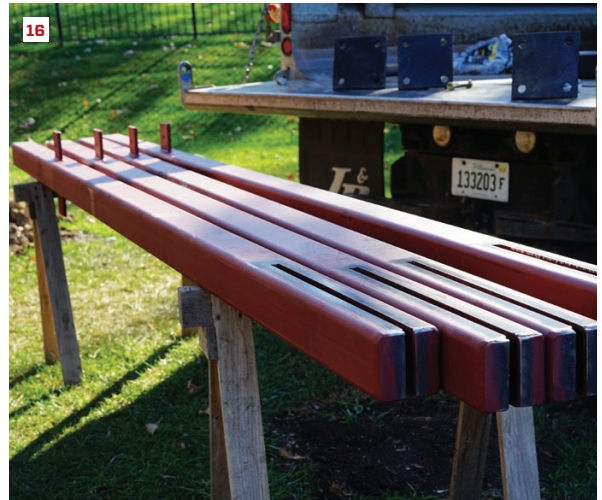
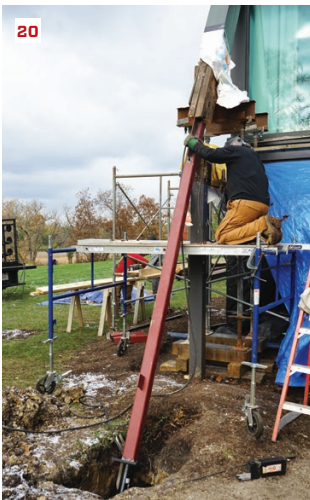
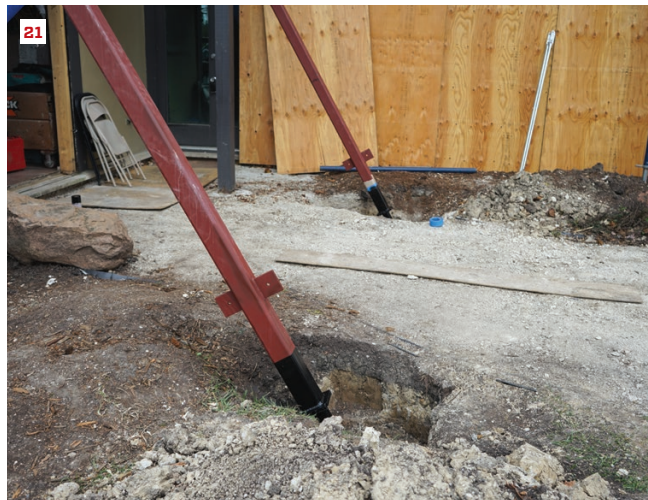
A strong field weld requires clean surfaces free from rust and paint, so a worker grinds the surface of an existing flitch plate (15) in preparation for welding on the HSS diagonal columns (16). These allow the column to slip onto the flitch plate; the column will then be cut to length and welded to the cap.

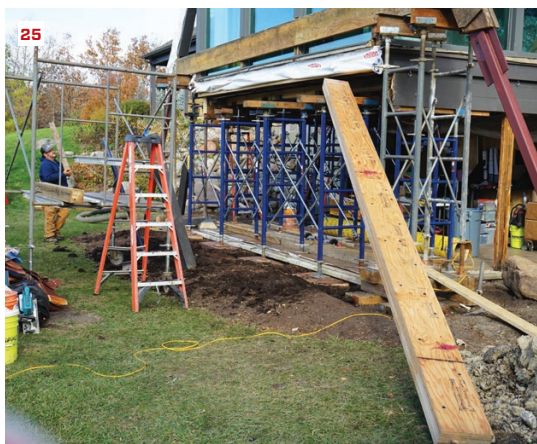
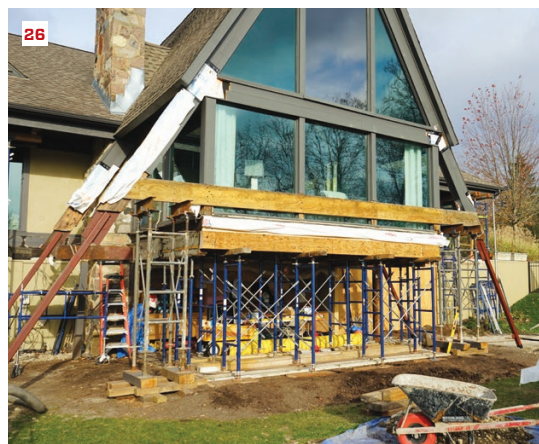
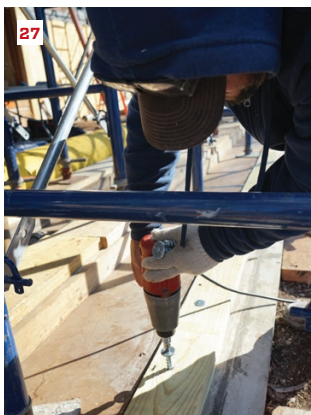
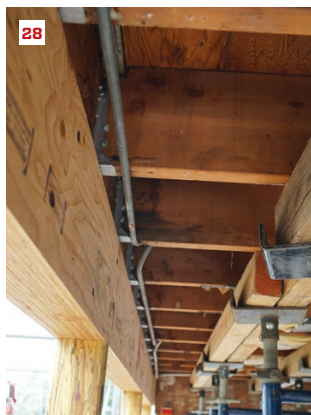
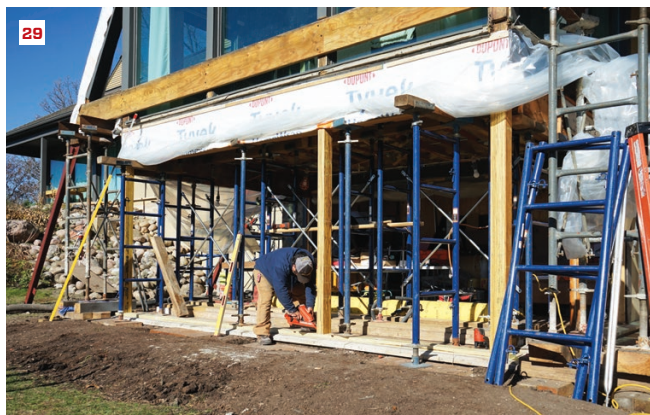
After removing the rotted ledger and grinding off the corroded bolts, the author made the first cut (22) to sever the connection between the flitch plate spliced into the rafters and the plate sandwiched between the ledger and the rim joist. The flitch plates running along the bottom of the gable end were cut and removed in sections (23, 24).

As the crew stripped away the layers, they discovered how deteriorated the rim joist was. Shoring was added to support the temporary LVL spanning the gable end, and a new LVL beam supporting a new rim joist was installed (25, 26).
