Avoiding Wood Flooring Gaps

by DOUG HORGAN

Troubleshooting / Avoiding Wood Flooring Gaps

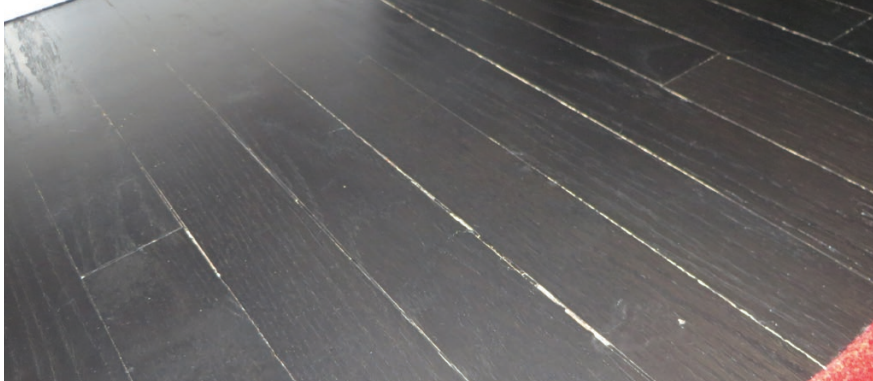
In an especially cold January (2025), shrinkage gaps between oak floorboards were a frequent callback. The dark stain emphasized the gaps.

A case in point is a home in which the stained oak floors opened up last January, which was the coldest winter we'd experienced in Washington, D.C., since 2014. The house had a humidifier installed on the HVAC system, but it had not been turned on at the start of the season. Because the floors were stained a dark color, the gaps were especially evident. Gaps are more apparent on very dark or very light floors because the crack is such a different color.

The culprit causing most "normal" gaps is indoor humidity, and we first look to the HVAC system. In many cases, a humidifier should be installed (see "Humidifying Homes," Mar/2022). We also monitor the indoor humidity conditions over a period of time while evaluating the change in the gaps.

In this case, as in most homes, we recommend maintaining indoor settings below 40% RH to avoid condensation issues in winter and monitoring windows for condensation (40% may be too high). Most clients report that 30% to 35% feels comfortable. At that humidity level, wood shrinkage is minimal.

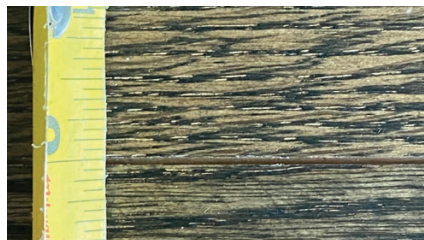
The gaps in the third-floor bedroom were particularly noticeable. Most were about $\frac{3}{64}$ inch wide, with a couple closer to $\frac{1}{16}$ inch. The wider ones tended to have some normal gap filler or finish in the space, indicating the boards were slightly gapped at time of finishing, so the shrinking since then seemed to be consistent at $\frac{2}{64}$ to $\frac{3}{64}$ inch (see photos, below).

This gap (left) is about $\frac{1}{32}$ inch with no finish or filler, so the boards were probably tight when installed. This gap (right) is $\frac{1}{32}$ inch open, with about $\frac{1}{64}$ inch of finish in the gap, indicating a $\frac{1}{64}$ -inch gap when finished.
