# Wood I-Joist Do's and Don'ts

*To banish squeaks, sags, and splits, steer clear of these common mistakes*

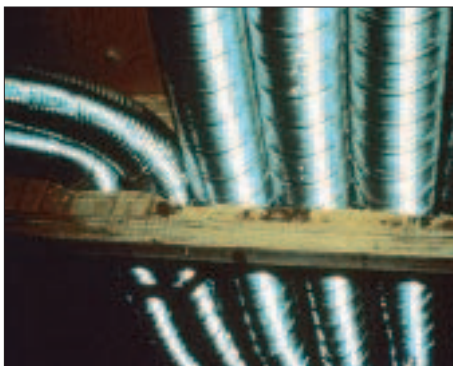
**Figure 1.** Routing five ducts through this I-joist meant removing the web, which effectively destroyed the joist.

Sometimes the problem is obvious. For instance, the hole cut for the ducts in Figure 1 has completely destroyed the web, and with it the joist. (By the way, the problem was fixed by sliding a new I-joist next to the old and rerouting the ductwork.) Less obvious are properly sized holes drilled too close to the bearing point (Figure 2), which also compromises the strength of the joist. There's no need to guess about the location of holes in I-joists: Manufacturers supply hole charts with their I-joists. If you follow the chart, you'll avoid problems.

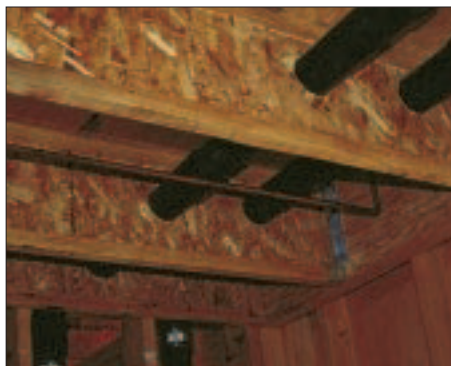
**Figure 2.** These large holes are too close to the end bearing point, so they compromise the strength of the joists. Follow the I-joist manufacturer's hole charts to avoid problems.

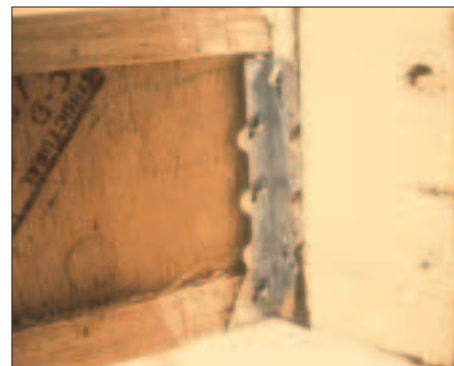
The next most common error is the improper use of joist hangers. The hanger in Figure 3 isn't tall enough to catch the I-joist's top flange. This leaves the top flange without lateral support, making it more likely to roll in the hanger. A worse problem is that the bottom flange had to be chiseled away to make it fit the seat of the hanger. This reduces the strength of the joist.

**Figure 3.** Because this joist hanger isn't tall enough to catch the I-joist's top flange, the joist may roll in the hanger. Note also that the builder has chiseled away the bottom flange to make it fit in the hanger, weakening the joist.

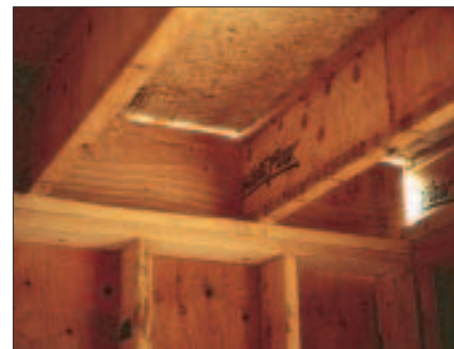
One of the main functions of a rim joist is to transfer loads from the wall above to the wall or foundation below. To accomplish this, the rim joist must be the same depth as the floor joists. A typical 2x10 is only 9¼ inches deep, so it doesn't match up well with a 9½-inch I-joist. Using the 2-by as a rim joist leaves a gap at either the top or bottom (Figure 4). Some manufacturers make 9¼-inch I-joists, but even here a "matching" 2x10 won't do. The 2-by

**Figure 4.** A 2-by rim joist is usually shallower than the I-joists; even if it's not, it will eventually shrink and leave a gap. This concentrates the structural load on the narrow joist webs, which aren't designed to support concentrated loads. Acceptable rim materials include I-joists, plywood strips, or an engineered rim material.

The trouble with this gap is that it puts all the loads on the joists themselves; in fact, it concentrates the load at the points where the thin I-joist webs meet the flanges. Depending on the web and flange materials, this concentrated force may either crush the web or cause it to knife through the flange. The same bearing problem occurs where the I-joists cross a girder and support a bearing wall; in this situation, the blocking between the I-joists must be full depth.

The solution, of course, is to use a full-depth rim joist. This can be another I-joist, ripped strips of  $\frac{3}{4}$ -inch plywood, or an engineered rim joist. I usually recommend using engineered products because you can lag ledger boards for decks and porches into them without installing special blocking — something

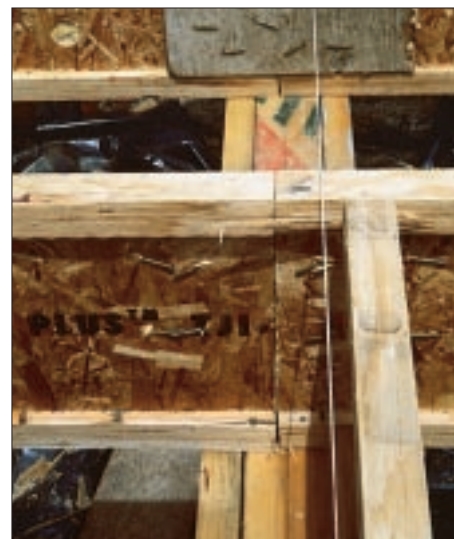
**Figure 5.** Avoid breaking an I-joist at midspan over a girder, as the builder did here. Crossing the girder with a continuous-span I-joist will yield a stiffer floor, and will not require full-depth blocking to resist rotation where the joists end on the girder. Note also the nail splitting the bottom flange, which reduces the joist's carrying capacity.

Most I-joist systems are designed to run the entire width of the building, regardless of whether they cross an intermediate support. The main reason is performance: A 30-foot I-joist running continuously over an intermediate girder provides a stiffer floor than two 15-footers that break at the girder. This means that the floor in Figure 5 will be bouncier than it should be.

An additional problem with Figure 5 is the nail in the I-joist's bottom flange. Because it was driven too close to the end of the flange, the nail caused a split. Splitting the flange reduces the allowable bearing stress because the web doesn't have as much flange to bear on; you need a minimum  $1\frac{3}{4}$ -inch bearing surface under I-joists. Nails should be no closer than  $1\frac{1}{2}$  inches from the end.

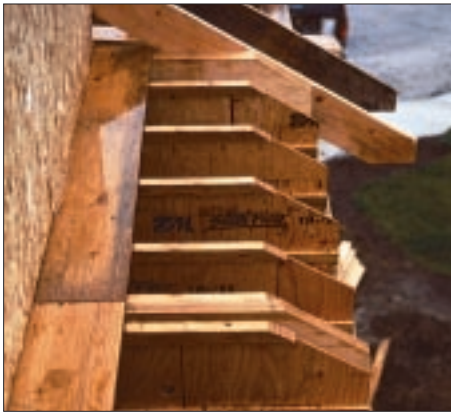
**Figure 6.** Beveling a joist beyond the inside of a bearing wall reduces its resistance to shear forces, which are greatest at the bearing. In this photo, the problem is made worse by the wall at the left, which rests on the joists with no bearing wall below.

Where I-joists meet rafters at an exterior wall, it's not uncommon for the joist bevels to be cut beyond the inside face of the bearing surface (Figure 6). Even with solid joists this isn't a good idea, because it reduces their effective depth.

Small loads and short spans are less worrisome than heavy loads and long spans, but other factors may contribute to the problem. Note, for example, the load-bearing wall on the left in Figure 6 — the exterior wall of a shed dormer. This wall raises the load on the already

Our engineers fixed this problem by having the builder add plywood gussets to the webs. How far back these need to go depends on the situation and must be worked out by an engineer. It's better to avoid the problem altogether by designing the structure so that the rafter line is as high as possible, ensuring a small bevel cut on the joists.

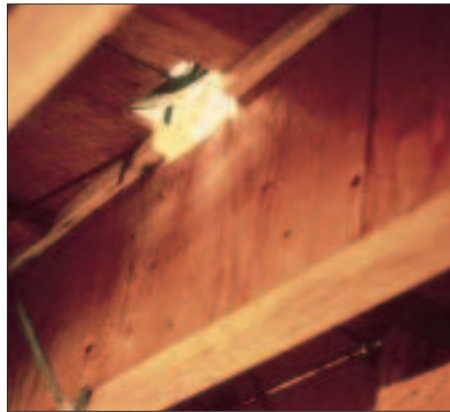
**Figure 7.** Notching the flange of an I-joist seriously weakens it; the closer the notch is to the middle of the span, the worse the problem. You can fix a notched joist by putting an additional joist next to it, or by removing the notched portion and supporting it with headers that span between the two adjacent joists.

It's not unusual for a plumber or hvac installer to notch part of a joist when installing pipes or heating ducts. With an I-joist, this might mean cutting the flange (Figure 7). I-joists have their highest-strength material in the top and bottom flanges. Cutting a flange seriously compromises the joist capacity and should be avoided at all costs.

The problem was fixed by cutting out the notched section and running a pair of headers between the two adjacent joists. Whether this would work in other cases depends on whether the two adjacent joists can handle the load. To find out, you'll need to go back to your designer or supplier so they can look at the original design. The best solution, of course, is to route

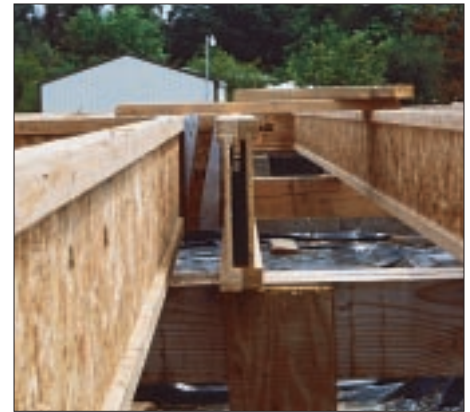
**Figure 8.** Where two or more I-joists serve as a girder, the web area should be filled in with blocking. The absence of blocking between the double joists in the photo means that the load at the joist hanger will be carried entirely by the I-joist it's attached to, instead of by the girder as a whole. The most likely result is a squeak or sag in the floor.

Two I-joists that are doubled to serve as a header must be joined together with blocking at joist hanger locations. Without this blocking, one joist will have to support a load that should have been distributed between two (Figure 8). You could end up with a squeaky floor, or even with a lump in the floor. Where several I-joists are joined to form a girder, blocking between the members is even more important.

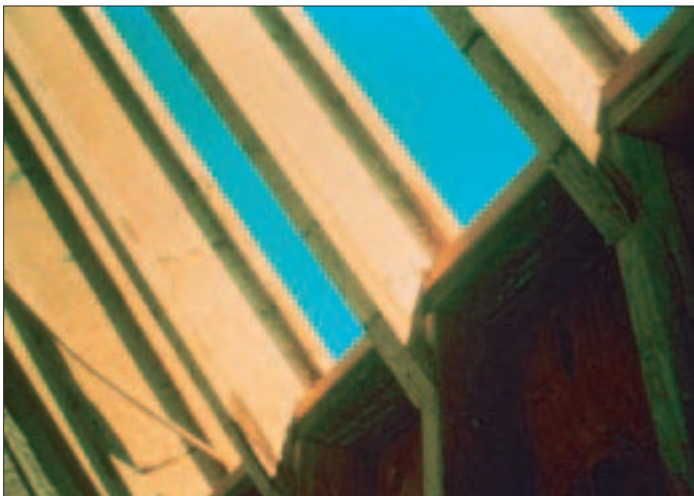
**Figure 9.** Notching a rafter over the inside edge of a wall leaves it bearing not on the heel, where it should, but on the toe. These rafters will split up the middle when loaded.

Toe-bearing is a common mistake with 2-by rafters (see "Common Roof Framing Errors," 8/95), and I-joists are no exception. Never notch an I-joist rafter beyond the inside edge of the bearing wall: You risk splitting the web section of the rafter up its centerline (Figure 9).

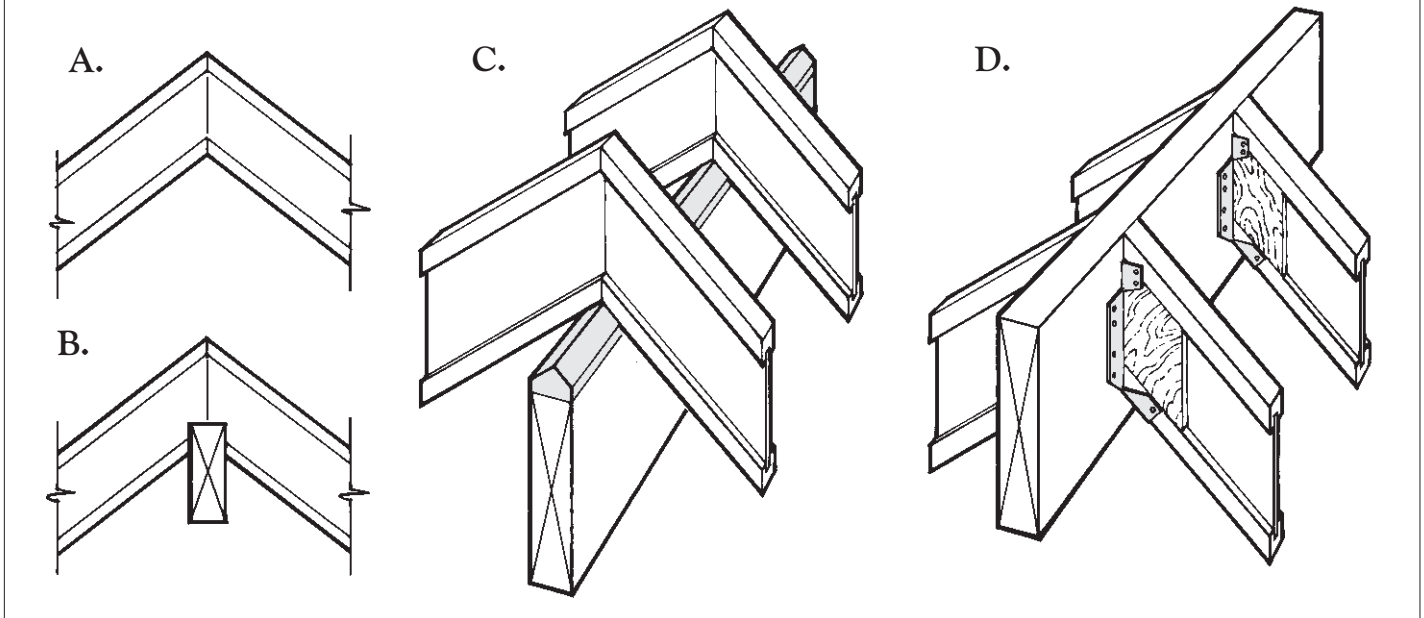
**Figure 10.** I-joist rafters can't be rested against each other at the ridge like 2-by rafters (A). Birds-mouths aren't permitted, either (B). Instead, use a structural ridge and either rest the joists on a beveled plate (C) or hang them from the beam (D).

Some roof framing problems are unique to I-joists (Figure 10). An I-joist roof is like an I-joist floor in that it requires bearing at both ends. This means that you can't just bring the rafters together at the peak of the roof and expect them to hold each other up. To keep them from failing or sagging, you need to support the peak with a structural beam. You can't cut birdsmouths at the top of I-joist rafters, because this means cutting the bearing flanges. Instead, you'll need to either hang them off the face of the beam with joist hangers or cap the beam with a beveled plate and lay the rafters on top of this. ■
