## CASE STUDY:

# Timber Frame Fiasco

*Decay and carpenter ants started the destruction. The lawyers finished it.*

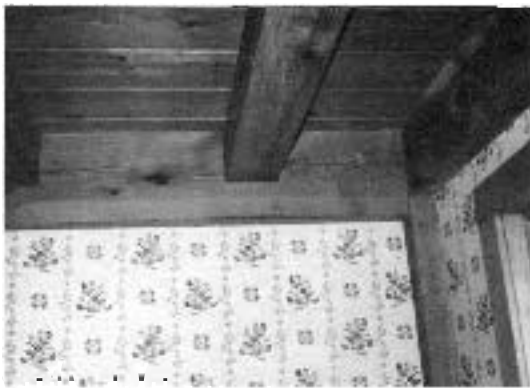
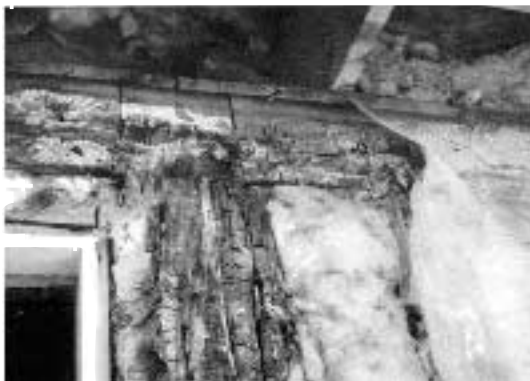
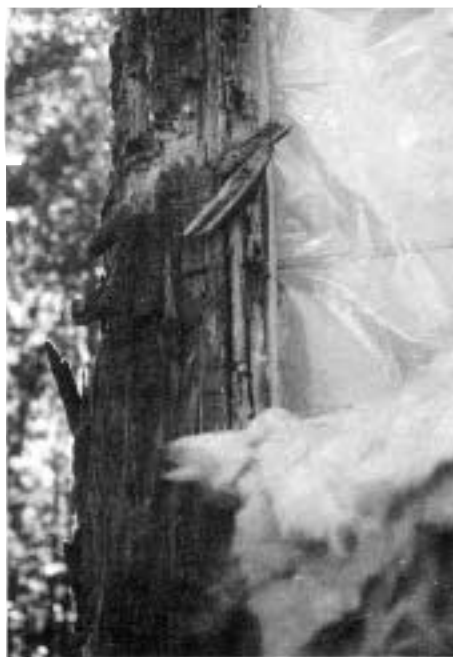
High moisture penetrated the exposed timbers on the interior (above, left) and condensed under the foam sheathing on the exterior. With the foam removed, decay in the sheathing and timbers became apparent (left). One corner post (above) had only 2½ inches of solid wood remaining.

As I saw it, the excessive interior moisture was penetrating the wall cavity through and around the exposed timbers, then condensing when it reached the cold sheathing. Note, however, that five of the six recommendations involved the owner reducing the humidity inside the house. That's because without the high moisture, the holes in the vapor barrier would not have led to decay. The vast majority of homes have unsealed vapor barriers and do not rot. The lawyer/homeowner did not like these recommendations, however, because I did not blame the contractor for the entire problem.

In addition to damaging the pine sheathing adjacent to the timbers, the rot now also reached deep into the 8x8 timbers, leaving in some places only 2½ inches of solid wood. Despite the substantial damage, we felt that the repairs were fairly straightforward and that any experienced timber framer could repair the house for under \$30,000.

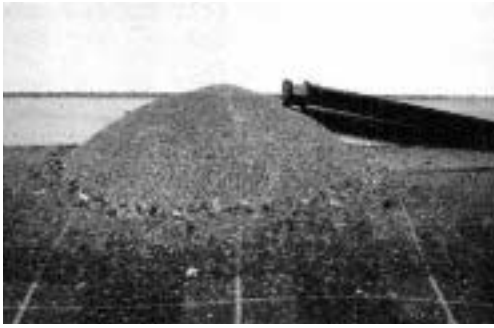
Once wet and softened from decay, the timbers attracted hordes of carpenter ants. One pile of ant dust measured 3 inches high by 8 inches in diameter.

The decay and insect damage occurred in the sheathing adjacent to the timbers and deep into the timbers themselves.
