Good Neighbors Make Good Fences

by Tim Matson

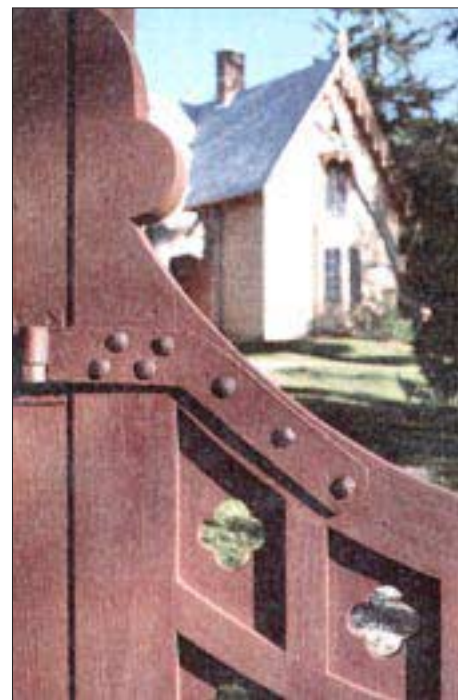
The entrance gates feature swooping curves and handmade iron hinges.

For Spencer and crew, one of the biggest challenges of the fence restoration was bringing the two fence sections together at the main gate. Due to changes in the ground level over the years, the curved panels flanking the gates did not meet properly. Because the homestead is an historic site, no trees could be cut and little regrading could be done. The solution was to build one of the curved panels with a slight taper.

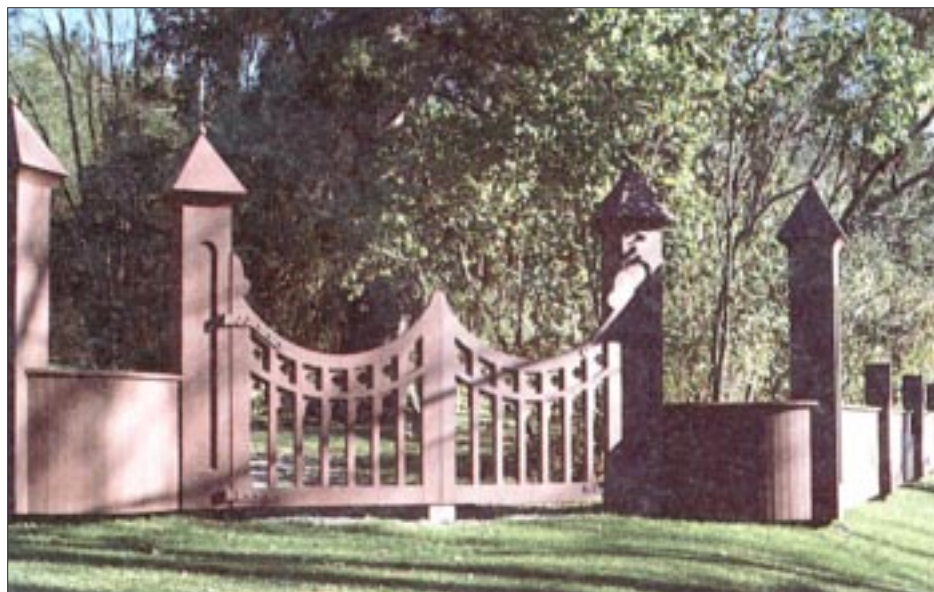
Builder Blake Spencer used historical photos to work out the details of the historic fence restoration at the Morrill Homestead in Strafford, Vt. The main gate is the kind you would imagine passing through on the way to meet St. Peter. Or Walt Disney.
