# CO Leaks

## CAUSES & CURES

by Thomas Greiner

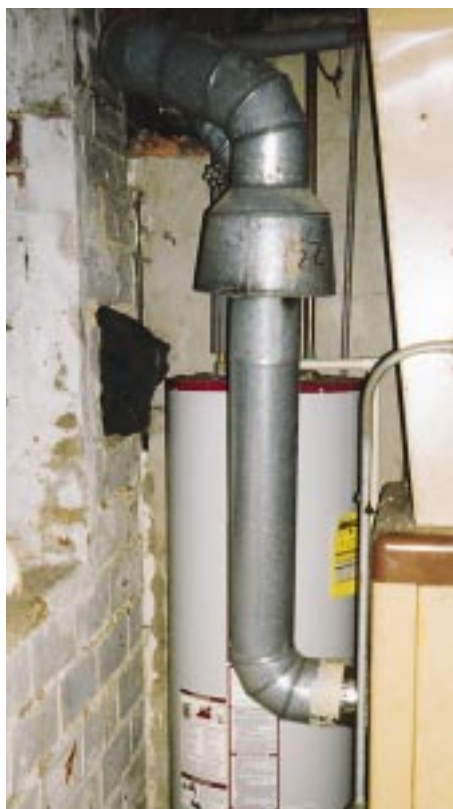
The water heater and furnace are common-vented in the back corner of this basement. In this case, common-venting caused severe CO problems when a bird's nest on the top of the house blocked the chimney. CO spilled into the basement from both appliances. (If the appliances had been vented separately, only one would have spilled CO.)

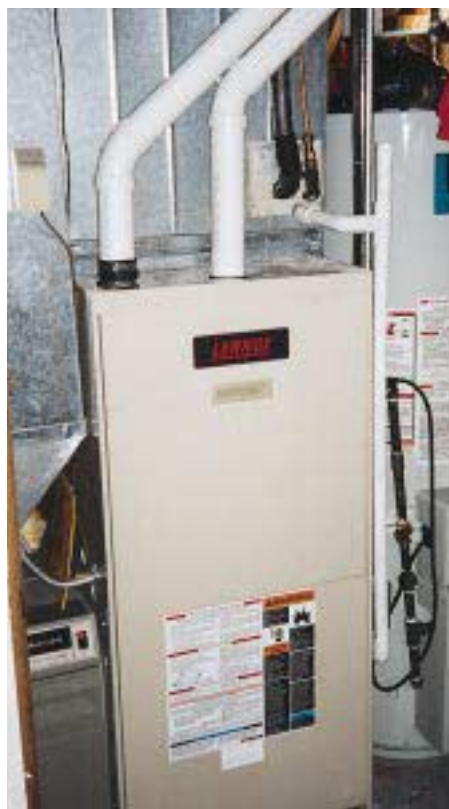
This direct-vent sealed-combustion high-efficiency furnace is installed correctly. Note the plastic discharge pipe and sealed plastic air intake pipe. Being completely sealed, they can work independently of any air pressures within the home.

By installing new high-efficiency, direct-vent furnaces, the homeowner eliminated problems with insufficient combustion air and house depressurization. The furnaces' sealed and dedicated pipes obtain needed combustion air directly from outdoors, regardless of the depressurization in the house. New furnaces are relatively simple to install, don't cause drafts from combustion air being drawn into the house, and decrease heating costs.

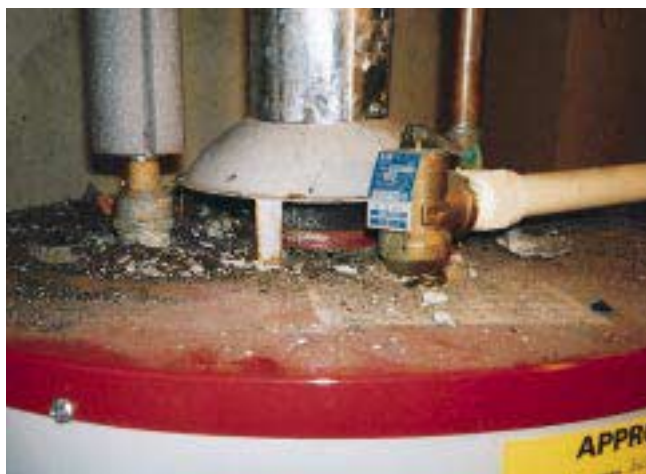
The top of this water heater shows evidence of flue gas spillage — the rust, paint discoloration, and debris are all clues to a backdrafting problem. A CO detector would give more immediate warning of the same problem.

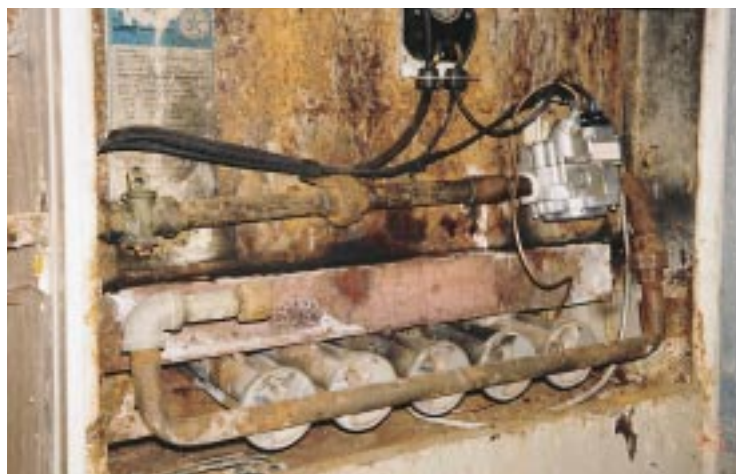
Some backdrafting problems leave obvious markers, such as the rust and corrosion inside this furnace burner compartment.

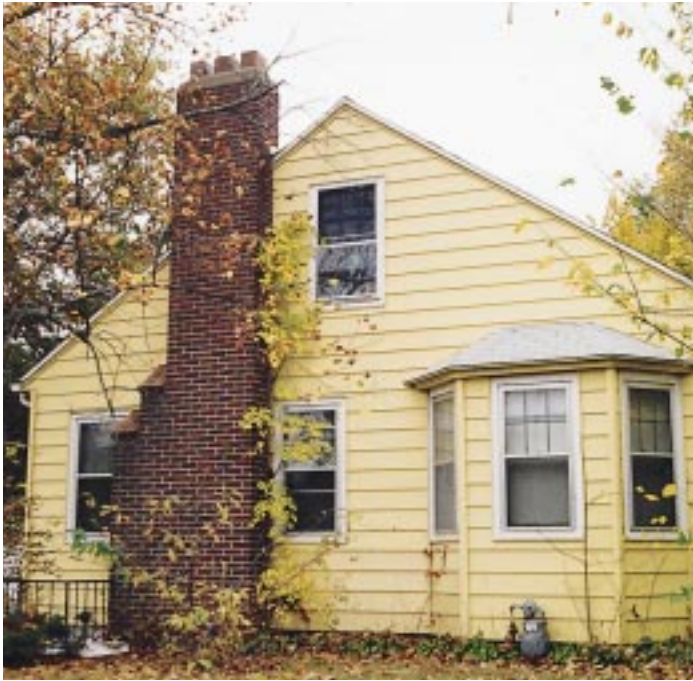
The family then purchased a listed carbon monoxide detector, but a week after they thought the problem was fixed, the detector indicated 39 ppm and they called me. When I checked their home and heating system, I discovered several serious problems with the furnace and the vent system. The old furnace was badly out of adjustment, in poor repair, and producing extremely high levels of carbon monoxide — over 3,300 ppm in the flue gases. By placing the metal vent pipe in contact with wood (a code violation and a fire hazard), the contractor had created another problem. The vent had a long, horizontal run which did not draw well. The 39 ppm reading was caused by the slight spillage of extremely high concentrations of carbon monoxide. These concentrations were so high that I observed birds sitting on the chimney top falling into the open chimney, poisoned by the CO exiting the flue.

A simple CO detector alerted the owners of this house to a serious carbon monoxide problem, which a technician blamed on a chimney stuffed with dead birds. The author was called in after a second alert, and found that the furnace was producing tremendous amounts of CO, which spilled into the basement even without the obstruction in the chimney. The CO killed birds landing on the chimney; the dead birds then fell into the vent, worsening the spillage into the basement.

Increasing the primary air supply to the furnace burner reduced the CO production from 3,300 ppm to 9 ppm. Still, because of the age of the unit and the vent problems that still existed, the owner replaced the furnace.

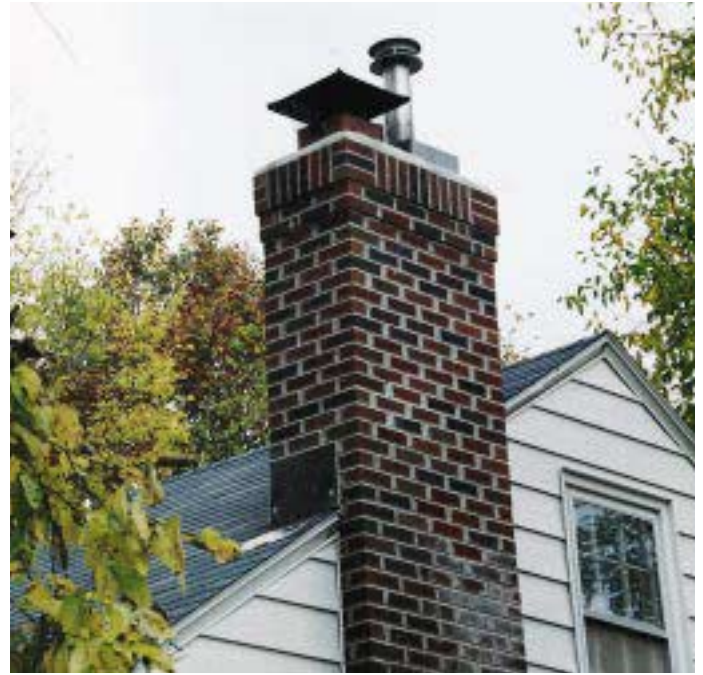
This chimney, in contrast, is equipped with a proper cap on the gas vent, which will prevent bird entry. However, as the earlier case demonstrates, the roots of carbon monoxide problems are often complex, and heating contractors need to look beyond simple solutions.

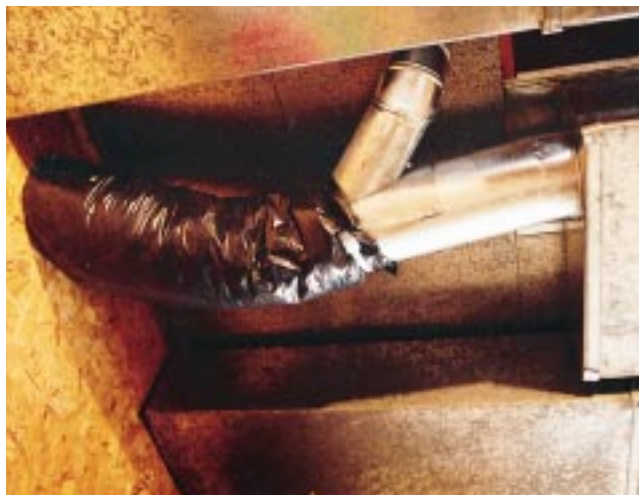
A contractor investigating a CO problem attempted to alleviate a furnace backdrafting condition by providing an additional combustion air intake (note the black plastic tubing at left.) While this measure helped to equalize pressure in the house, it was not sufficient to counteract all the exhaust fans in the house and correct the problem.

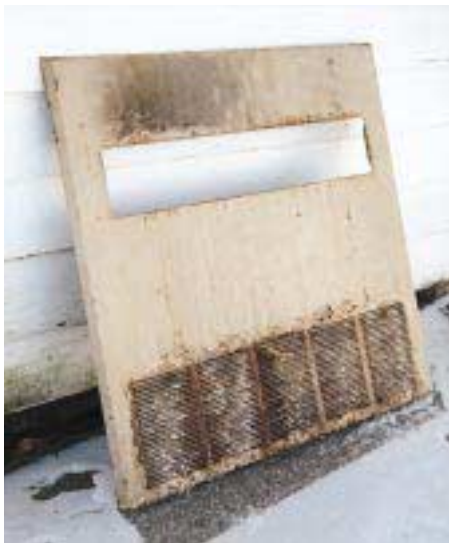
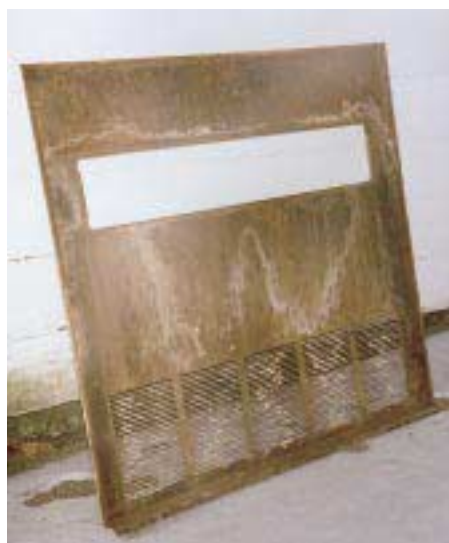
The rust and soot on the outside of this furnace cover is echoed by the mess on the inside. The rust is usually a result of moisture that forms when trapped gases condense inside the furnace as a result of backdrafting.
