# TROUBLESHOOTING Common Chimney Problems

by Stephen Bushway

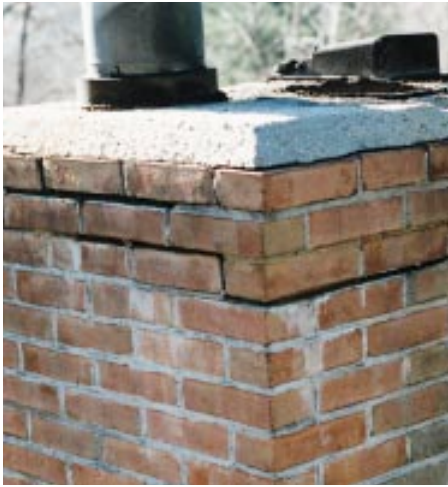
**Figure 1.** This chimney crown dried too quickly, causing the edges to curl and pull away from the masonry, allowing water to penetrate. This crown also bonded to the flue liners. When the liners expanded, they lifted the top of the chimney, causing the top three courses of brick to crack.

**Inadequate curing.** When a freshly cast crown dries too quickly, the exposed top surface sets more rapidly than the interior portion. As the surface dries, it also shrinks, pulling at the outer edges and causing the crown to curl (see Figure 1). The resulting gaps will allow water to penetrate into the interior of the chimney.

**Bonded flues.** The photo in Figure 1 illustrates another common problem. As flue liners heat up, they expand. If the crown bonds to the flue liners, the liners can actually lift the top of the chimney as they expand, stressing the mortar joints and creating cracks that allow water to infiltrate the chimney.

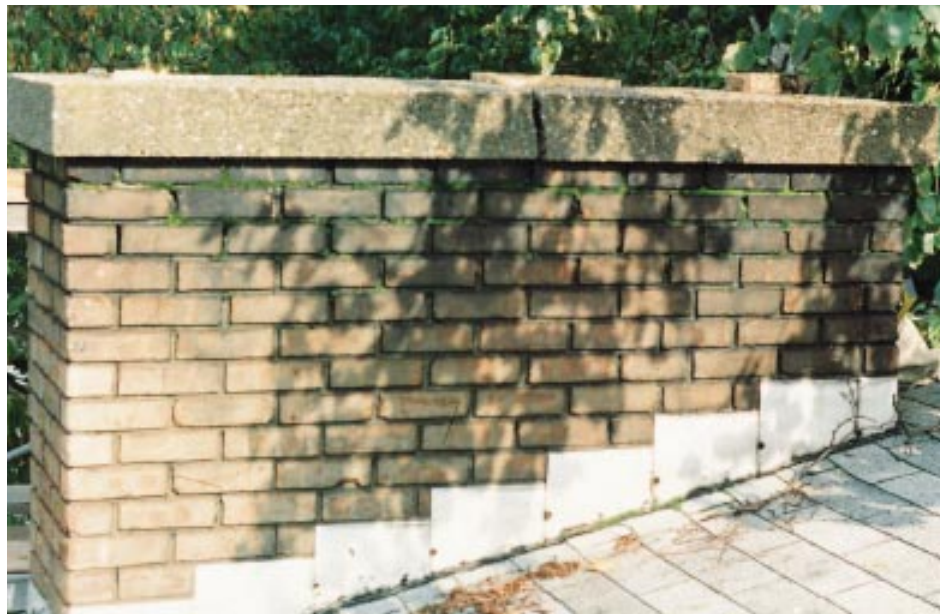
**Figure 2.** Excessive shrinking caused this crown to crack at the weakest point — the area where a flue penetrated the surface. Proper curing reduces the amount of shrinkage, and reinforcing fibers added to the concrete crown mix add tensile strength.

weak links. As the crown shrinks, improperly built crowns will pull apart and crack at the weakest point (Figure 2).

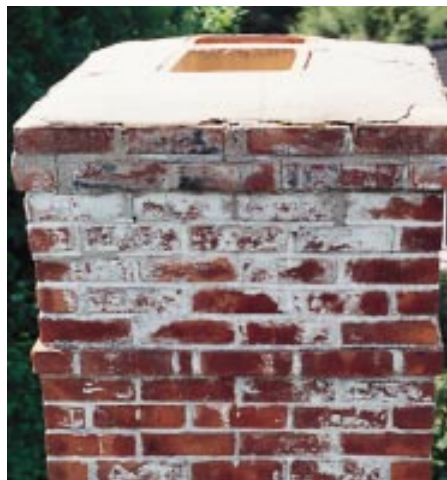
**Figure 3.** Flue liners should project at least 3 inches above the crown. Here, a thin crown and recessed flue liners caused this chimney crown to leak. As the water worked its way out of the chimney and evaporated, soluble salts remained behind, leaving a whitish stain called efflorescence.

**Feathered crown.** The mortared “wash” on the top of the chimney in Figure 3 is guaranteed to fail. My guess is that the mason ran out of flue liners before bricks. The feathered edge of the mortared wash broke down quickly, and

the recessed flue liners allowed rain to penetrate the interior of the chimney.

**Efflorescence.** The whitish haze that appears on the outside surface of the chimney in Figure 3 is called efflorescence. The staining occurs when water within the chimney works its way to the exterior surface and evaporates, leaving behind soluble salts.

While efflorescence itself is a cosmetic problem, the water penetration that causes efflorescence can lead to serious structural problems in colder climates. When the penetrating water freezes, it expands, and will eventually break the chimney apart.

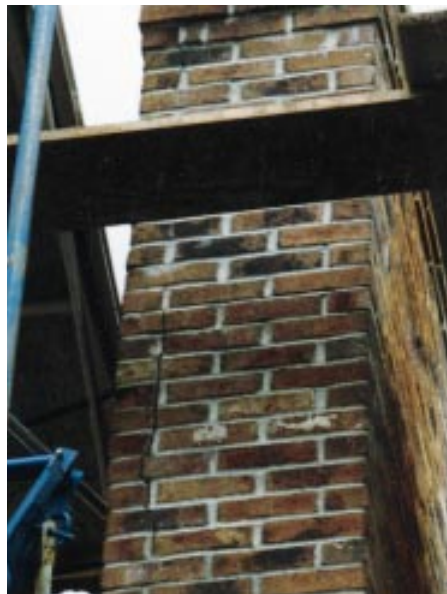
**Figure 5.** The code-required air space between the flue liners and the chimney walls allows the liners to expand and contract freely. In this chimney, the void between the bricks and the flue liners was filled solid with mortar, and resulted in a 7-foot-long crack when the liners expanded.

Recently, I was called in to repair a chimney that had a 1/2-inch-wide vertical crack 7 feet long, starting at the crown (Figure 5, previous page). I discovered that the space between the bricks and the flue liners had been filled solid with mortar. The homeowners had adapted a wood stove to the existing fireplace, and creosote accumulated on the walls of the oversized flue liners. At some point, the intense heat of a chimney fire caused the flue liners to expand, literally pushing the chimney walls apart.

The NFPA 211 Standard (National Fire Protection Association, Batterymarch Park, Quincy, MA 02269) requires a 1/2- to 1-inch *free* air space between the flue liner and the chimney wall. To stabilize the liners within this free air space, I cut strips of ceramic wool insulation (available from Sleepy Hollow Chimney Supply, 85 Emjay Blvd., Brentwood, NY 11717; 800/553-5322), and wrap the liners above and below each flue joint.

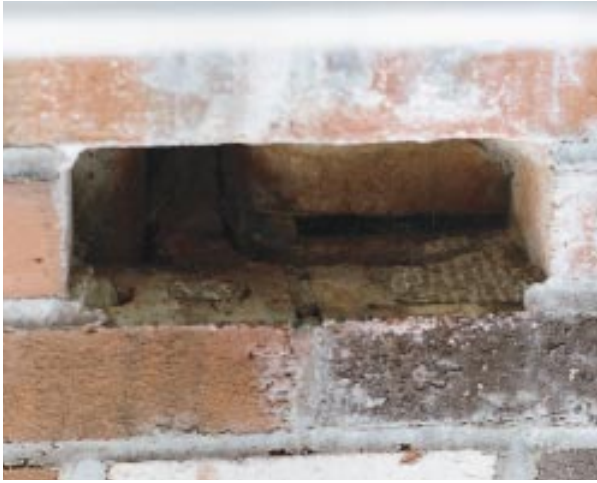
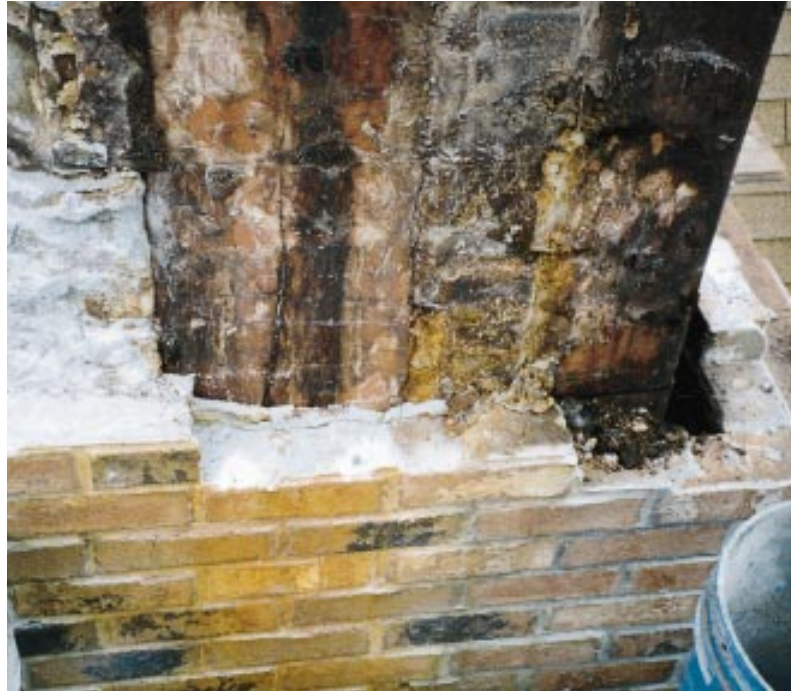
**Figure 6.** On removing a loose brick during a repair, the author discovered that the standard mortar used to set the flue liners had eroded (above), allowing creosote to leak in between the liners and the chimney wall (right). Flue liners should be set in non-water-soluble refractory cement.

the damaged bricks, I discovered that the flues had been set in conventional mortar. Portions of the joint were missing entirely (Figure 6).

Upon deeper inspection, I found that creosote had leaked into the interior of the chimney walls, causing extensive

The problem was in the mortar. Flue liners and joints need to be able to withstand the intense heat of a chimney fire and resist corrosive condensation. If standard mortar is used, the joint will eventually deteriorate.

I always set flue liners in a non-water-soluble refractory cement from Ahrens Chimney Technique. Whenever possible, I use round, lap-joint refractory flues or stainless steel liners designed for solid fuel appliances (wood stoves, for example). The stainless liners are available from Heat-Fab (130 Industrial Blvd., Turners Falls, MA 01376; 800/772-0739).

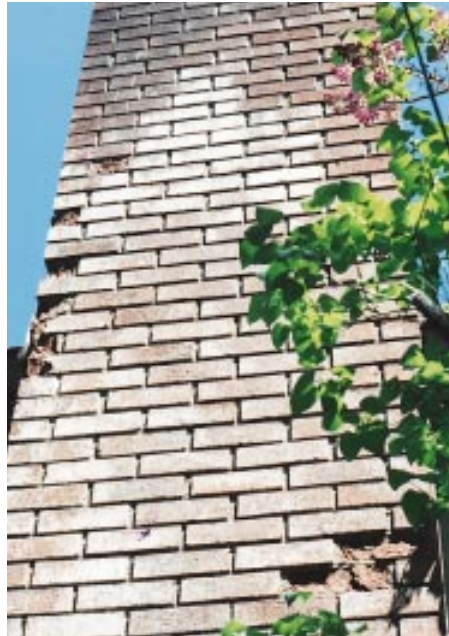
**Figure 7.** The decorative, deeply raked joints in this chimney allowed water to pool and soak into the brick. When the saturated brick was exposed to extended sub-freezing temperatures, the water froze and expanded, causing the brick to spall.

Improperly designed mortar joints can also create problems. The brick chimney in Figure 7 was built using raked mortar joints that were recessed nearly 1/2 inch, forming a shelf at each horizontal course. Rainfall tends to collect on these ledges, and if the brick happens to tilt towards the chimney core, the water can be absorbed by the brick. When a heavy rain is followed by an extended stretch of sub-freezing temperatures, the absorbed water freezes and expands, and can cause spalling.

afford to have the chimney rebuilt, I've used a water-based product called Chimneysaver (Saver Systems, 1751 Sheridan St., Richmond, IN 47374; 800/860-6327). It's a vapor-permeable siloxane treatment that usually prevents further spalling by imparting an electrostatic charge to the bricks. I'm always careful to advise my customer that some bricks may have already experienced internal damage that has yet to become visible.

In new work or rebuilds from the roofline up, I prefer to use a concave mortar joint. It's attractive, holds up well in my climate, and the concave striking tool compresses the mortar into a dense, weather-resistant surface. I'm careful to wait until the mortar is "thumbprint hard" before striking. Mortar that's tooled too early will not compress properly.

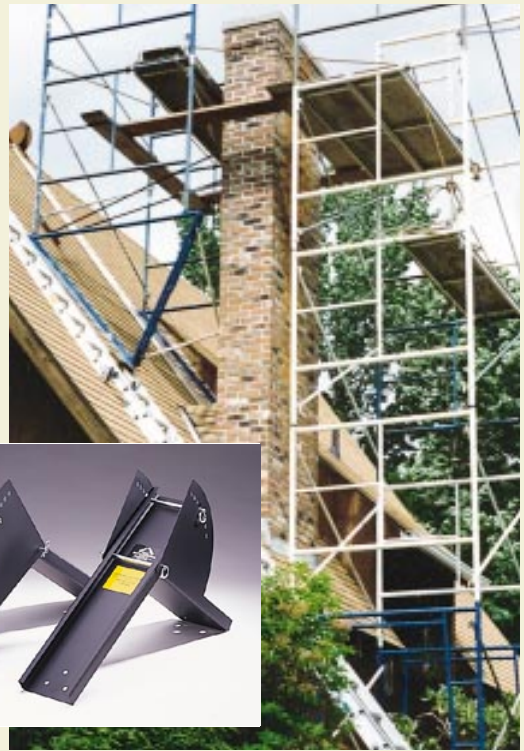
Roof-supported scaffolding increases safety, and provides a more efficient work area. The heavy-duty ridge hooks (inset) are attached to 2-bys, which provide a nail base for the adjustable scaffolding brackets (visible to left of chimney).

Two products that I have come to rely on are Ultimate Ridge Hooks, which I developed for my own work and now manufacture (Deer Hill Enterprises, 224 West St., Cummington, MA 01026; 800/588-9660), and Vanguard chimney brackets (Lynn Ladder and Scaffolding, 220 S. Common St., W. Lynn, MA 01905; 800/225-2510). The ridge hooks provide a secure nail base that is hung from the ridge of the roof, and is independent of the finish roofing material (see photo). The adjustable chimney brackets provide a level launch base for my tubular steel scaffolding frames.

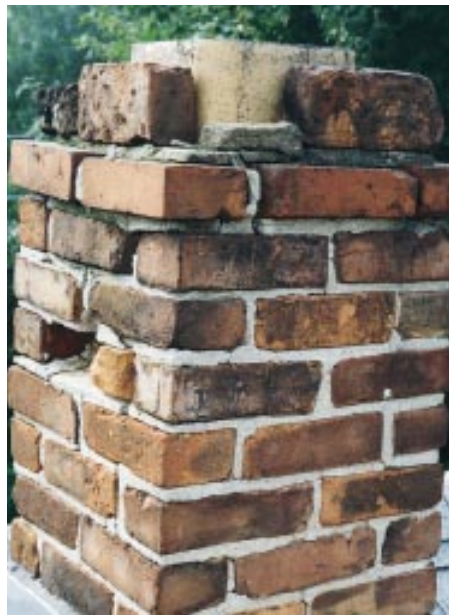
**Figure 8.** Older chimneys with deteriorated lime-and-sand mortar must be torn down to the roofline and rebuilt.

Sometimes, the problem with a chimney is just plain old age. Many older chimneys were built with weak lime-and-sand mortar (Figure 8). In most cases, I tear the chimney down to the roofline, install new flashing, and rebuild the chimney. Typically, these chimneys come apart very easily. I was able to dismantle the chimney shown in less than an hour, with hardly the need for a chisel blow.
