REPAIRING Cantilevered Balconies

The right flashing details, reinforced framing, and durable waterproof decking give new life to old balconies

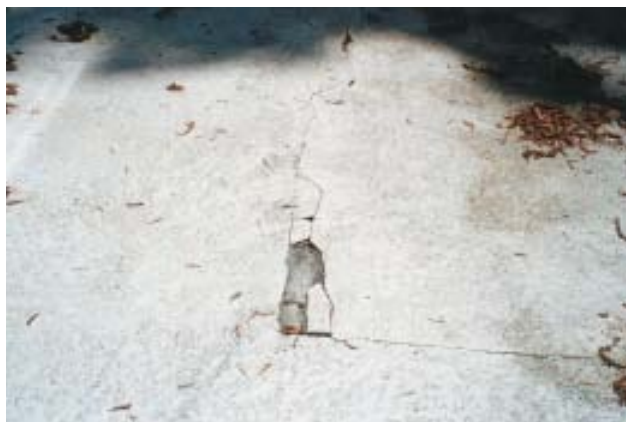
Figure 1. Surface cracks in a balcony's waterproofing are often the first sign of hidden structural damage. Cracks typically appear above joints in the plywood deck sheathing.

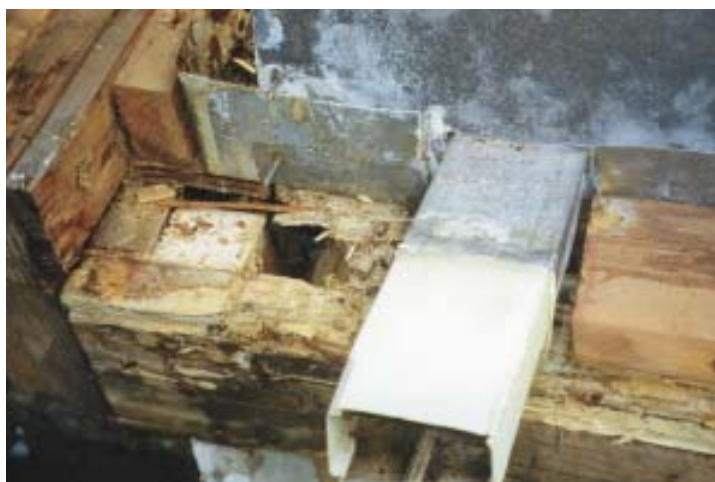
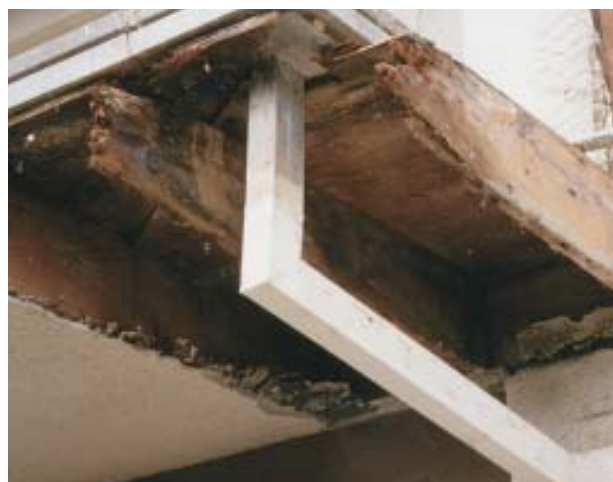
which makes for easy construction and provides privacy for the residents. It also prevents runoff from a balcony from dripping directly onto one below, but at a cost: The rainwater that falls onto each balcony must be collected and directed outside. This is usually handled by a floor drain or an open, floor-level scupper draining to a gutter. Either drainage method can lead to rot unless the spout that passes through the framing is properly installed and sealed (Figure 2).

Figure 2. Improperly flashed scuppers (left) and floor drains (right) often allow water into the framing, leading to hidden rot.

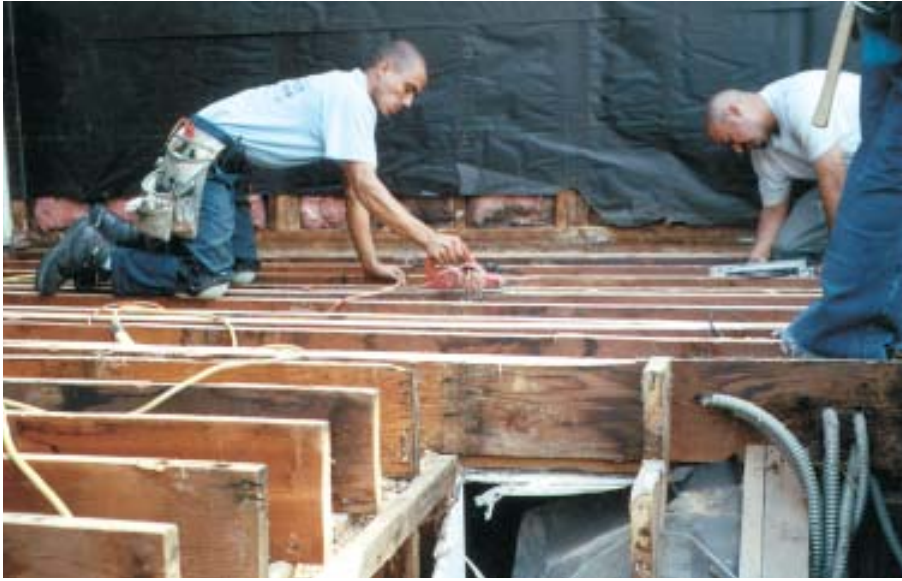
Figure 3. To eliminate puddling, the author rips a 1/4-inch-per-foot taper from the top edge of the cantilevered joists, creating a positive drainage slope. A power planer cleans up the cut.

Any top-edge rot gets ripped away to undamaged wood and replaced with a new ripping, which we simply gun-nail into place. We treat all cuts with a termite and rot repellent, Jasco Termin-8 (Jasco; 888/345-2726, www.jasco-help.com), a green, oil-based copper-naphthenate solution that helps prevent future infestation. If the original joists didn't incorporate a drainage slope, we'll rip a full-length, 1/4-inch-per-foot taper on the top edge, cleaning up the cuts afterward with a power plane (Figure 3).

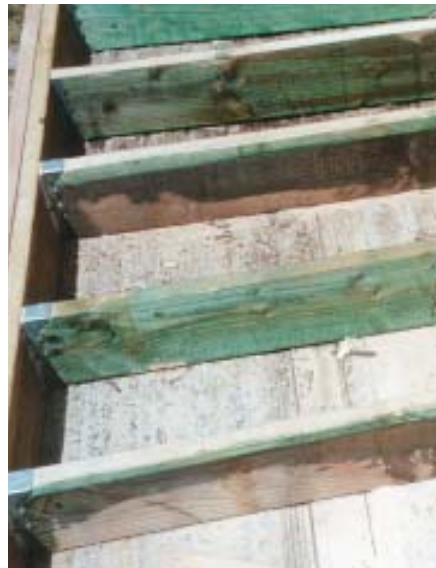
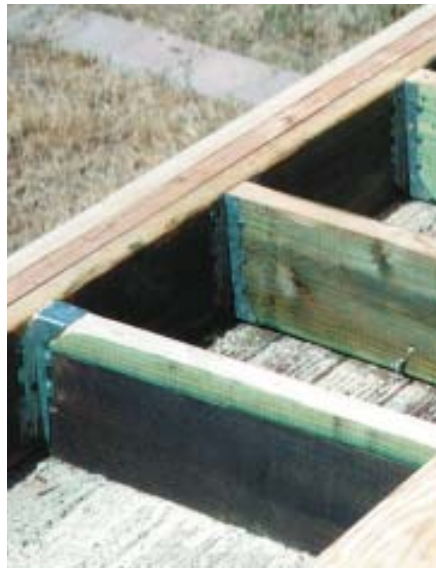
Figure 4. Joists that are too far gone to repair must be replaced between the wall plate and the new double rim joist (left). The rim hangs at the ends of the intact cantilevered joists on upside-down joist hangers. The replaced “cripple joists” are hung conventionally (right).

Shifting the load. Joists that are too far gone to repair must be replaced. With no practical way to insert a new cantilever, this can pose a real problem if the rot is extensive. Fortunately, we usually find that only one or two of the original joists are rotted to the point of being unusable. In such cases, we rely on the remaining members for structural support by installing a new, double rim joist at the outboard edge and tying it to each solid joist with an upside-down joist hanger (Figure 4).

This beefed-up rim hangs from the sound joists, providing outboard support to the few joists that must be completely replaced. The inboard ends of the replaced joists rest on the wall plate, while the outboard ends are supported by conventionally installed joist hangers at the rim — an approach that shifts the load from these replaced “cripple joists” to the repaired and sistered joists through the rim.

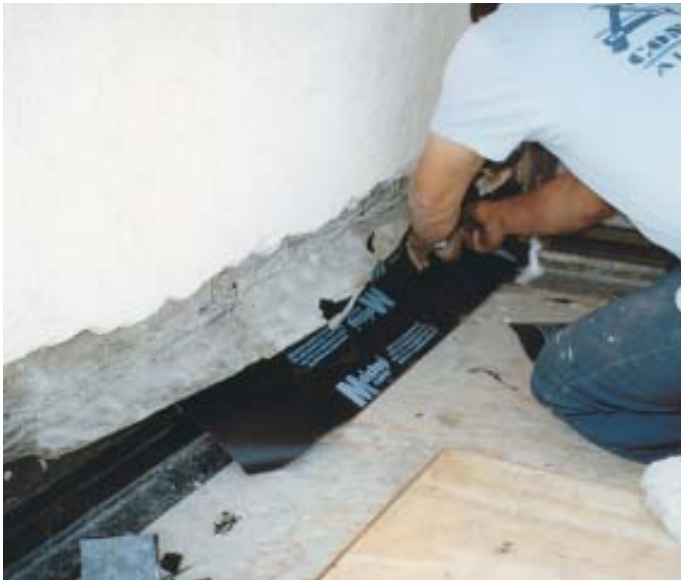
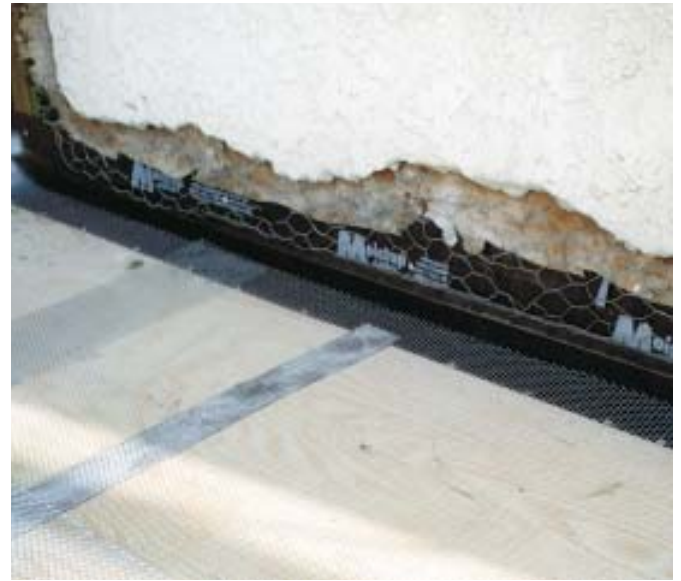
Figure 5. Flexible membrane flashing, tucked behind existing building paper and overlapping a sheet-metal skirt flashing, provides positive wall drainage onto the new balcony surface.

except where a shear panel is required. Instead, stucco lath is applied directly to the studs over 60-minute building paper. To make sure that the transition from deck to sidewall is watertight, we break the stucco (or other siding) back about 6 inches up the wall and run a 9-inch-wide Moistop strip over the sidewall framing, behind the original building paper and over the flange of the 26-gauge bonderized, galvanized sheet-metal (C&J Metal Products,

Long Beach, Calif.; 800/500-8660, www.cjmetals.com) transition flashing that runs onto the deck surface (Figure 5, previous page).

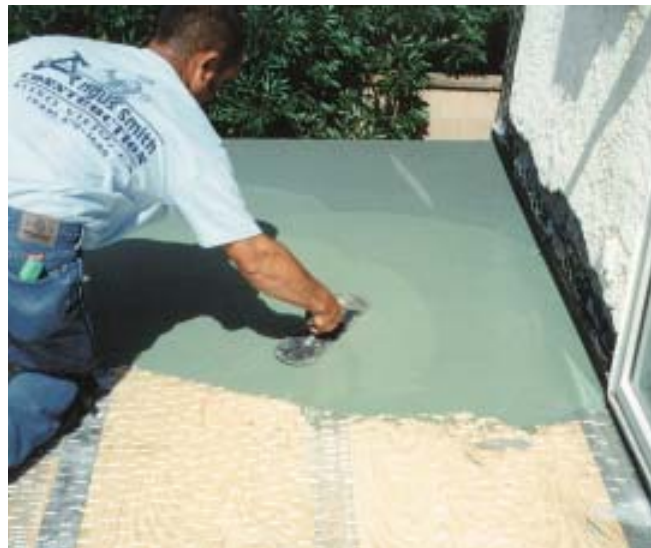
Figure 6. Galvanized expanded metal lath, thoroughly stapled to the plywood deck, reinforces the cementitious waterproofing membrane. Plywood expansion joints are isolated and protected from filling by a proprietary seam tape.

First, we install bonderized sheet-metal wall flashing and drip edge, nailing it directly to the plywood and sealing overlaps with an approved polyurethane caulk. To prevent the expansion joints between plywood sheets from filling up, we cover them with self-adhesive, 40-mil-thick Life Deck Seam Tape. Then we install a layer of galvanized expanded metal lath over the plywood and flashing and thoroughly fasten it with a pneumatic stapler, using at least 16 staples per square foot (Figure 6, previous page). The base coat — a thick, soupy mix of cement and acrylic polymer — is poured on and troweled into the lath. After the base coat cures, we trowel on a similar, slurry layer to build up the membrane and fill any voids. The third, texture-coat layer is splattered on using a hopper-fed texture gun, at about a 70% coverage rate, and knocked down with a steel trowel while wet.

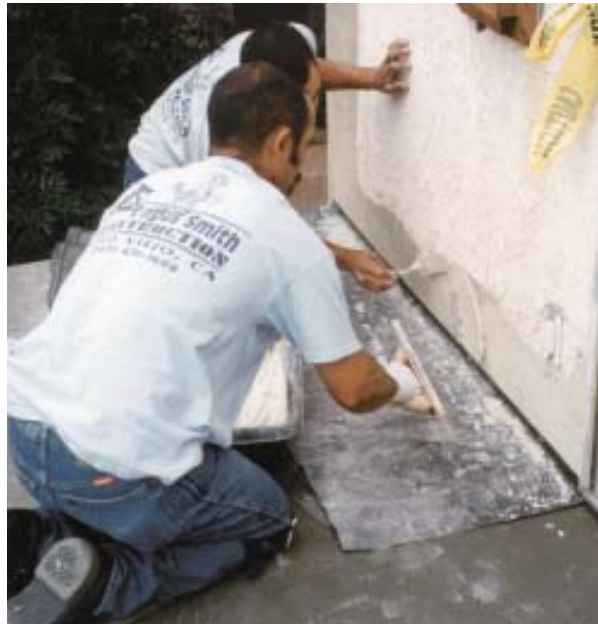
Figure 7. Stucco siding repairs follow the original three-layer process of scratch coat, brown coat, and color coat. A narrow strip of the sheet-metal flashing is left exposed to allow crack-free movement between wall and deck.

Once the texture coat can be walked on, we complete the patching of the stucco siding, following the original steps of 60-minute building paper, stucco lath (wire), scratch coat, brown coat, and a color and texture coat. Usually, we're patching small areas, so we use a quick-drying mortar mix to help expedite the job (Figure 7). We take the stucco down over the apron flashing but not all the way to the deck, leaving a narrow band of metal exposed. This allows for some necessary structural movement and elimi-

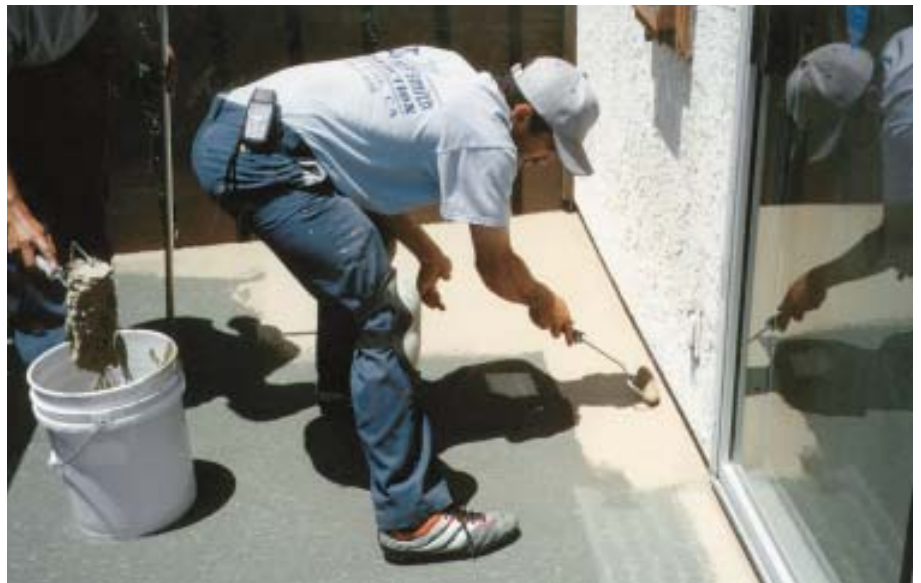
Figure 8. A final, acrylic color coat seals and protects the multilayered deck system from water absorption.

A proprietary acrylic color coat seals and completes the deck surface treatment (Figure 8). The deck can be walked on within about 4 hours, but it's best to wait 24 hours before putting the surface to regular use.
