Remodeling for Accessibility

To meet HUD requirements, this apartment needed wider doorways, lower kitchen cabinets, and a barrier-free shower

by Greg Burnet

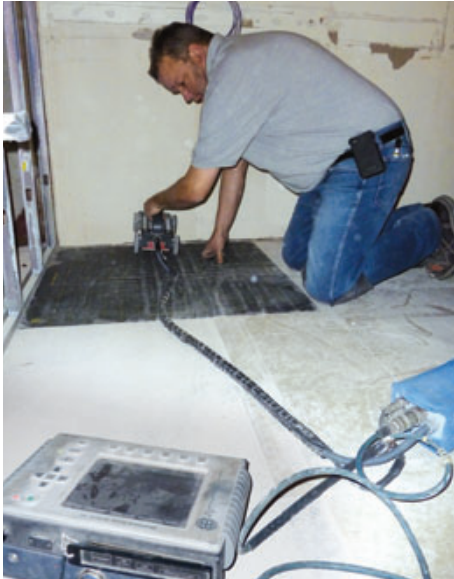
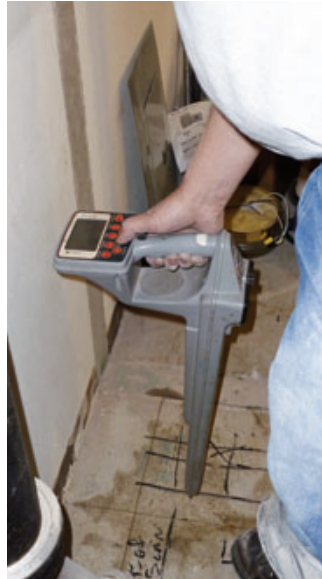
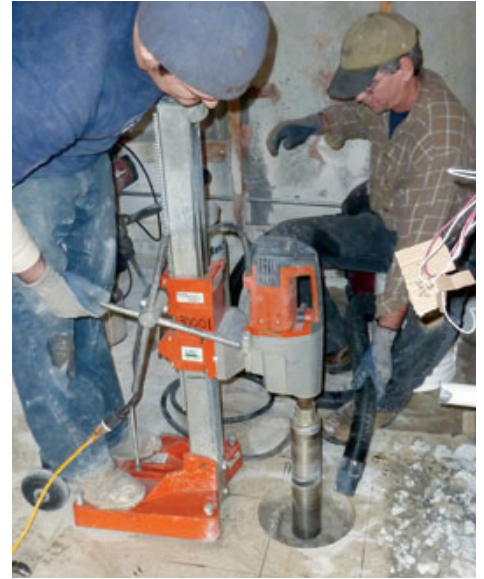
The technician arrived on the scene with an inspection device that uses ground-penetrating radar to determine the exact position of objects within poured concrete (see Figure 1, page 3). After placing a grid-embossed mat on the floor, he ran a wheeled scanner over the grid on both X and Y axes. The scanner relayed the coordinates of each item embedded in the slab to a connected computer, which then plotted it using the grid as a point of refer-

Figure 1. A technician uses ground-penetrating radar to map the position of electrical conduits and other obstructions in the reinforced slab floor (above left). Unlike a wheeled scanner, his handheld scanner can't map results or plot exact depths, but it can get closer to walls (above right).

ence. Within minutes we had a road map of sorts, telling us what was where in the floor.

The nominal expense (under \$500 to scan four separate locations) was money well-spent, as the technician identified a series of electrical conduits in the path of the proposed hole for the roof drain. Since drilling through the slab in that location was out of the question, we decided to opt for the out-swinging entry door after all. The hallway servicing the apartment was 6 feet wide, so we'd easily be able to meet minimum clearance standards.

During his inspection, the technician had also found a number of obstacles in the slab where we planned to locate the new shower drain. But in this case, we were able to simply move the drain over a few inches to avoid any problems.

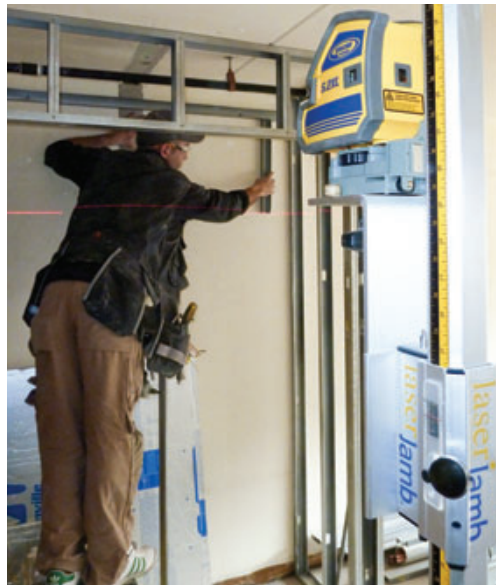
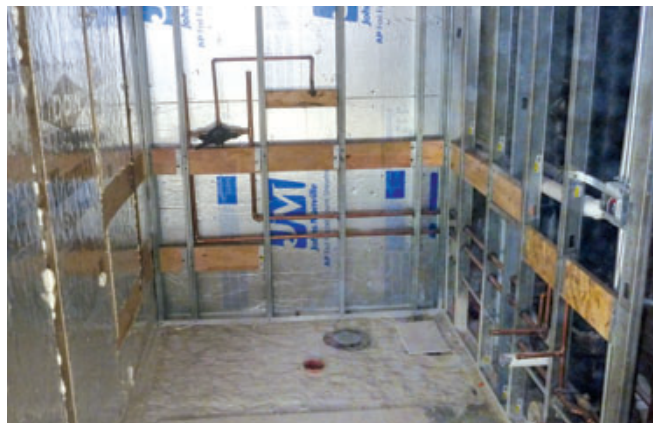
Blocking. We framed the new partitions with steel studs, then installed all the necessary wood blocking for grab bars, fixtures, cabinets, and countertop supports as we went (**Figure 3**). This is a critical step in any accessible retrofit, as missed or incorrectly positioned blocking would mean having to open finished walls down the road.

Positioning grab bars — which need to be able to support at least 250 pounds — can be particularly tricky, so we installed an

Figure 3. With no structural loads to worry about, the new partition walls were quickly framed with steel studs (left). Plenty of blocking was needed to easily position and install grab bars, a fold-down shower seat, and other accessories (below).

almost continuous horizontal row of blocking in both the shower and the toilet areas. We also installed plenty of additional blocking for the folding shower seat, and for the wall-hung lavatory sink and some of the kitchen cabinets and counters, which gave us needed flexibility in their left/right positioning.

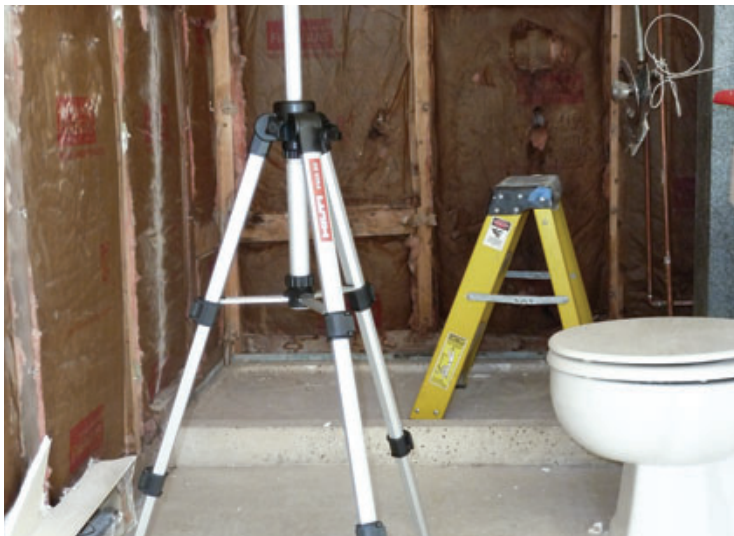
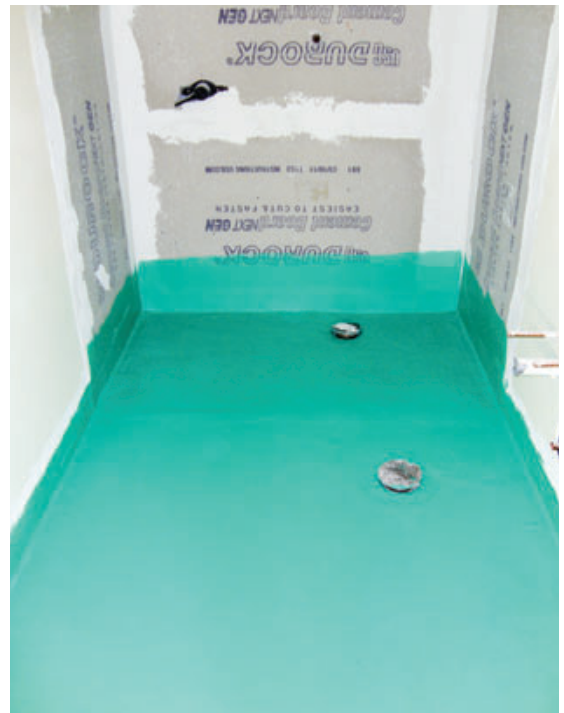
shower base presented a 3-inch hurdle for someone in a wheelchair. Since UFAS guidelines dictate no more than a 1/2-inch-high curb, plans called for the removal of the shower base and, in its place, the installation of a wider roll-in tile shower (**Figure 4**).

We had to chip away about one inch of concrete from the 8-inch-thick floor in the shower area to completely eliminate the curb and provide the proper slope for the relocated shower drain. To do this, we first scored the slab in a roughly 3-inch-square grid pattern with an electric cutoff saw set to a depth of 1 inch. Then we broke out the pieces using a rotary hammer in chipping mode. To shape the 36-inch-by-65-inch shower floor and pitch it to the new drain, we screeded a couple of thin coats of unmodified thinset mortar over the roughened concrete.

We rolled three coats of Laticrete 9235 liquid waterproofing membrane (800/243-4788, laticrete.com) onto the entire bath floor. When we waterproofed the shower walls, we rolled the waterproofing membrane an extra few inches beyond the shower area. Then we installed the ceramic tile.

Figure 4. The original shower base had a 3-inch-high curb, common in standard construction but a major obstacle to a wheelchair (above). After removing it, the author lowered the concrete slab in the shower area by an inch, smoothed and sloped the surface toward the new drain, and waterproofed the entire bathroom floor with a liquid waterproofing membrane (right).

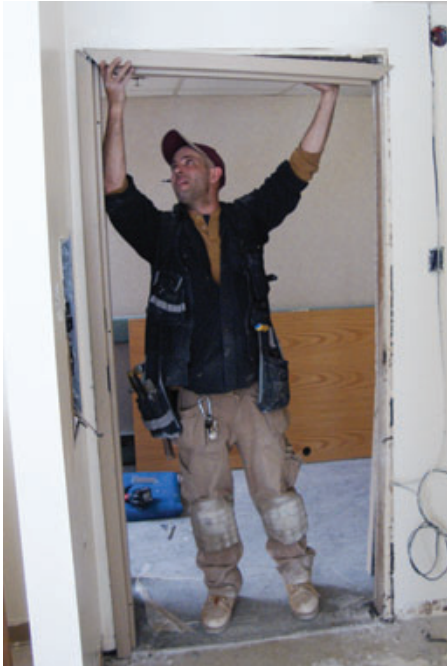
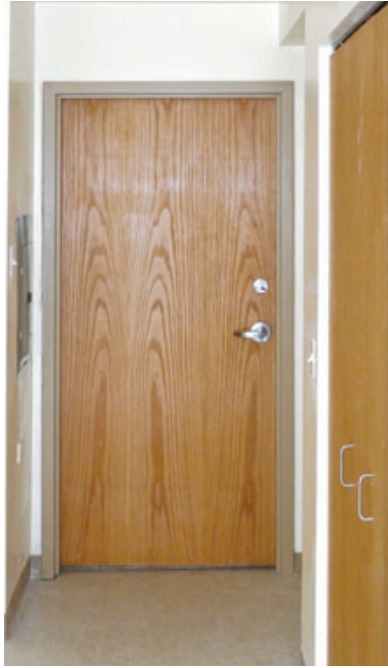
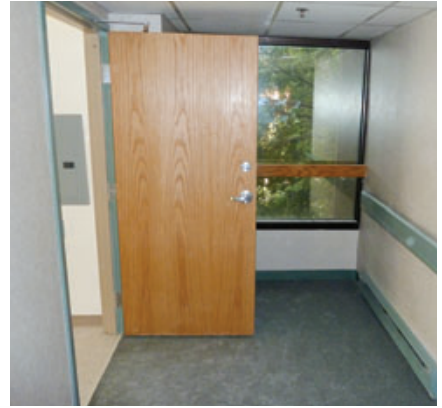
While most wheelchairs are only 26 inches wide, accessibility guidelines typically call for at least a 32-inch clear opening at doorways. To meet this requirement, we replaced the entry, bedroom, and bathroom doors with 36-inch-wide units. The standard off-the-shelf 3/0 doors were fitted with metal jambs — typical in this type of construction. We installed levers rather

Figure 5. All of the doorways needed to be widened to a full 3/0 to accommodate a wheelchair (far left). Though the location of an existing drain made it impossible to provide a full 5-foot clear floor space at the entry inside the apartment (left), HUD rules permit the clearance to be outside the apartment in the hallway (above).

than knob sets to make the doors easier to operate (**Figure 5**).

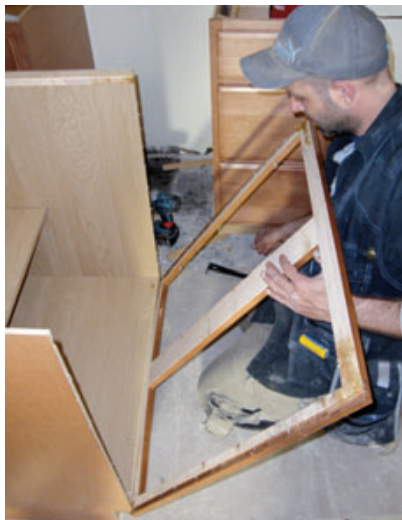
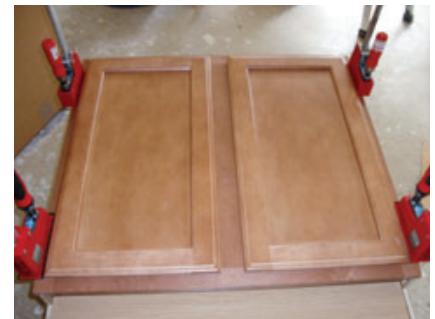
At the sink, plans specified a 34-inch-high countertop, but the cabinet manufacturer's only 32 $\frac{1}{2}$ -inch-tall UFAS-compliant cabinets had nonstandard 9-inch-high toe-kicks. To lower the countertop height here while keeping the toe-kicks and bottom rails at the same level as the rest of the cabinets, we modified two 34 $\frac{1}{2}$ -inch-tall stock base units by removing their face frames and cutting 2 inches off the top of the boxes. Then we applied matching — but shorter — vanity face-frame and door assemblies supplied by the manufacturer (**Figure 6**).

When we were cutting the boxes, we also dramatically shortened the back on the sink base so that it would clear the P-trap and shutoff valves. Now both cabinets can be

removed to provide wheelchair access to the sink without disconnecting the plumbing.

Figure 6. The author ordered face-frame and door assemblies sized to fit vanity cabinets and in a finish that matched the kitchen cabinets, then applied them to stock boxes that had been modified to fit under a 34-inch-high countertop.

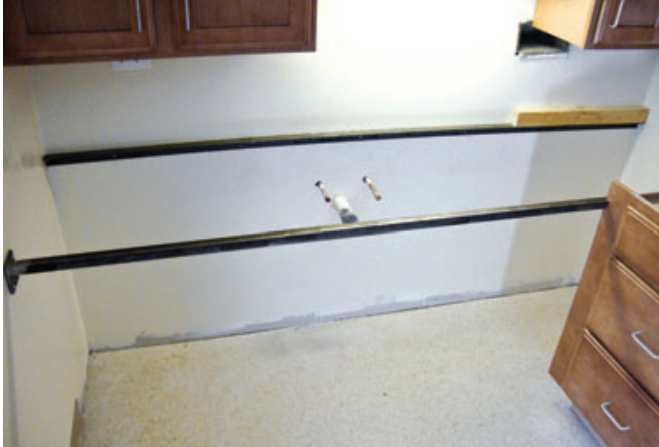
We installed a pair of horizontal steel supports for the countertop to bear on so that it too would be unaffected if the cabinets were removed (**Figure 7, page 6**). A length of 1 $\frac{1}{2}$ -inch-by-1 $\frac{1}{2}$ -inch-by- $\frac{1}{8}$ -inch angle iron bolted to the wall carries the rear of the counter, and a custom-fabricated length of 1-inch-by-1-inch bar stock with mounting flanges welded to either end carries the front. The steel bar nests behind the bullnose edge of the 1 $\frac{1}{2}$ -inch-thick solid-surface countertop. We fastened the mounting flanges to blocking buried in the walls with 2-inch-long #8 sheet-metal screws.

Figure 7. The sink countertop is supported by steel angle at the wall and bar stock at the front (left), so that the cabinets underneath can be quickly removed for wheelchair access without interfering with the countertop or plumbing (right).

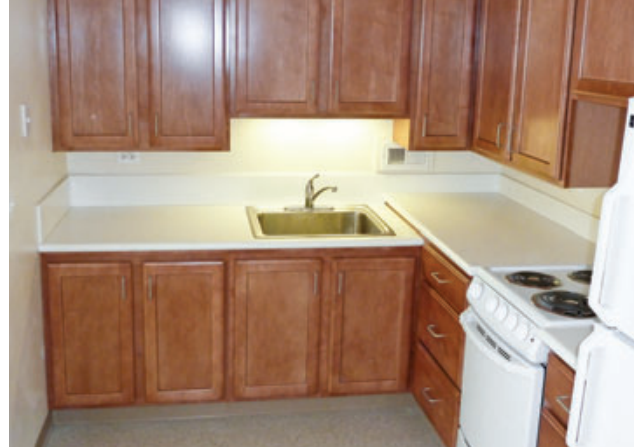
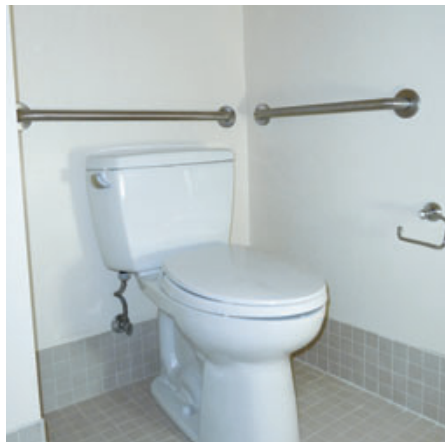
In the shower, we installed a height-adjustable glide-bar shower-head and a Grohe antiscald thermostatic shower valve equipped

Figure 8. The barrier-free shower is equipped with a flexible rubber dam that helps contain water without inhibiting wheelchair access; note the second floor drain under the sink (below). Like the shower, the high-rise toilet is equipped with grab bars securely fastened to wood blocking (left).

with a volume control (**Figure 8**). Located right next to the fold-down shower seat, the valve is easy to use in either a standing or a seated position. Since the walk-in shower no longer has a curb, we installed a WaterStopper, a 1³/₈-inch-high self-adhesive collapsible rubber dam (800/727-9907, best-bath.com) to help with water management, plus we added an extra floor drain equipped with a trap primer underneath the lavatory.

We also installed a Toto Drake high-rise toilet (888/295-8134, totousa.com) and a matching wall-hung sink. The latter is a two-piece affair consisting of the bowl itself and a shroud that covers the piping below, which satisfies UFAS requirements for knee space and scald protection. On previous projects, we've installed preformed insulation specifically designed for scald protection, but I think the two-piece sink offers a cleaner look and does a better job of satisfying HUD requirements.
