Troubleshooting a Kitchen Remodel

Twists and turns in a complex kitchen installation call for constant problem-solving and a little luck

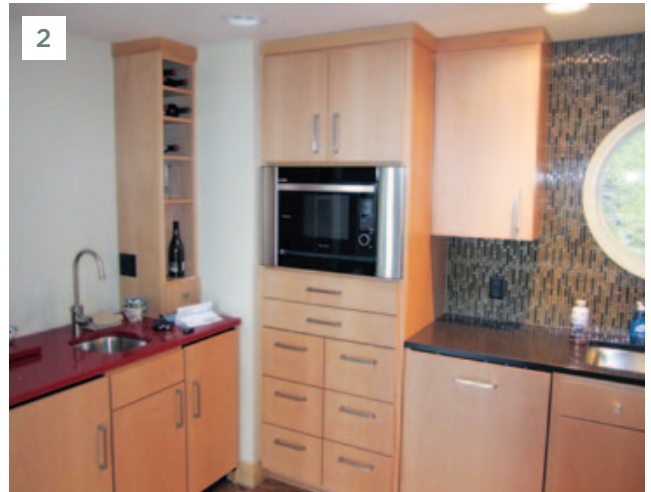
The microwave and pantry base cabinets (2) were also so large that it took four men to carry them into the house, even after we had removed the doors and drawers. The integral toekicks compounded the problem. I generally ask cabinetmakers to provide separate bases and kicks — it's easier to level a 10-pound toekick than a 150-pound base cabinet — but, again, I wasn't dealing with the cabinetmaker directly on this project.

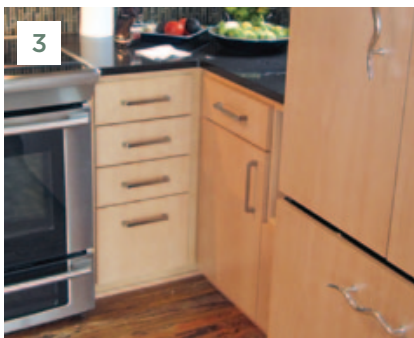
One corner of the base cabinet run was a trifecta of conflicts (3). The first had to do with the drawers on either side of the corner (4). These slid by each other easily until we installed the pulls; fortunately there was just enough side-to-side adjustment in the slides to gain the necessary clearance.

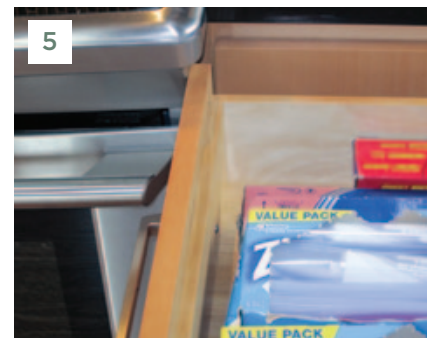
The second was a conflict between one of the corner drawers

and the range, which prevents the drawer from opening fully (5). There was no good solution, but because the restriction is only a couple of inches, the owners find they can live with it.

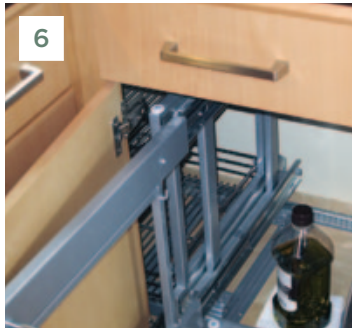
The extra depth of the refrigerator created another problem (6). The inside corner base cabinet to the right of the range contains baskets designed to pull out and then to the right, to give access to an inner basket. The problem was that when the hardware was pulled to the right, it ran into the projecting refrigerator panel.

This was the cabinetmaker's mistake, so he had a metal shop cut down the outer basket to fit. We made the necessary adjustments on site to reinstall the hardware and get it to work.

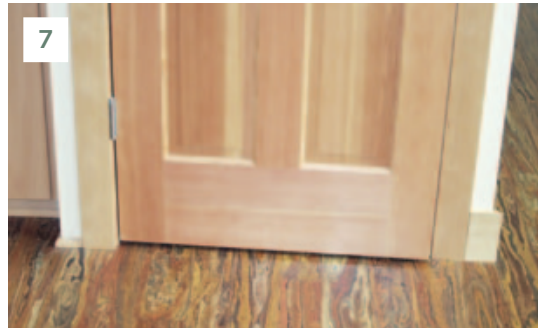
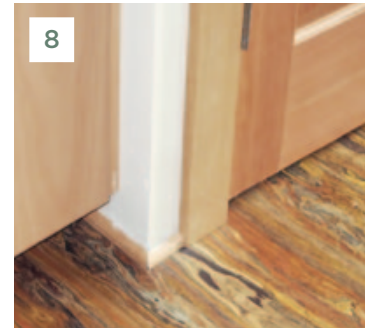
The pantry unit has a rotating inner shelf that spins only if the door is opened beyond a certain angle. Unfortunately, the 5-inch fir baseboard used everywhere else in the kitchen got in the way here, so we substituted a piece of 3/4-inch base shoe (7, 8). So far, no one has complained.

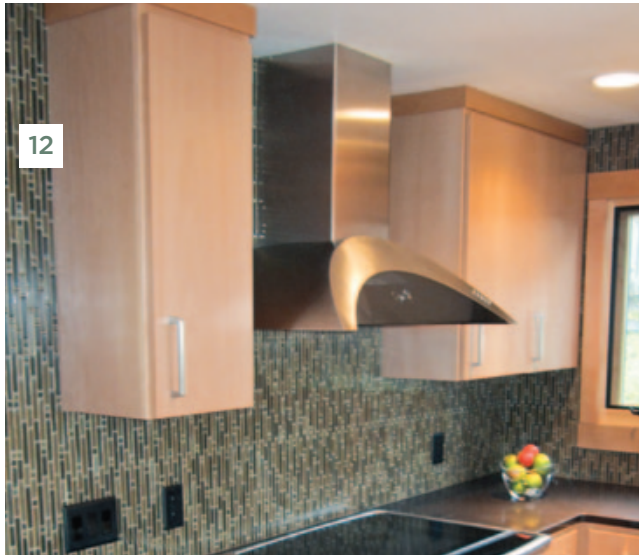
The high-end range hood mounts to the wall on a concealed bracket, with a telescoping two-part rectangular chase above it

that contains the electrical components and exhaust duct (12). Because it's made for an 8-foot ceiling but we only had 7 feet 8 inches, the only way to make it work was to shorten the rectangular chase — a task we farmed out to a local sheet-metal shop. They did a neat job, and the modified unit went in fine.

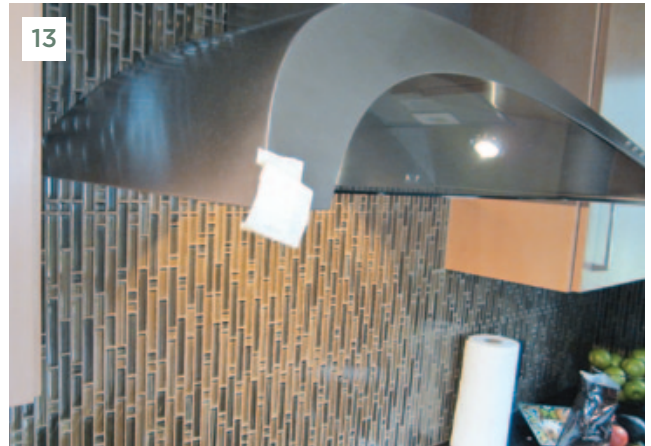
Unfortunately, the sharply angled corners of the hood itself have proven to be a liability (13). My carpenter, the electrician, and I all managed to drive these corners at least a little way into our heads while installing the unit, and the homeowners have had the same problem. This is really a design defect, and there are only two possible solutions — throw the expensive item away and install a different one, or learn to avoid the corners. The homeowners have opted for the second course.
