# Why Stucco Walls Got Wet

Designs, methods, codes, and workmanship all played a role in Florida's soggy storm experience

by Joe Lstiburek

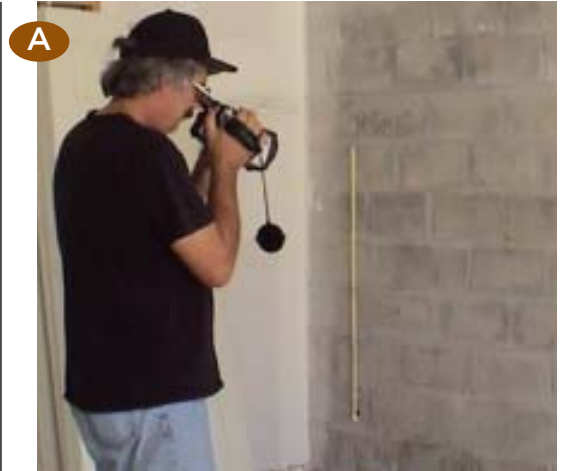
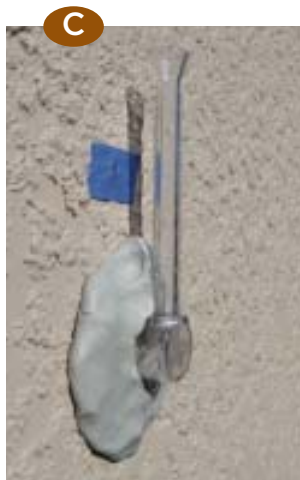
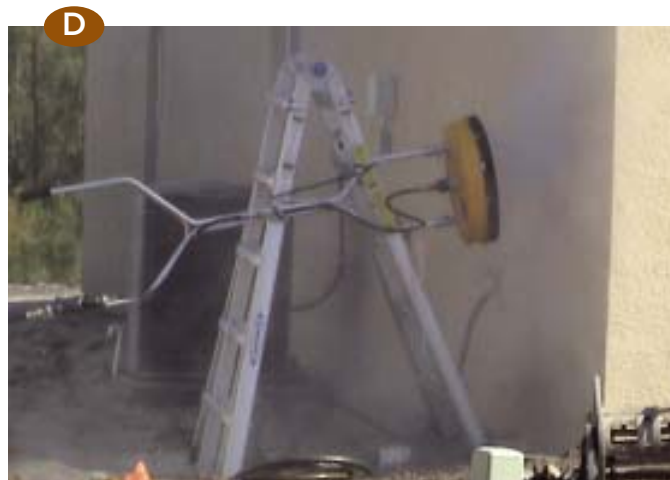
**Figure 1.** Members of the author's investigative team examined stucco walls with infrared cameras (A) and camera probes (B). To measure water leakage, they applied hydrostatic head tests (C) as well as simple water sprays and simulated wind-driven rain (D).

We applied a wide range of investigative techniques (see Figure 1, next page): We inspected homes soaked by the storms as well as new

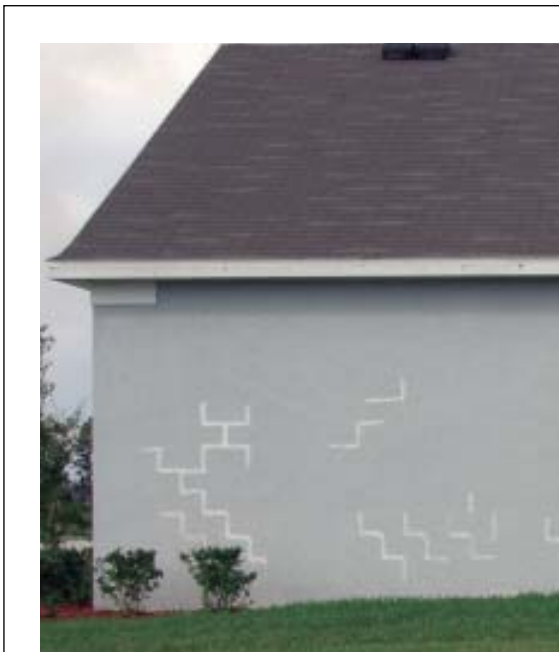
**Figure 3.** Houses shift after construction as supporting soils consolidate and materials change size with changing temperature and moisture content. This movement of substrates, though typical and expected, inevitably brings about some cracking in brittle surfaces like stucco, creating the need for ongoing maintenance and repair in the early years of a building's service life.

So why not change codes to require either a mandatory curing period between coats or the use of additives in the mix? That wouldn't really be a practical solution. Neither technique will prevent shrinkage cracks altogether. Nothing will. More to the point, there's another cause of cracking that we also can't prevent: settlement (Figure 3). Virtually all buildings move and shift enough in the first few years after construction to cause some cracking of the stucco — and no stucco, whether traditional or polymer-modified, is immune to that.

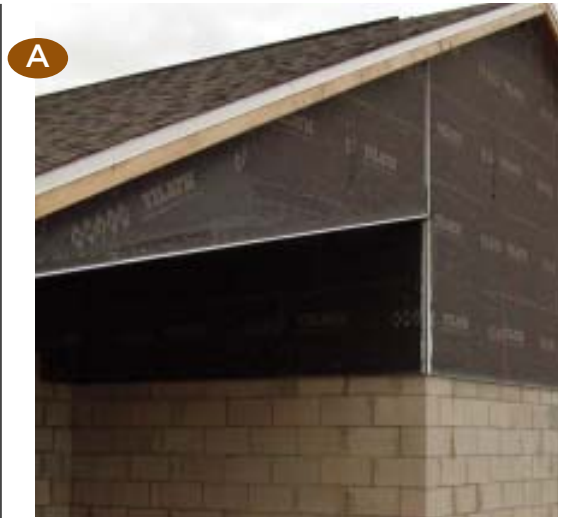
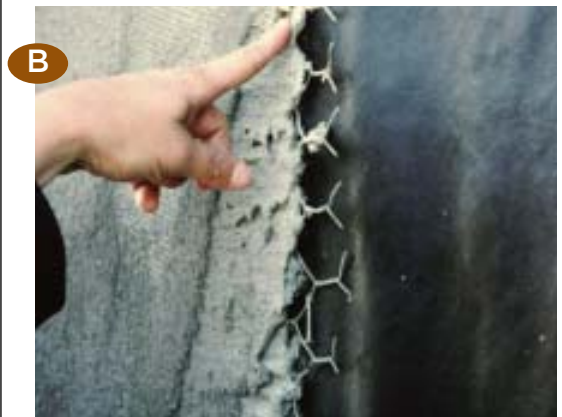
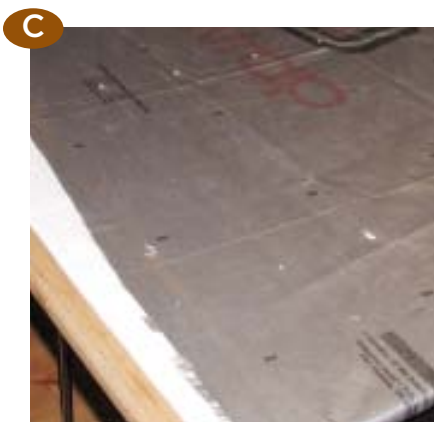
**Figure 4.** Upper-story walls in central Florida are typically stick-framed, while lower-story walls are laid up with concrete block (A). Both wall types leaked, but for different reasons. Designed as drained assemblies, frame walls were handicapped by the bonding of building paper or housewrap to the stucco coatings, which prevented free drainage (B). Forced into contact

with trapped water, most housewraps allow some water penetration, as shown in table-top testing at the author's shop: Water dripped onto a horizontal housewrap surface (C) soaked into the absorbent test material underneath (D). In the field, saturated stucco coatings over imperfectly performing housewrap allowed water into sheathing and stud bays (E).

One reason Florida walls leaked was that the housewraps or papers installed beneath the stucco did not function effectively as a drainage plane (Figure 4). Stucco tends to bond to housewrap and building paper, eliminating the air space in which water is supposed to drain. Also, the housewrap or building paper itself loses water repellency when stucco adheres to it, or when it comes in contact with surfactants (soap-like chemicals that reduce the surface tension of water). In Florida, water that reached the housewrap or building-paper layer in the walls often bled through into the frame assemblies.

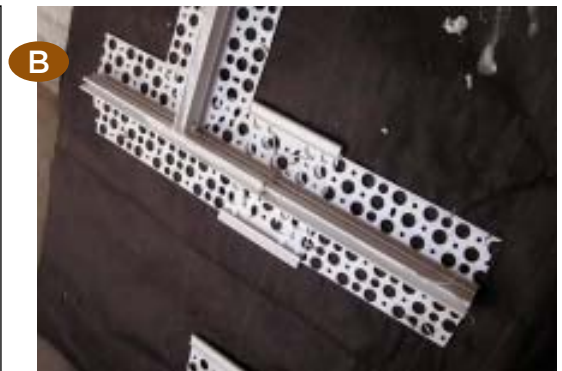
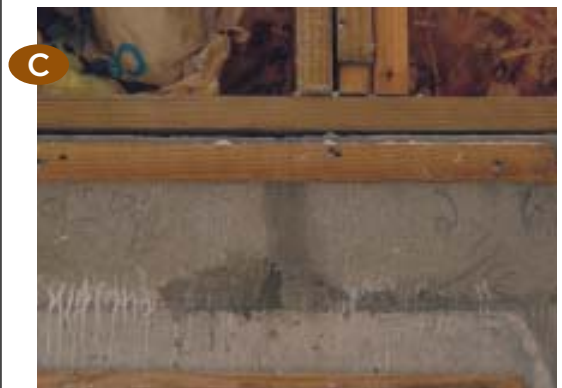
**Lower-story mass walls.** Masonry-block walls with stucco cladding aren't intended to function as drained assemblies. They are "mass assemblies." Water that penetrates the stucco through cracks is supposed to be absorbed by the masonry mass, which it doesn't damage, and then dry slowly to both the exterior and the interior during periods of dry weather (Figure 6, next page). Central Florida's masonry walls, for the most part, were able to manage moderate amounts of rain but were simply overwhelmed by the huge water onslaught from three consecutive hurricanes.

Rather than suggest a modification of the stucco materials or installations, I've suggested a few small design changes that would enhance the ability of these systems to absorb and dissipate water without allowing it to enter living space or damage finishes. But even improved masonry mass walls shouldn't be expected to handle rain-

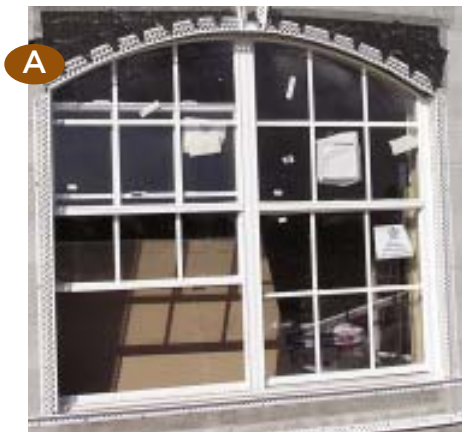
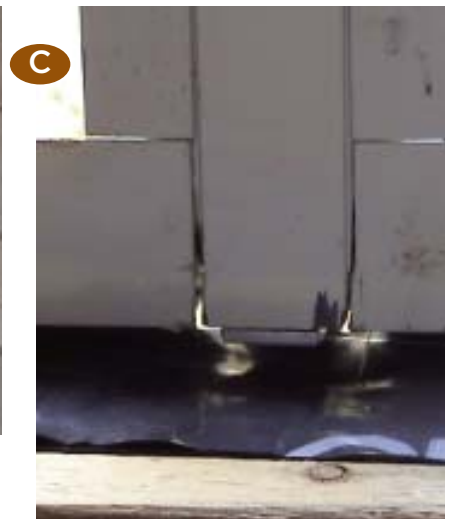
**Figure 7.** Factory-assembled windows like this double unit (A) are frequently found to leak at the corners (B) and the center joint (C).

On the other hand, our testing of windows and window assemblies indicates that many of them leaked under conditions well below their listed, rated value. In fact, many tested windows leak under a simple water spray with no wind pressure at all. Factory testing of windows seems to be missing a widespread incidence of leakage at the window-assembly corners. Also, windows are tested as single units, but are often sold as preassembled “mulled” units, with two or more windows combined in a composite arrangement. Every preassembled mulled unit we tested leaked at zero wind pressure (Figure 7).

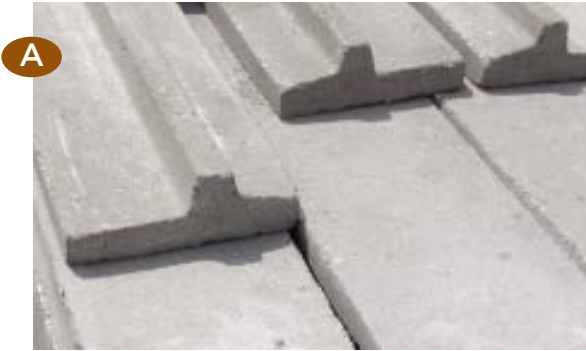
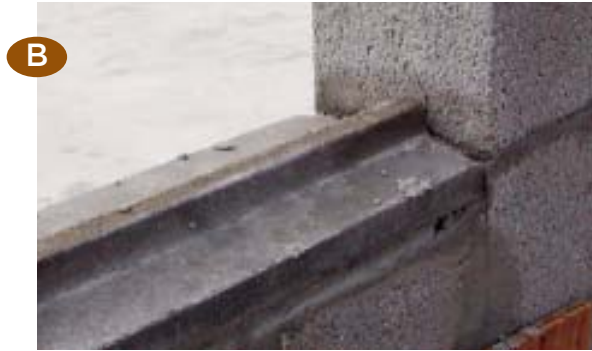
**Figure 8.** Precast concrete windowsills for block walls (A and B) have a profiled flange attachment rib that directs some leakage toward the interior (C). A better windowsill design would direct water toward the outside (D).

Window installation is also an ongoing concern. The methods used in Florida, as elsewhere, often don't ensure reliable water management. In particular, precast concrete windowsill components sold into the Florida market are shaped in a way that directs some leakage into — rather than out of — the building (Figure 8).

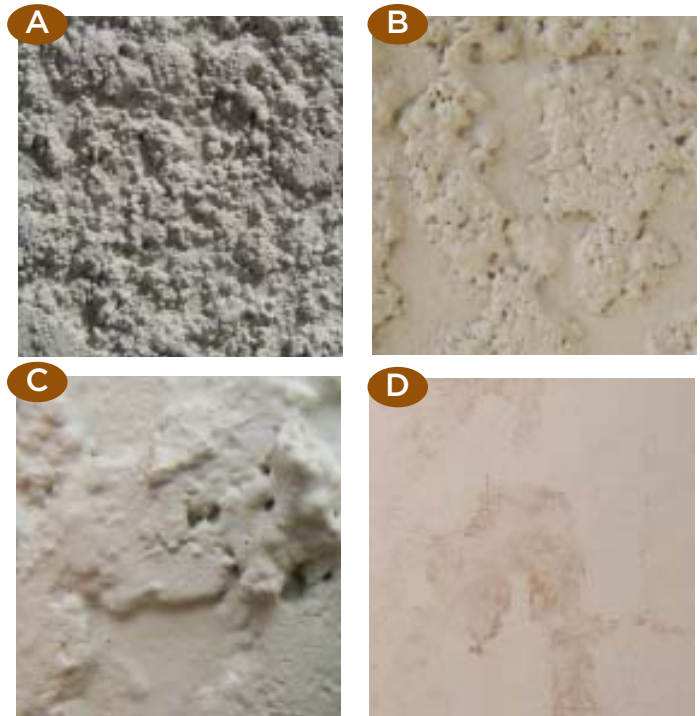
**Figure 9.** Paints and coatings are not highly effective at spanning cracks and pinholes in a rough stucco coating. Ordinary paint (A), a 3-mil high-build coating (B), and a 10-mil elastomeric coating (C) all leave pinholes that can be seen under magnification. Thick elastomeric coatings over stucco can also be prone to blistering (D).

Also, high-build paints and elastomeric coatings span microcracks most effectively when the surface is smooth. On rough-surfaced stucco, which is a very common finish in the industry, coatings are much less effective at sealing surfaces (Figure 9).

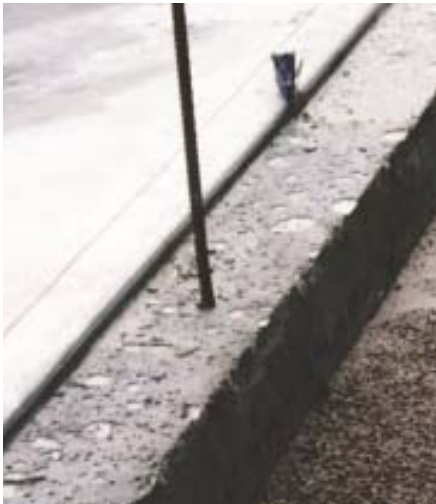
## Stepped-Down Foundation Detail

**Figure 10.** To help block walls store greater amounts of incidental water and to direct the moisture back outside rather than allowing it to trickle into the home, foundations should have a stepped-down shelf at the slab edge. A weep screed at the lower termination of the stucco will allow accumulated water to get out.

Two proven methods would improve the performance of these walls. First, the foundation slab or footing should be built with a stepped-down seat or shelf where the first course of masonry block is set, as in Figure 10 (previous page). This will direct water that reaches the base of the wall outward to the outdoors, rather than inward, where it can damage floors or cause humidity problems.
