REPAIRING A Bulging Foundation

This commonsense approach uses concrete deadmen on the outside to stabilize a buckling basement wall

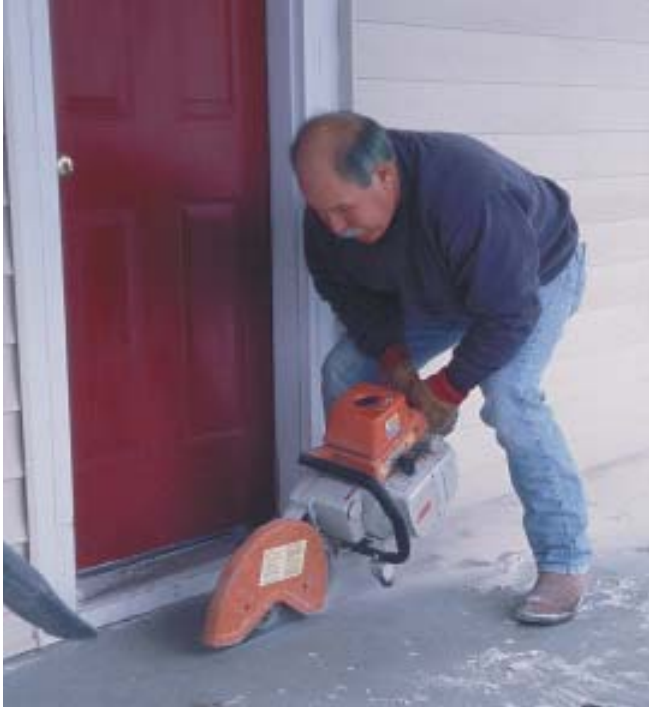
Figure 1. Cutting the existing porch slab prevented the concrete pieces from seesawing and damaging the siding. The crew used a leaf blower to remove dust and make it easier to see the blade and cut line.

The first section of foundation was below an existing concrete porch. I was concerned that removing the existing porch slab would damage the house or siding as the pieces were broken up. To prevent damage, we used a gas-powered cutoff saw with a diamond blade to cut the slab close to the house (see Figure 1). Once most of the pieces had been broken up and hauled away, we removed the smaller pieces, using a little more finesse than the improvised ram attached to my subcontractor's backhoe (Figure 2).

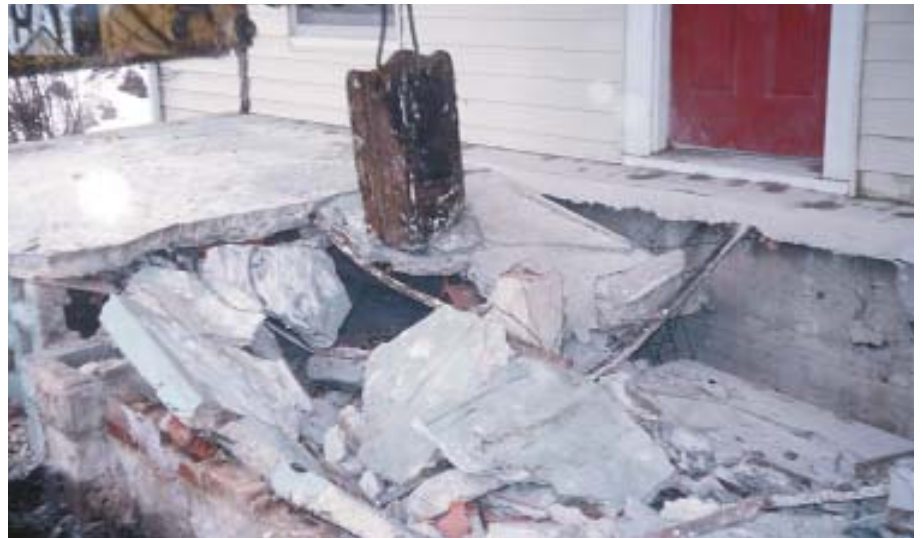
Figure 2. To avoid the risk of running a jackhammer on an elevated slab, the excavation sub used an improvised ram to break up the concrete. When the slab and foundation were gone, the smaller pieces close to the house were removed with a sledgehammer.

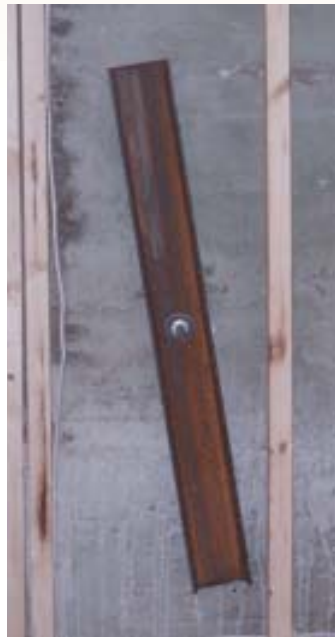
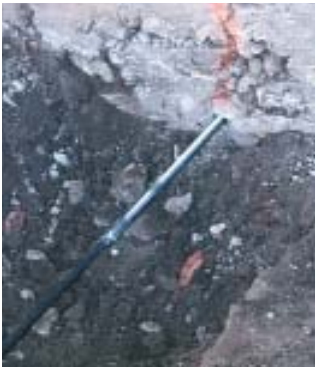
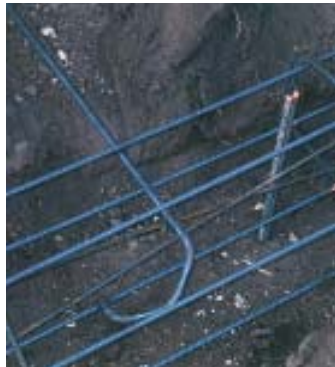
Porch Footings Do Double Duty as Deadmen

Figure 3. Like a giant plate washer, steel C-channel (right) placed across the existing foundation's weak area spreads the resisting force from the concrete deadman outside. Threaded rod passing through the foundation wall (below left) is welded to steel rods that hook around the rebar in the deadman (below right).

Using a rotary hammer, we drilled through the foundation wall in four spots, about 7 feet on-center. I inserted lengths of 3/4-inch threaded rod and bolted them to 30-inch pieces of heavy-duty steel channel. The channel would act like a huge washer, and the threaded rod would make it easy to bring the assembly under tension once the footings and foundation were in place (Figure 3). With the threaded rod running through the wall to the exterior, I had a local welder attach it to lengths of hot-rolled steel that were hooked around the rebar, reinforcing the new porch footing.

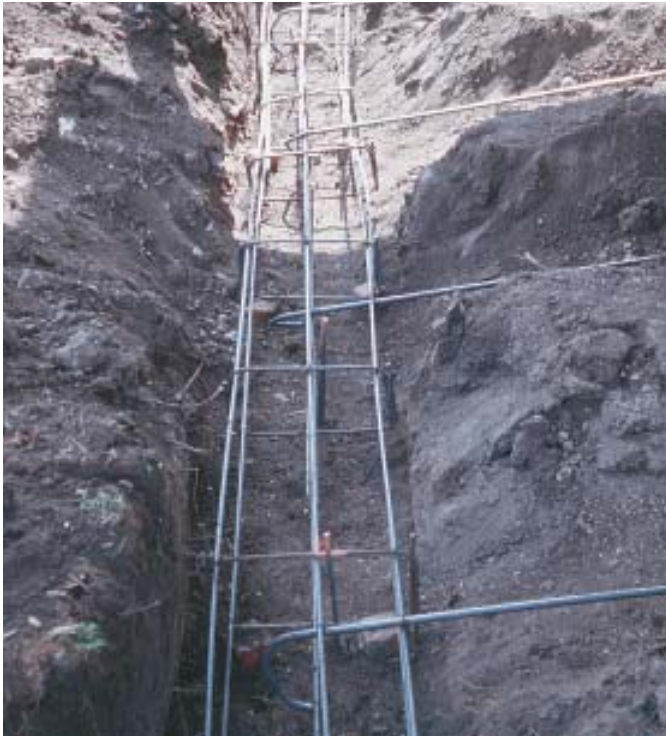
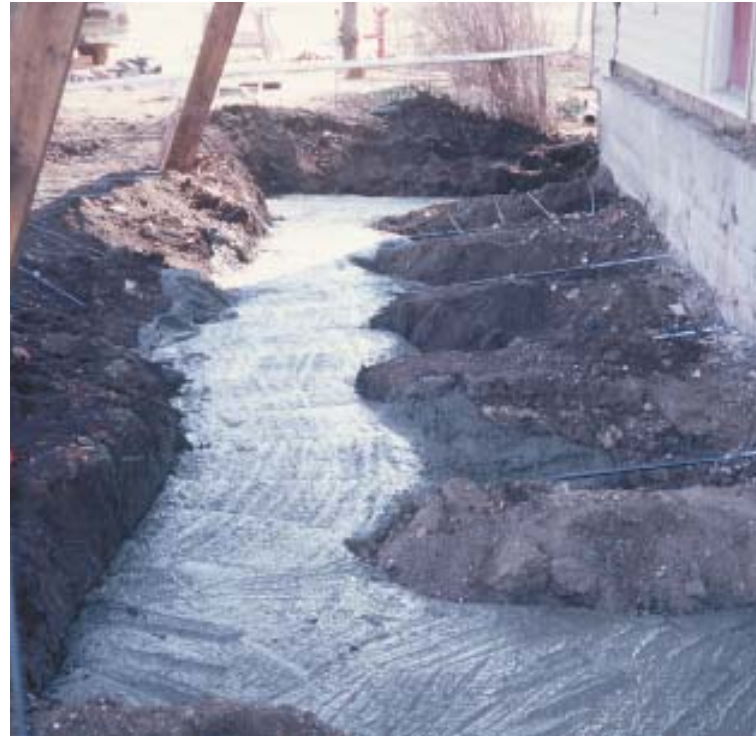
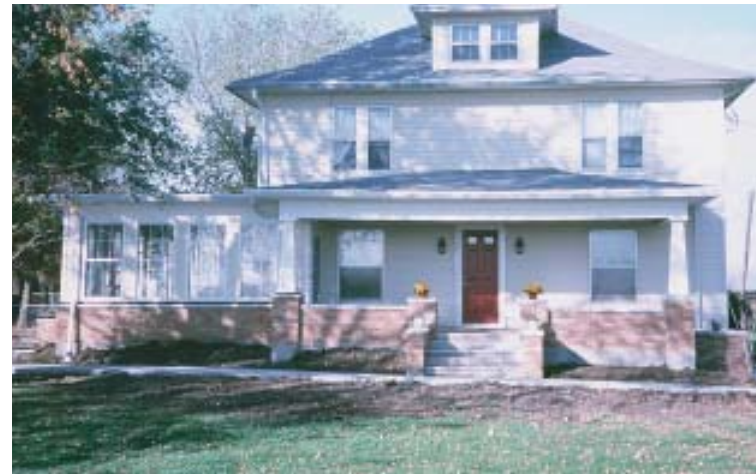
Figure 4. The heavily reinforced deadmen (top left) act as footings (top right) for the new front porch (above), which adds its weight to the resisting force.

Once all the reinforcing steel was in place, I ordered concrete for the footing (Figure 4, next page). We used a

stiff mix; although I didn't do a slump test, I estimated it at around 2 or 3 inches. A stiff mix is tough to work around rebar, but I wanted the concrete as strong as possible. Fortunately, we could get the chute all the way around the pour, so at least we didn't have to drag the concrete through the rebar. We used a vibrator to prevent voids, plunging and removing it about every 12 inches. While the footings set up, we went to work on the other damaged section of the foundation, where we had to form and pour a new reinforcing wall on the inside.

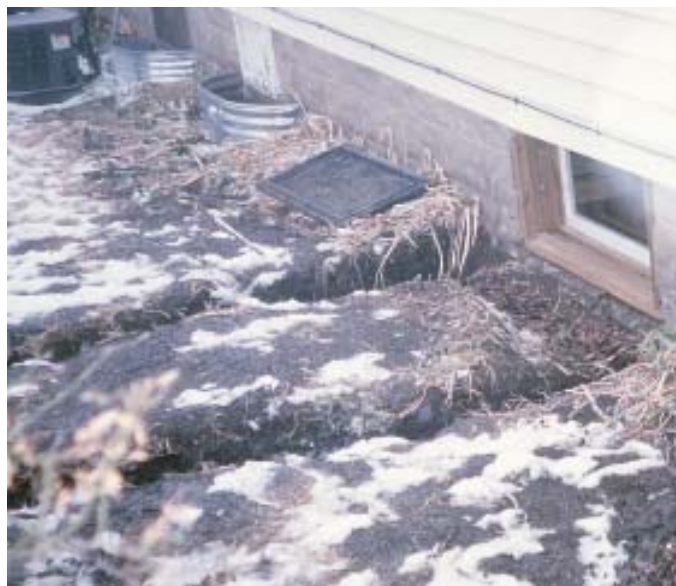
Concrete Deadman With Interior Reinforcement Wall

Figure 5. Four-foot-deep trenches (above) partially filled with concrete anchor the steel channel “plate washer” in this section of the foundation. The new reinforced concrete wall, poured in a one-sided form, consolidates the existing wall (drawing, top).

the wall and inserted $\frac{3}{4}$ -inch threaded rod about halfway up the wall, then welded it to rebar placed in two 8-foot-long trenches (Figure 5). The two concrete-filled trenches would ultimately be hidden below grade. We poured the trenches, then tightened up the nuts on the steel channel.

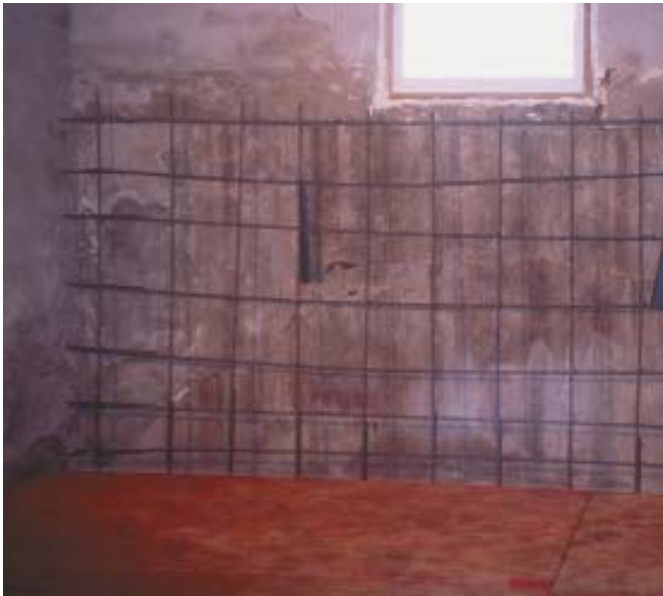
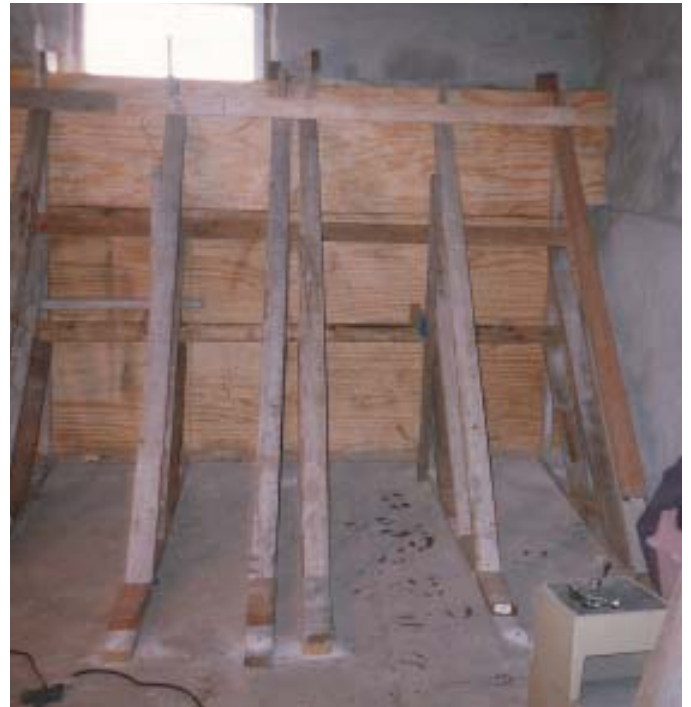
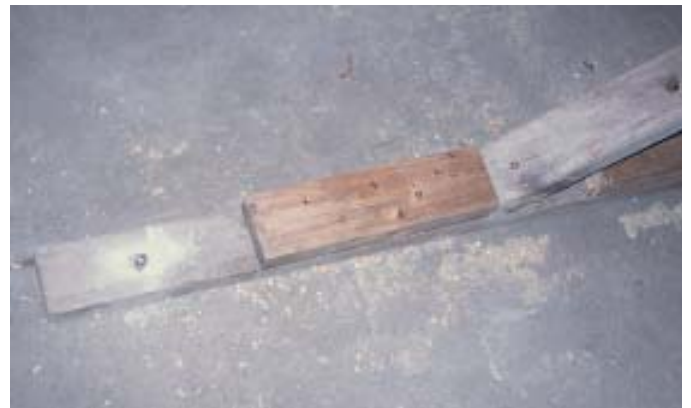
Figure 6. After tightening the nuts on the steel channel, the author placed a grid of 1/2-inch rebar (top left) behind a carefully braced one-sided form (top right). To prevent the form from moving, the kickers along the floor were secured with 6-inch lengths of rebar driven into drilled holes in the existing slab every 18 inches (above).

For the new wall, we placed $\frac{1}{2}$ -inch rebar placed on 1-foot centers horizontally and vertically. We secured the reinforcing grid by tying it to $\frac{1}{2}$ -inch rebar pins drilled into the adjacent walls and floor (Figure 6, next page). After the rebar was tied off, we could really see how much the wall had bowed — about 4 inches in the center.

While I’ve never had a blowout, pouring one-sided forms always makes me a little nervous. Adequate bracing is essential. My customer had maintained her good humor throughout the earlier process, but I thought two yards of slumping concrete sitting in the basement might be too much for her to take. To keep the concrete behind the form, we fastened six horizontal kickers to the floor about 18 inches on-center, using 6-inch pieces of rebar drilled into the floor.
