# Stone Paver Deck

**Manufactured stone pavers are a durable, cost-effective alternative to wood and composite decking**

by Mark Parlee

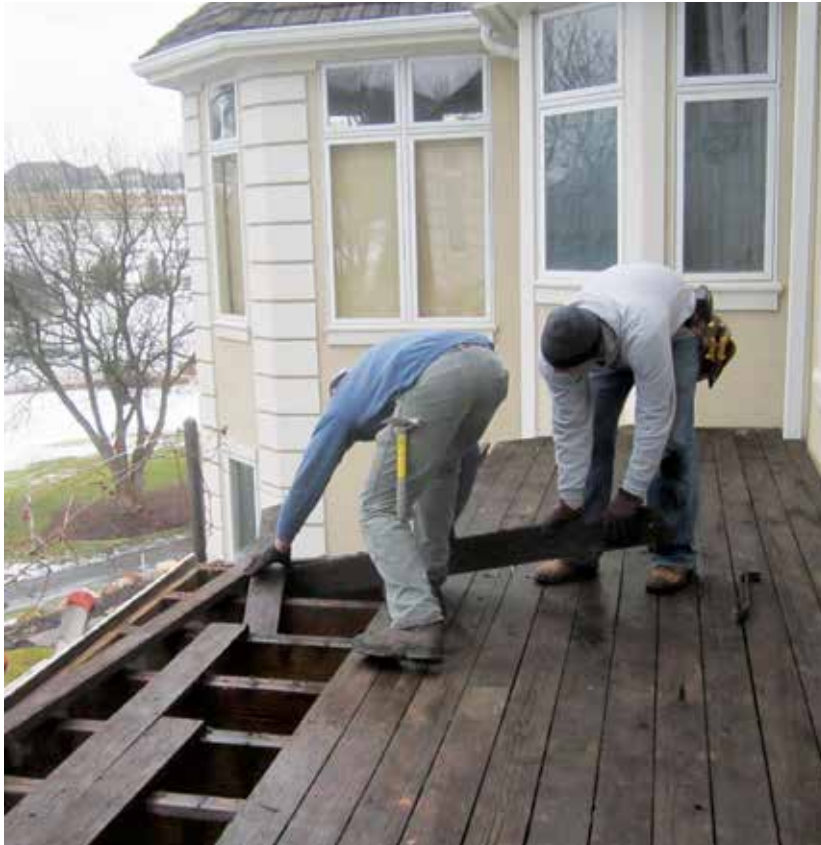
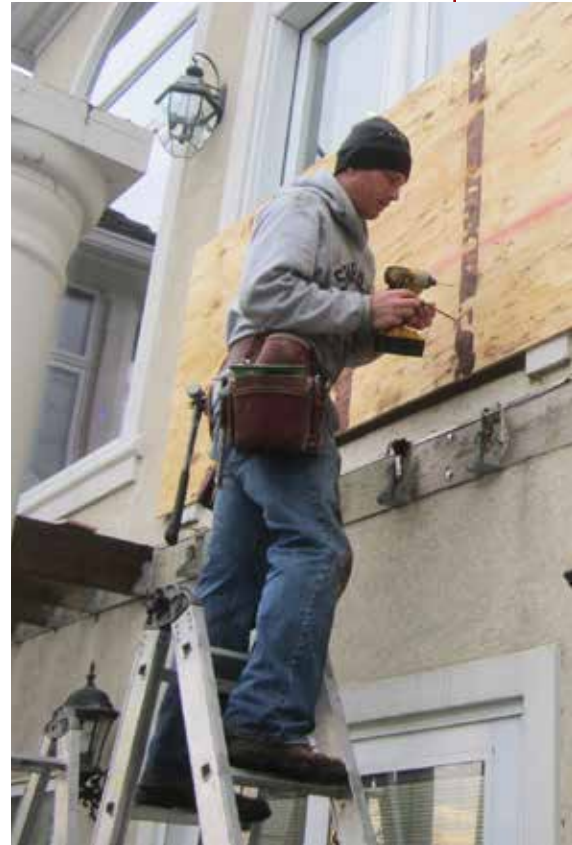
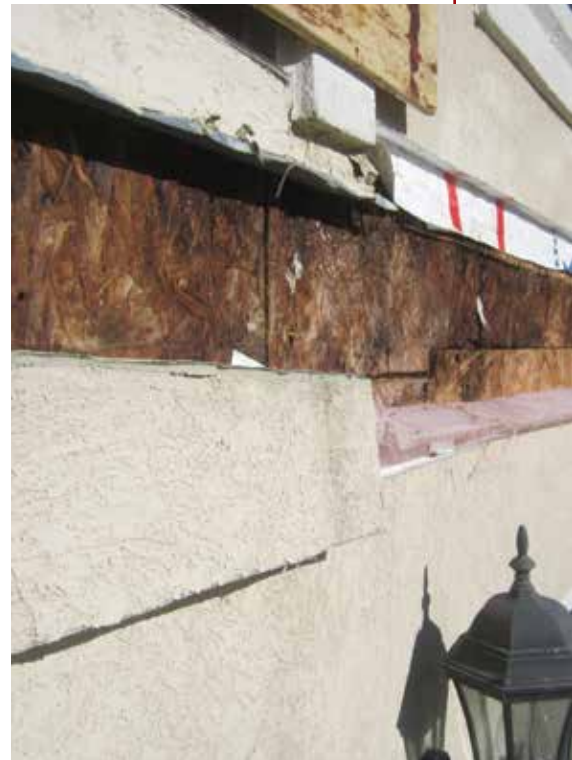
My company has worked on a lot of houses with EIFS cladding over the years, so we weren't surprised to find rotted OSB sheathing when we removed the millwork and original deck. The deck ledger in particular was poorly flashed, a detail that is often executed incorrectly with EIFS and only makes the problem of moisture trapped behind the cladding worse.

We used a moisture meter to analyze potential problem areas, such as at the ledger and underneath window openings. Normal readings are 9% to 15% moisture content; higher readings indicate trouble. In some locations on this house, we found readings of 29% and higher.

**Figure 1.** After removing the original cedar decking and framing (two photos, above), workers discovered moisture damage behind the home's EIFS cladding (right). The cladding had to be cut away to determine the extent of the damage to the sheathing and framing, and to make repairs.

To minimize the amount of patching that would need to be done later, we snapped chalk lines and cut away the EIFS cladding above and below the ledger. Most of the cutting in EIFS can be done using a wormdrive saw equipped with a carbide blade, but we also used a Fein MultiMaster to finish up the cuts in the corners and tricky areas (**Figure 1**). Eventually, enough moisture damage was uncovered that our clients decided to remove all the EIFS from the wall between the ledger and the middle of the half-round windows.

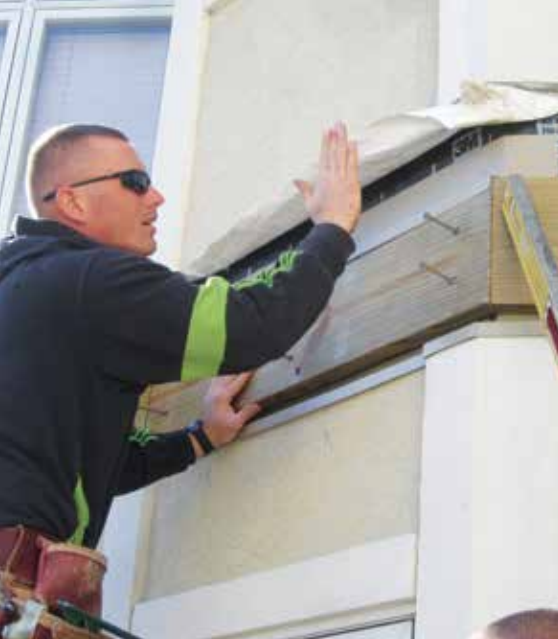
**Figure 2.** Before installing the new ledger, workers installed new metal flashing over the EIFS, and an SAF membrane over the sheathing.

replace the original OSB, we installed metal flashing and lapped it over the EIFS. Then we covered the wall sheathing with Grace Ice & Water Shield self-adhering membrane—lapping that over the metal flashing—before installing the new deck ledger (**Figure 2**).

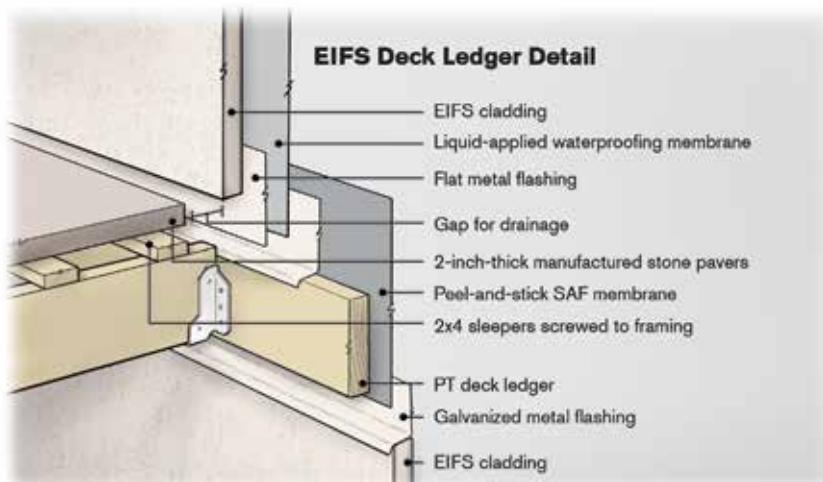
**Figure 3.** Proper flashing is important with any deck ledger, but it's critical with an EIFS-clad house, where leaks in the cladding can allow water to become trapped between the foam and the sheathing and quickly lead to rot.

Because it's critical that the deck ledger flashing is properly integrated with the drainage plane behind the EIFS, we design our own flashing and have it custom-fabricated from Kynar-coated 24-gauge galvanized steel (Exterior Sheet Metal, [exterior-sheet-metal.com](http://exterior-sheet-metal.com)). When we install the flashing, we overlap joints 3 to 5 inches and seal them with OSI quad sealant (**Figure 3**).

Once the ledger was installed, we fastened another metal flashing over it. Later, when the EIFS crew trowel-applied the Dryvit Backstop waterproofing membrane to the wall sheathing, they lapped the membrane down over the metal flashing.

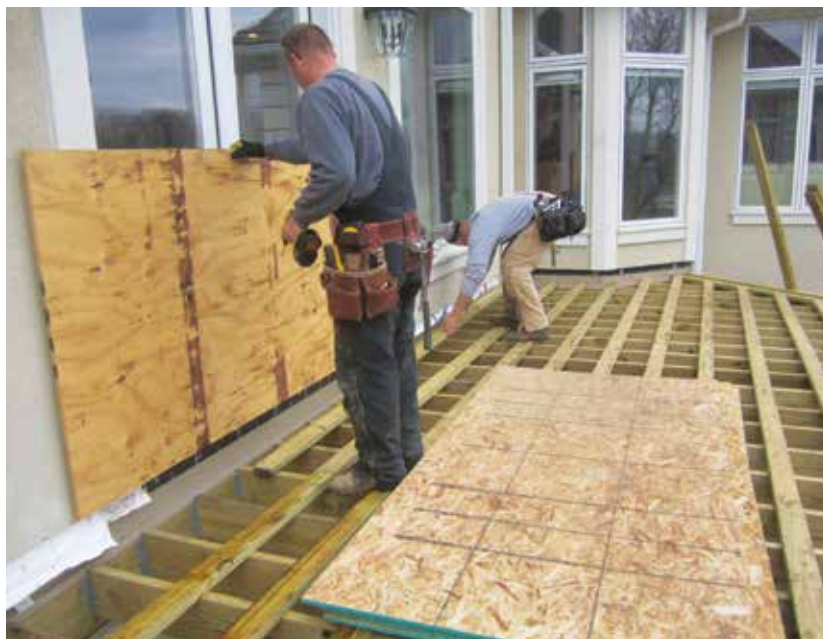
**Figure 4.** The new deck was framed with joists 12 inches on-center. To support the pavers, workers then screwed 2x4 sleepers to the tops of the joists, also 12 inches on-center.

Following the paver installer's recommendations, we framed the deck with 2x8 joists 12 inches on-center. Then we screwed down rows of 2x4 sleep-

ers on top of and perpendicular to the joists (**Figure 4**). These are also spaced 12 inches on-center to accommodate the patio stones, which are sized 1 foot square, 1 foot by 2 feet, and 2 feet square. Later, we would adhere the 2-inch-thick pavers to the 2x4s, leaving about a 1/4-inch gap between the stones to allow for good drainage.

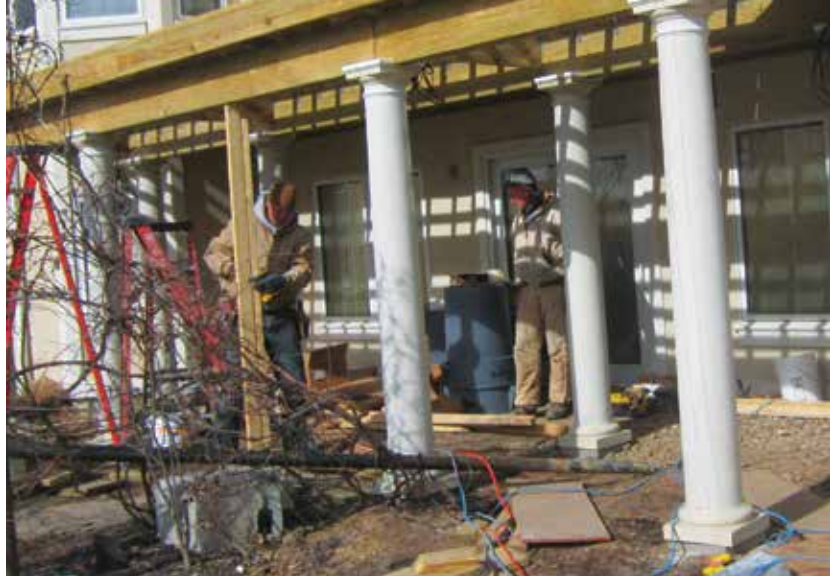
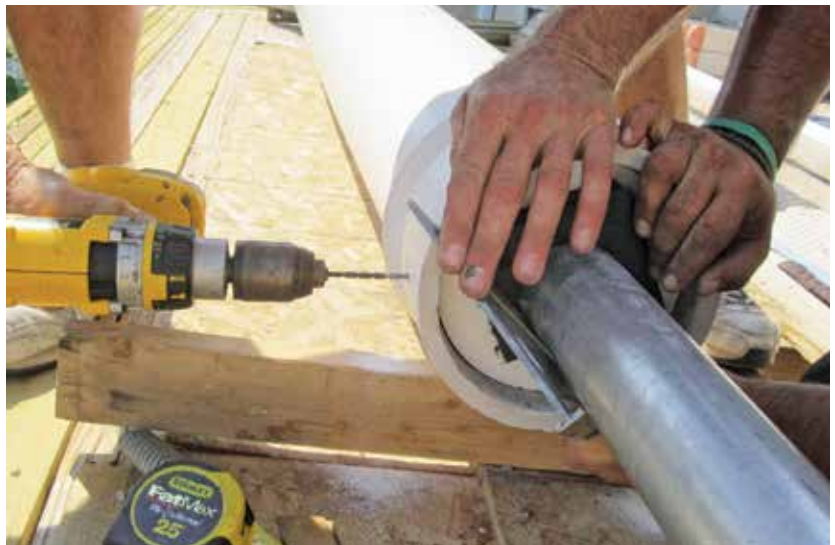
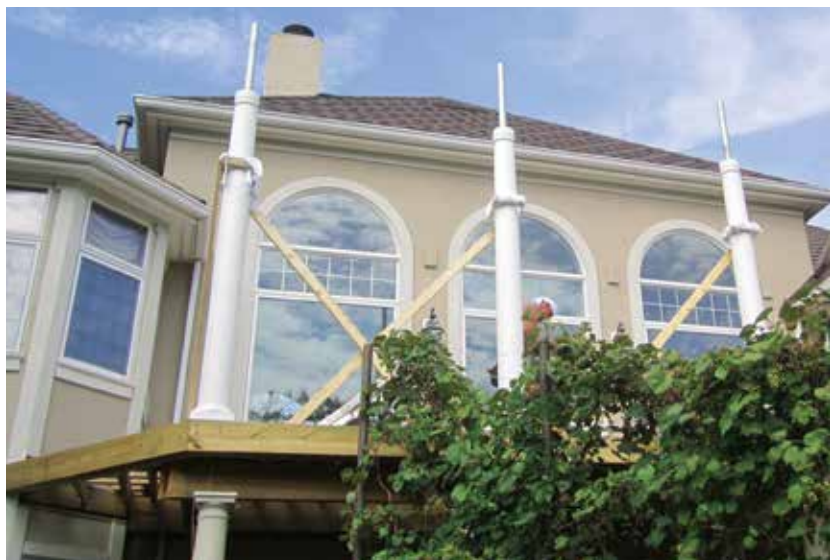
**Figure 5.** The lower columns were installed after the deck was framed (top). Workers added additional steel to the upper columns (middle) to provide a solid attachment point for the pergola and to resist both uplift and lateral movement (bottom). Each steel column has a steel plate welded to its base, which allows it to be bolted to the deck framing.

The fiberglass Turncraft columns we used on this project are structural. To support them, we poured new piers for the front columns, and reused the existing piers for the rear columns. To elevate the columns to keep them out of the dirt, we placed concrete pads on top of the piers. The pads are bedded in non-shrinking grout and shimmed level with the help of non-compressible shims—normally used for leveling pre-stressed concrete panels—which I got from my local building supplier.

Once the grout set, we drilled into the blocks and attached the L-clips that fasten the columns to the piers. The tops of the lower columns attach to the support beams, also with L-clips. PVC caps on the tops of the hollow columns keep water and debris out (**Figure 5**).

To support the pergola structure, we fitted the upper columns with 4-inch-diameter posts welded to 16-inch by

16-inch base-plates. The posts extend up through the top of the columns and provide an attachment point for the double beam carrying the pergola rafters.

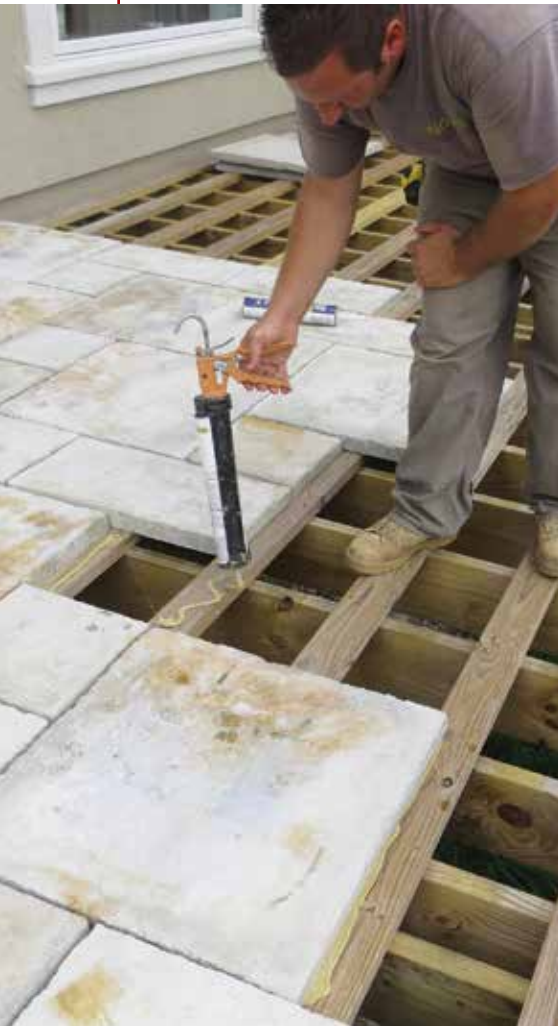
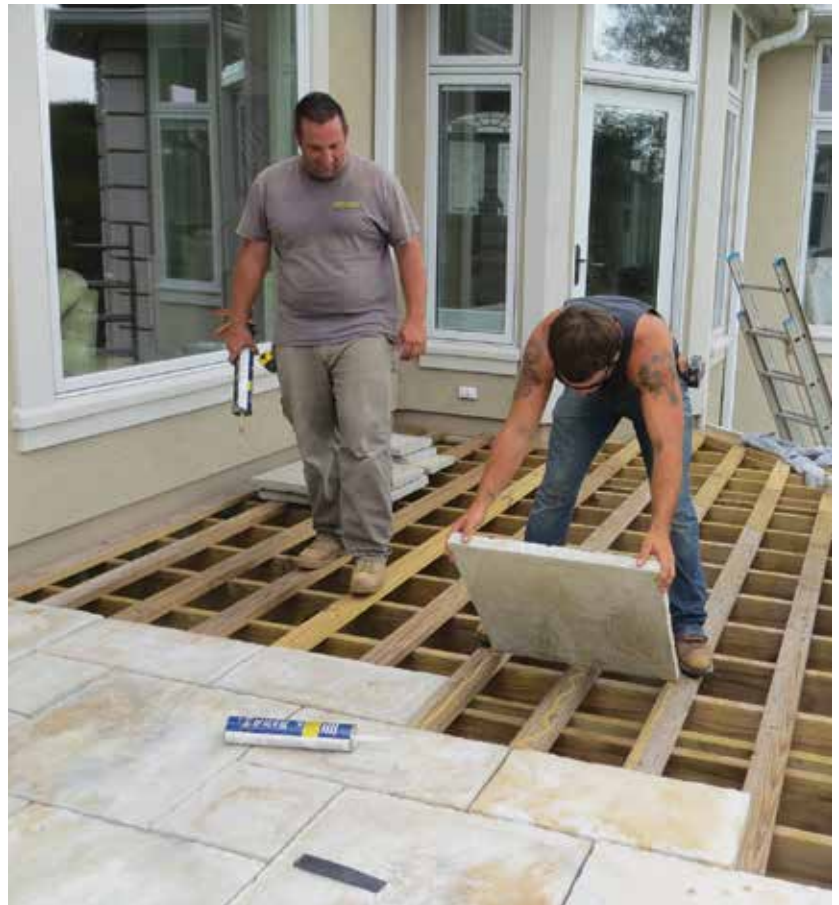
**Figure 6.** Paver installation goes quickly. Working from a CAD-generated pattern, workers apply landscaping stone adhesive to the sleepers (left), then fit the pavers into place (above). A 1/4-inch gap between the ungrouted pavers is critical for drainage.

The pavers were specced and installed by Matt Buman of Biondi Pro-Landscaping, who also provided the framing detail. I've worked with Matt on several projects, and he was the one who introduced me to the idea of finishing a deck with pavers instead of decking. He installed his first paver deck in 2007 and has put in about 15 more since then. For this project, Matt recommended Unilock Stonemark pavers ([unilock.com](http://unilock.com)), which he installed in an ashlar pattern on top

of the 2x4 sleepers. Matt laid out the pattern in a CAD drawing, and the crew glued the pavers down with Super-Stik ([super-stik.com](http://super-stik.com)), a high-performance exterior-grade adhesive that is also used for segmental retaining walls.

A selling point for Matt's paver deck system is the relatively low materials cost—about \$6 per square foot. But I was also surprised by how much faster installing the pavers was compared with installing standard decking. Of course, framing costs are a bit more, so the installed cost for these high-end pavers is roughly the same as that for basic composite decking (**Figure 6**).

plenty of drainage. In addition to the 1/4-inch gap between the ungrouted pavers, there is a 2-inch gap at the house between the pavers and the metal-clad sheathing. Matt also likes to seal the pavers after installation; on this project, he used DryTreat Stain-Proof impregnating sealer ([drytreat.com](http://drytreat.com)).

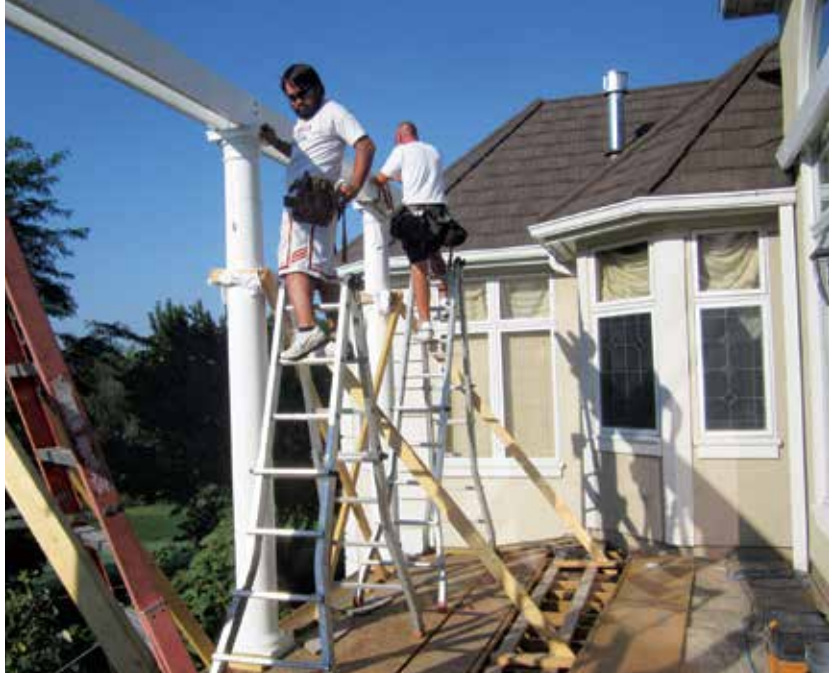
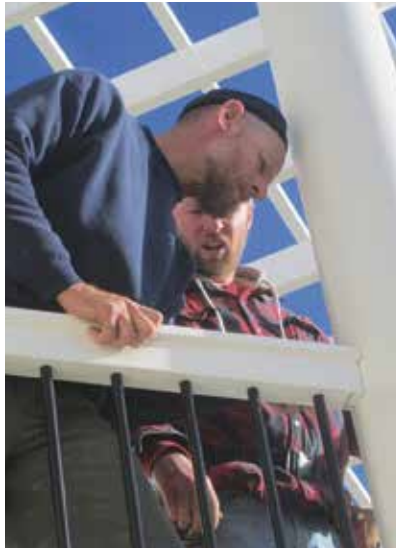
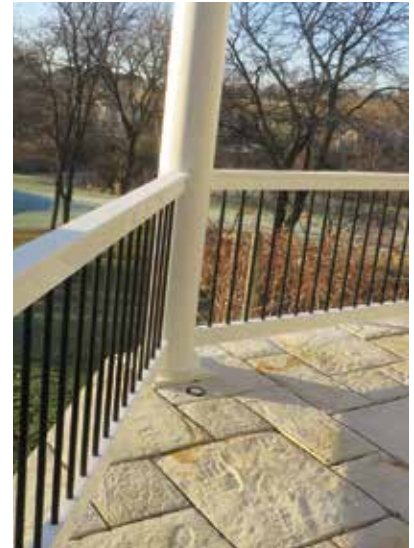
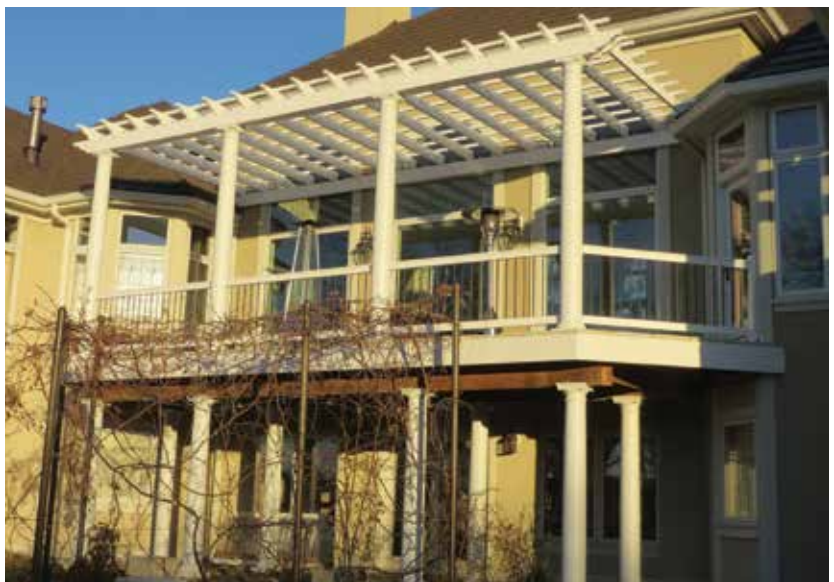
**Figure 7.** The pergola's double support beam is through-bolted to the steel columns (top). The vinyl pergola and rails were supplied by the same manufacturer; workers profiled the ends of the rail for a tight fit to the columns (middle left). Stone pavers are a surprising finish (middle right) on an elevated deck (bottom).

radiused the ends of the top and bottom rails with a belt sander for a tight and clean fit. The rails attach with a simple clip that's screwed to the column (**Figure 7**).

Since the pergola was prefabricated, installation was straightforward. The double beam carrying the outboard end of the rafters was attached with a pair of through-bolts to the steel posts running up through the columns. Because the beam is supported by four columns, the structure is quite stiff and didn't require any additional lateral reinforcement.
