# DECKS

## Common Deck Stair Defects

Build deck stairs according to best practices rather than code to protect your customers and avoid liability

BY BRUCE BARKER

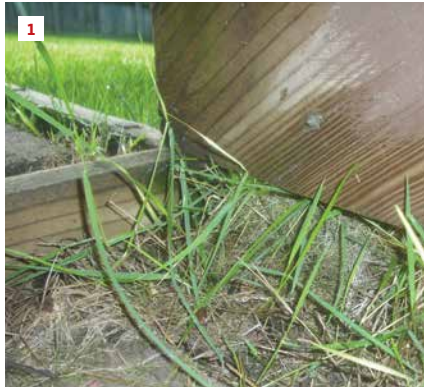
TOP ROW: The bottom of the stringer also needs adequate bearing: At least 1½ inches of the heel of the seat cut should bear on the landing. This example (1) is prone to splitting along the grain. Stringers also require adequate bearing on either a rim joist or a dropped header. Without it, the stringer can split along the grain (2, 3).

It's best if the entire stringer seat cut bears on a solid landing, but at minimum, at least 1½ inches of the seat-cut heel should bear on the landing. Allowing the toe of the seat cut to be the only part of the stringer that bears on the landing can cause the stringer to shear along the wood grain (1).

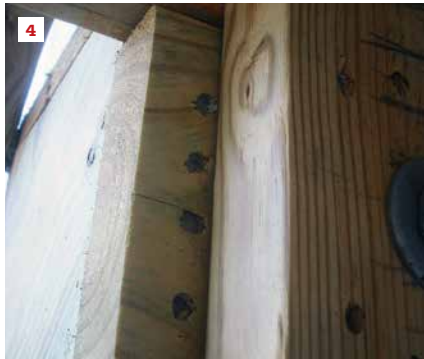
SECOND ROW: Fastening stringers with nails through the header into the end grain of a stringer (4) has minimal resistance to withdrawal. Toenailed stringers are less susceptible to withdrawal, but the connection can still fail as the framing ages and is structurally compromised (5). At a cost of a few dollars each for the connectors and recommended fasteners, the most cost-effective way to hang a stringer is with metal hardware. But this one (6) has been installed incorrectly: The stringer isn't fully bearing on the connector seat. Another red flag: The fasteners are drywall screws instead of approved connector nails.

with nails driven into the stringers' end grain (4). If the stringers are also bearing on—but not attached to—a landing and have no other attachment to resist lateral loads, the nails will do little to prevent the stringers from pulling away from the framing. If the stringers are bearing on the ground, the problem is even worse.

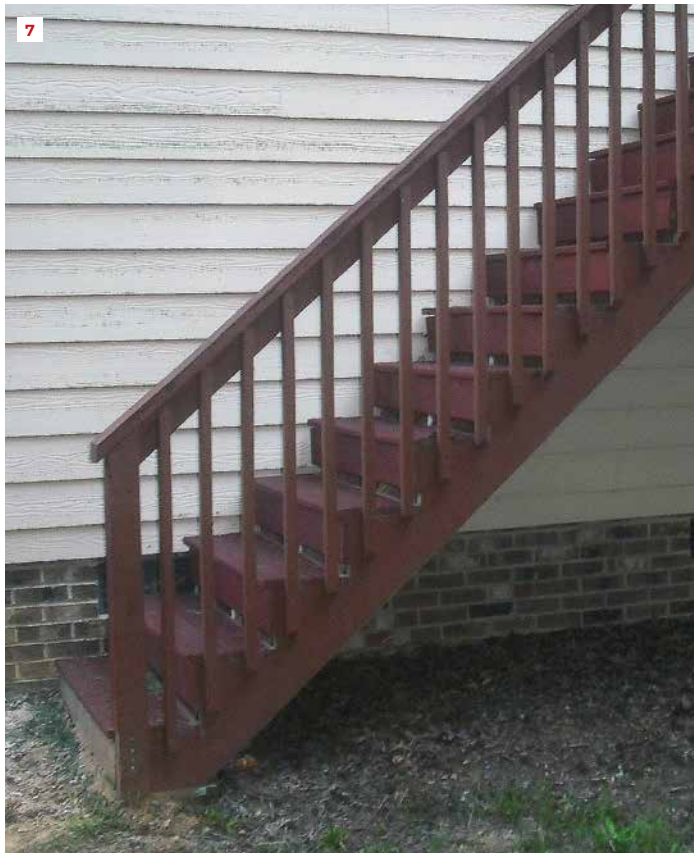
A 2x12 stringer has a maximum unsupported span of 6 feet. These stairs (7) are likely to deflect and cause the stringers to either pull loose from the framing or shear along the grain. The problem is made worse with overcut notches, which weaken a stringer (8). The minimum recommended depth of the uncut portion of the stringer is 5 inches, as measured to the closest saw kerf and not the notch itself. Shown in the illustration on the facing page are the recommended standards for deck stair guards, which are subject to the same requirements as interior stairs.

The minimum recommended size for a deck stair stringer is 2x12, which has a maximum recommended unsupported span of 6 feet. Often this maximum span is dangerously exceeded, resulting in overspanned stringers that will deflect and cause the connection at the deck to pull loose and fail. In some cases, overspanned stringers may shear along the wood grain (7).

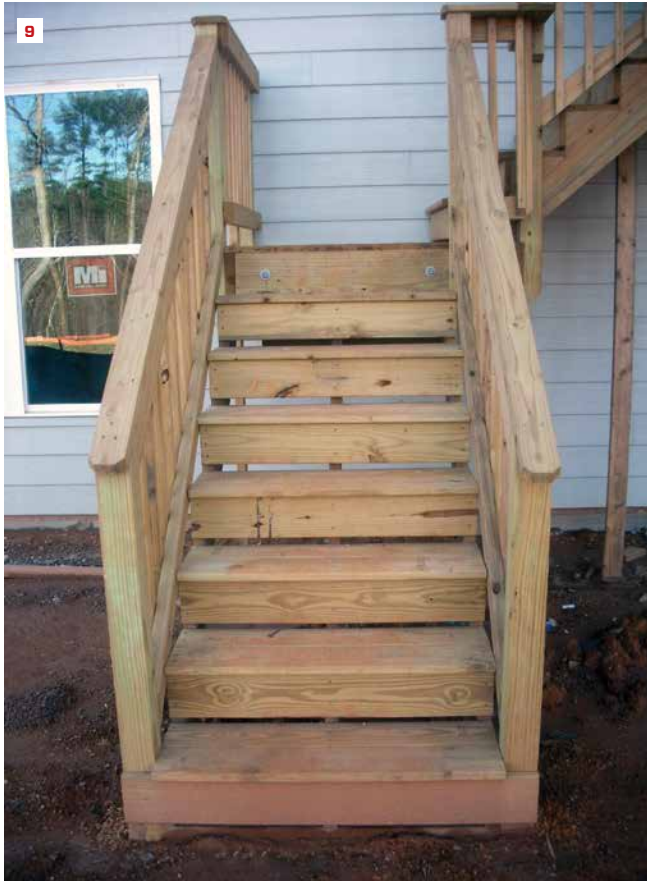
Though common, 2x4 handrails (9) are not considered graspable and should be avoided. Bottom guard rails on stairs should be oriented close enough to the tread nosings so that a 6-inch-diameter sphere will not pass through the triangle created by the riser, tread, and rail (10). Wooden stair guard posts should be located so that the span between posts (as measured horizontally) is no more than 6 feet. This is a new deck stair that passed inspection (11).

Like deck stair guards, deck stair handrails share the same requirements as for interior stairs, including requirements for a graspable shape and termination in a post or a return. This means that very few deck handrails comply with code or best practices, including those with typical 2x4 and 5/4 rail caps (9). A 2x4 handrail is not graspable, especially by children and others with small hands, the elderly, and those with impaired mobility—the people who need a safe, graspable handrail the most.
