# Installing a Wide Door In a Tall Brick Wall

In this renovation, engineered steel braces support a solid brick wall from the outside without disturbing the interior

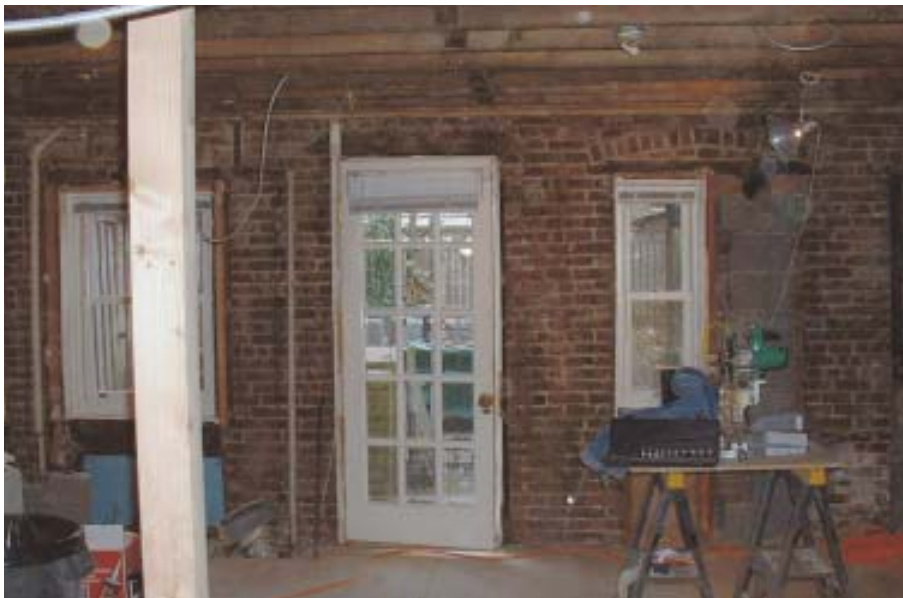
**Figure 1.** As the centerpiece of an extensive garden-level remodel, the new four-panel glass door would open up the ground level to the backyard, filling the dark room with natural light. First, though, a 12-foot-wide rough opening needed to be cut in the solid brick exterior wall of the Hoboken, N.J., home.

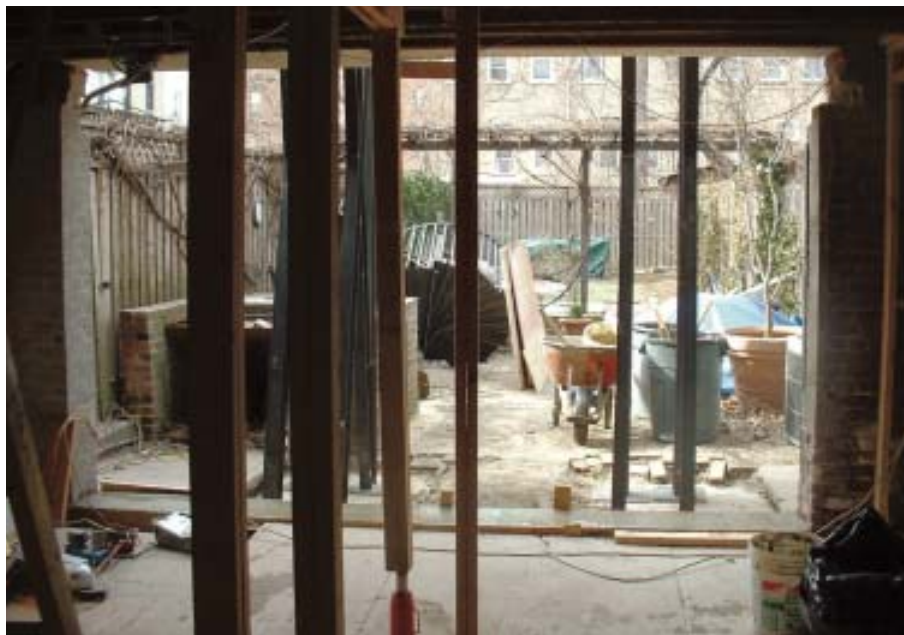
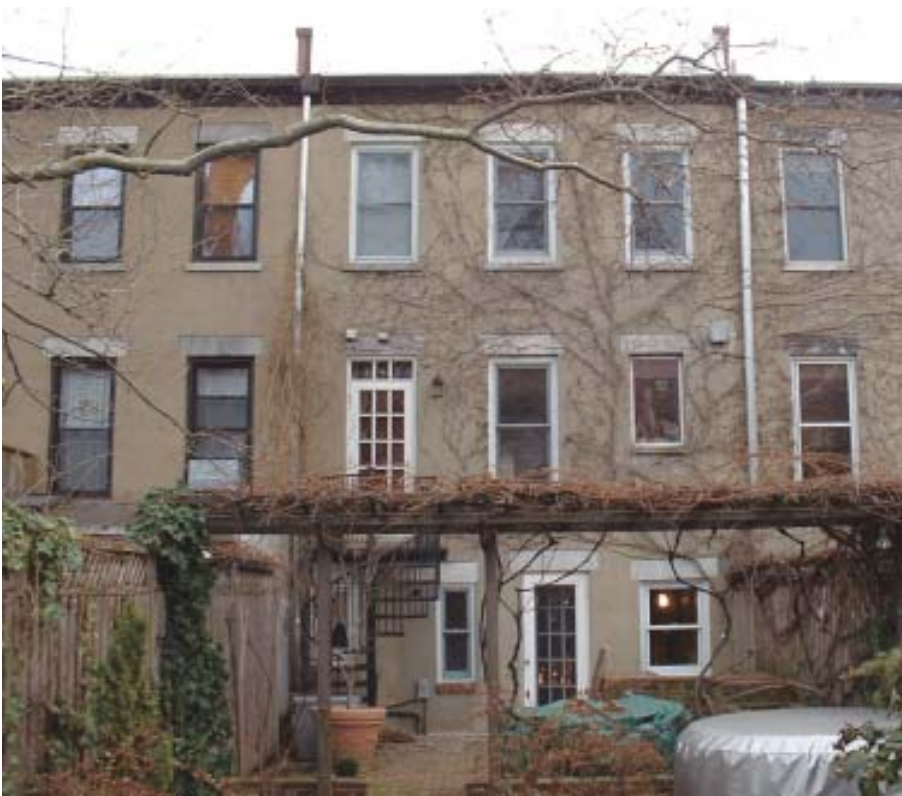
## Tributary Load on Steel Beams

**Figure 2.** After analyzing critical load paths and identifying the structure's main load-bearing "columns" (shown in the drawing at bottom), a structural engineer designed braces to temporarily shore up the 30-foot-tall, solid masonry wall during construction. Welded from steel I-beams and bolted to poured concrete footings, the four identical braces would support the home's masonry wall from the outside without disturbing interior finishes.

Structural engineer Rich Herschlag, of Turn-key Structural in Easton, Pa., identified four 36-inch-wide load-bearing brick "columns" within the exterior wall, each receiving loads from the numerous door and window headers stacked above each other. The left and right columns that were clear of the proposed opening wouldn't need to be supported, but the two middle columns would (Figure 2, next page).

The plan called for four identical L-shaped steel braces — which cost about \$675 each to fabricate — to be fastened to the brick wall from the backyard side, with each of the middle load-bearing columns receiving two equally spaced braces. Inserted 8 inches into the 12-inch-thick wall and positioned roughly

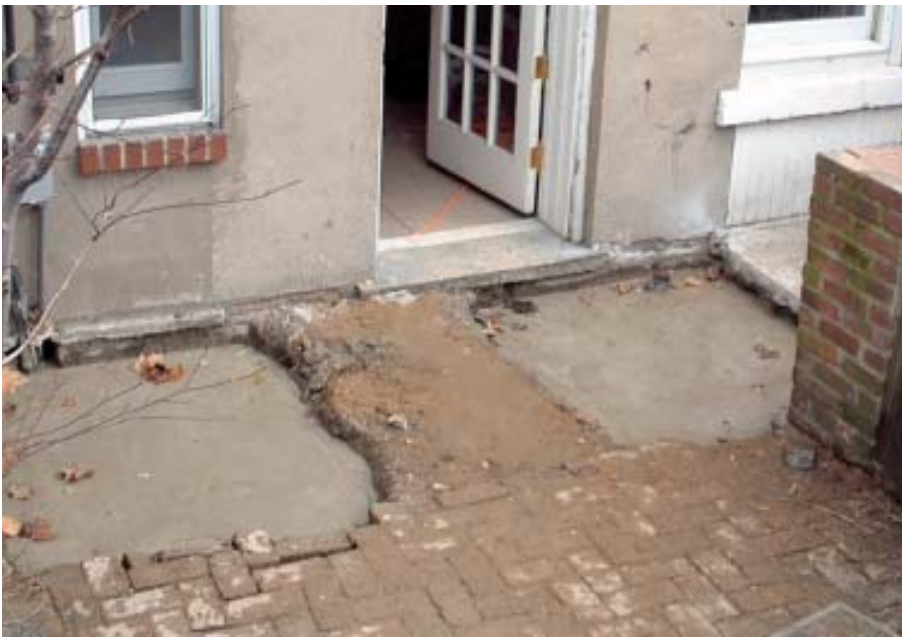
**Figure 4.** To prevent the braces from kicking out from the wall under load, the footings were buried below grade. The author used a transit to make sure the poured footings were level with each other.

Because we felt that concrete footings formed on the surface also might kick out, we decided to bury the footings in the ground to help anchor them. We used a transit to verify that the top of each footing was level with the other (Figure 4, page 5).

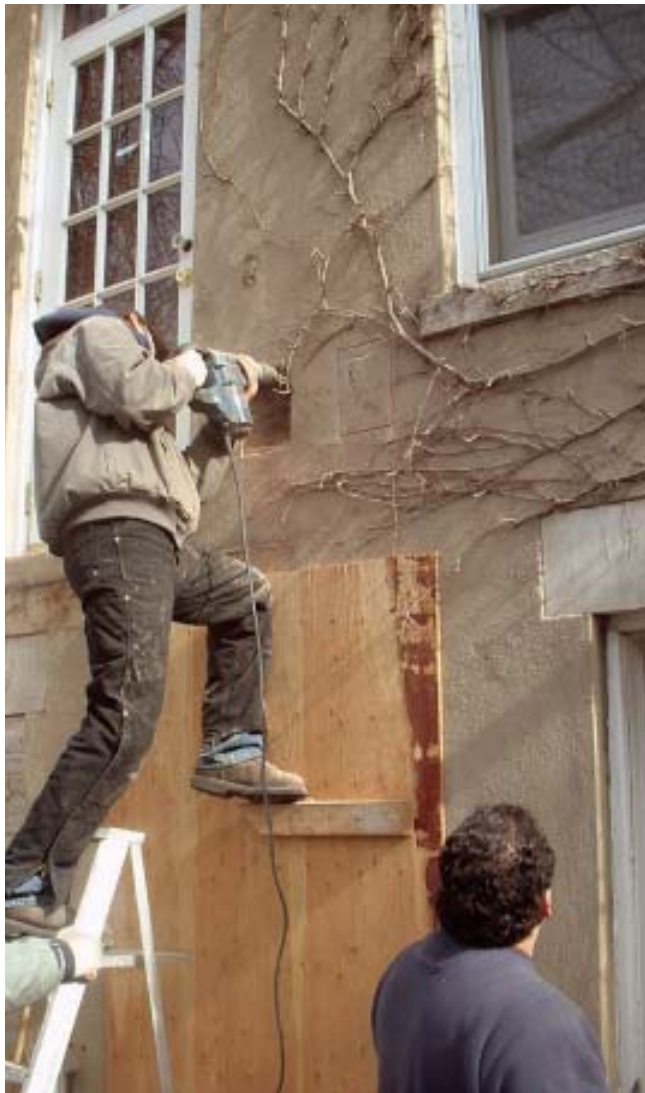
**Figure 5.** After placing the braces on their footings and marking their positions on the wall, the author's crew cut 8-inch-deep pockets into the 12-inch-thick masonry wall for the upper shelf of each brace.

We used an angle grinder with a diamond blade to score the stucco and outline the pockets that would temporarily house the braces. A rotary hammer equipped with a chipping bit made quick work of the brick as we cleared the pockets (Figure 5). Finally, we inserted

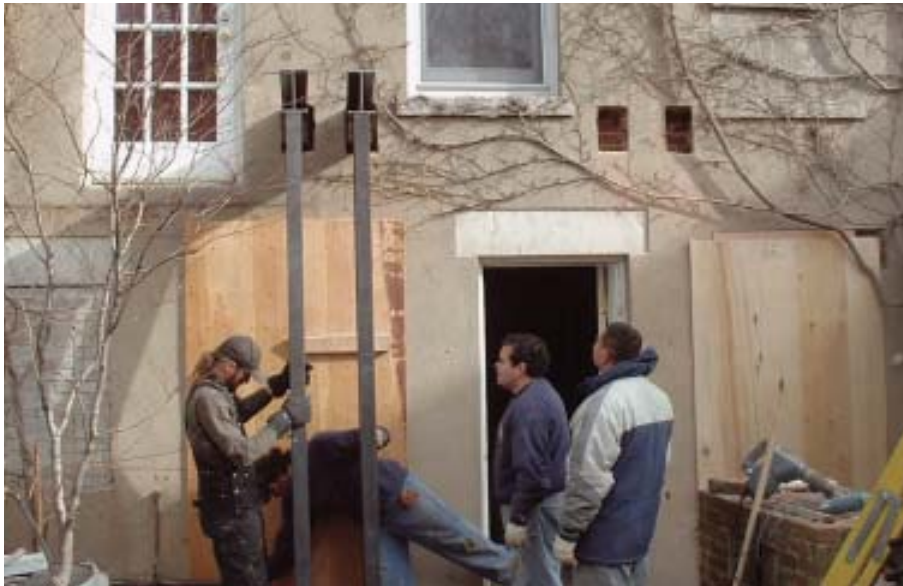
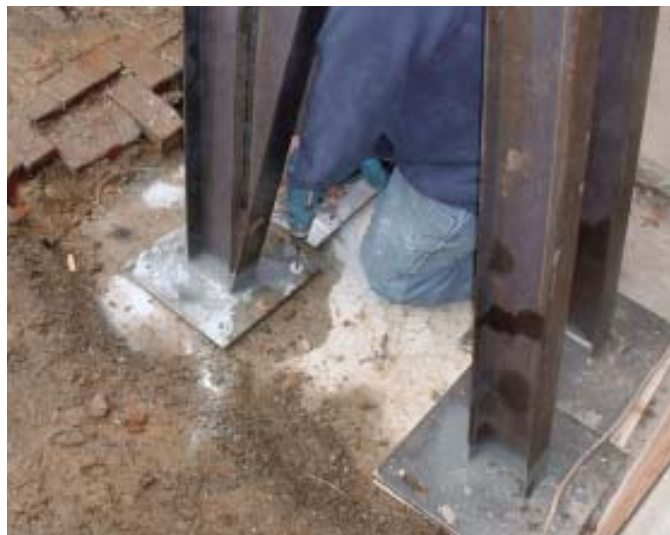
**Figure 6.** Once the braces were maneuvered into position, the crew shimmed them (above) and bolted them securely to the concrete footings with wedge bolts (right).

the four support braces. We shimmed where necessary, using wood ripped from 2x4s and pounded into place, and bolted the base plates securely to the footings with wedge bolts (Figure 6).

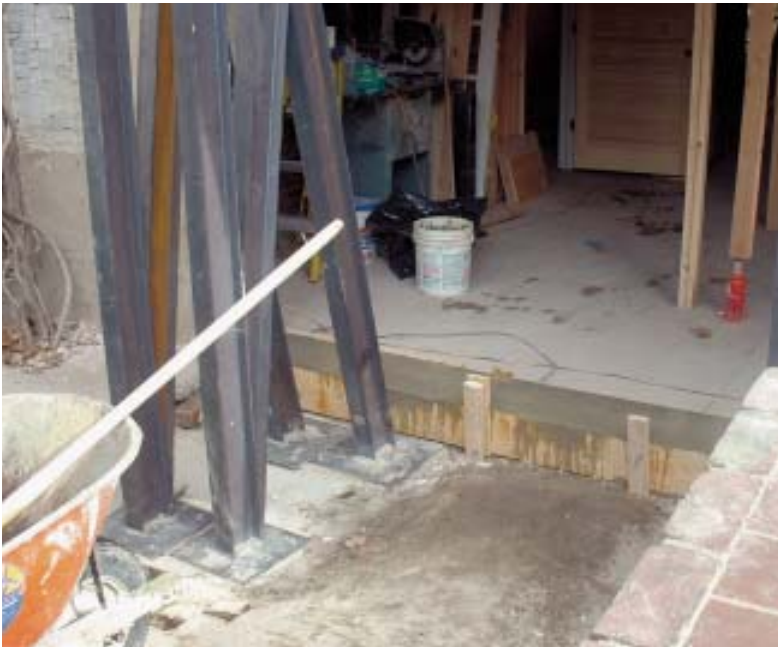
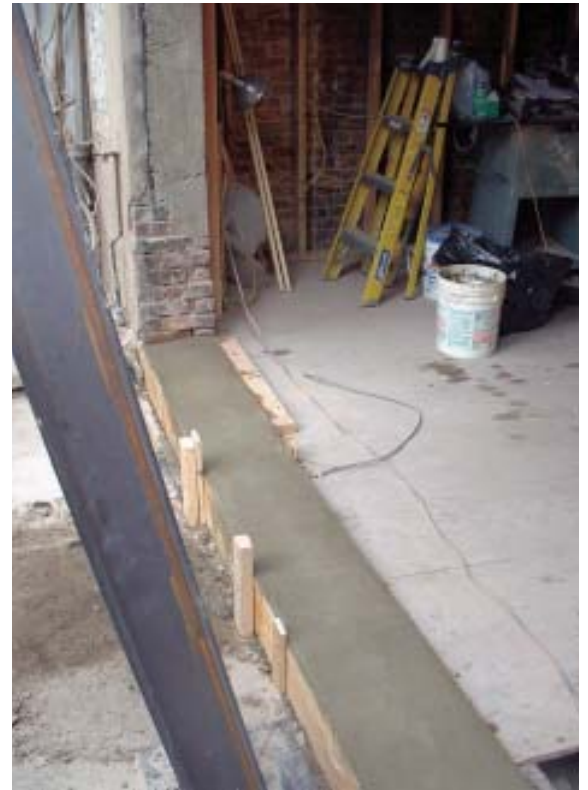
**Figure 7.** Formed on top of the broken-out foundation wall, the newly poured threshold offered a smooth, level reference point for laying out the rough opening. The brick side walls shown in the photo at right would receive a smooth mortar cap before installation of the new door.

stalling the new door, we had to create a level threshold. We began by cleaning up as much of the old foundation wall coming up from the basement as we could with a chipping gun. Then we drilled, vacuumed, and screwed 3-inch-long masonry fasteners into the top of the wall, leaving 11½ inches exposed to help tie the new concrete to the old masonry as we formed and poured the new threshold. After marking both the left and right walls at 82½ and 92½ inches to indicate the top and bottom of the beam, we chiseled 6 inches into the walls to create ledges for the beam to sit on, adding ½ inch to the rough opening to accommodate steel plates under each end of the beam (Figure 7, next page).

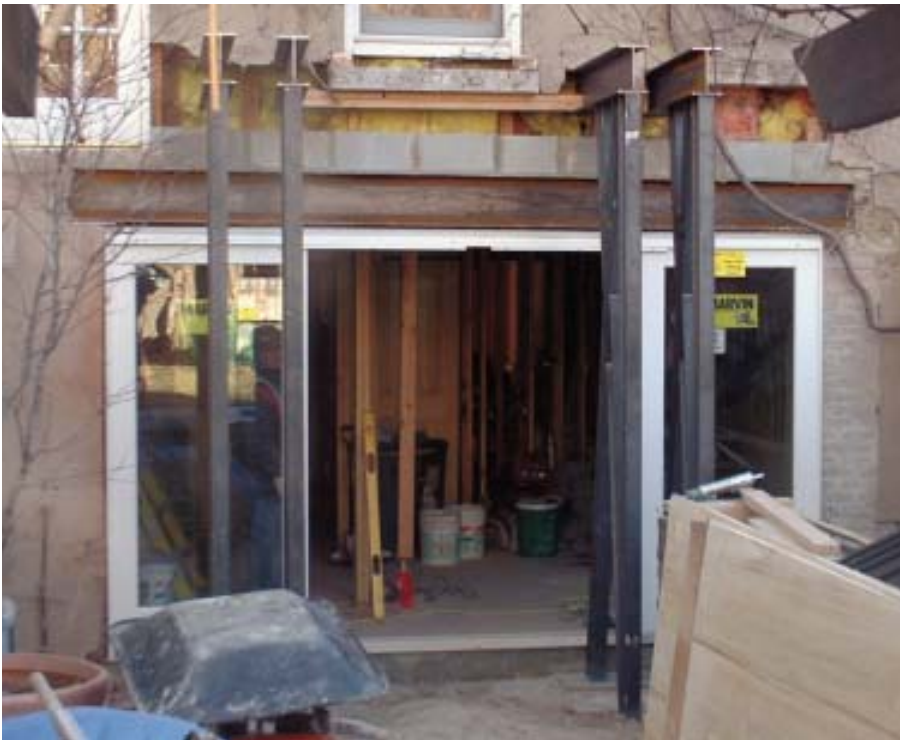
**Figure 8.** A pair of 5 1/2-by-10-inch steel beams supported the masonry above the new door opening. The author chose to install the door before removing the braces, making it easier to secure the site during construction.

The original plans called for a single W14x38 steel beam (measuring 14 inches high by 6¾ inches wide, and weighing 38 pounds per lineal foot), fabricated with a brick shelf composed of three 3½-by-3½-by-¼-inch angles welded together. But the estimated weight for that girder was 675 pounds, way more than we wanted to handle, so Herschlag substituted two 285-pound W10x22 steel beams (measuring 10 inches high by 5½ inches wide by 13 feet long, and weighing 22 pounds per

lineal foot, at \$275 each) for the W14x38. While not exactly light, these beams were easier to wrestle into position, and their combined 11-inch width was better suited to the 12-inch thickness of the wall. Because the exterior façade had a cover of stucco, we were able to substitute concrete block for brick to rebuild the section of wall above the girder, thereby eliminating the need for the brick shelf.

After we insulated around the girder with fiberglass and spray foam, we were ready for the door. We could have finished patching up the exterior wall at this point and removed the braces, sparing ourselves the risk of dropping something through the glass below. But, for weather and security purposes, we elected to install the door first (Figure 8).

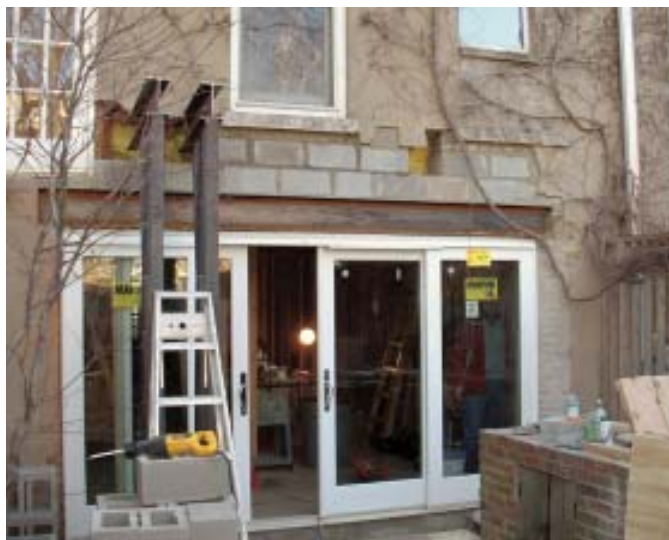
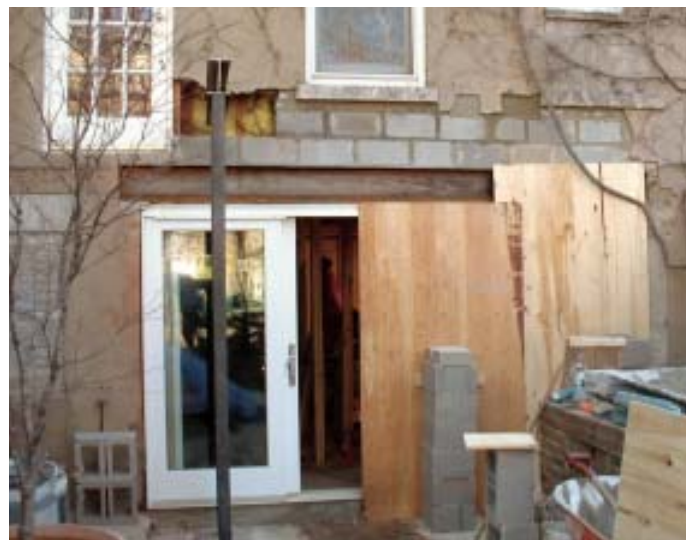
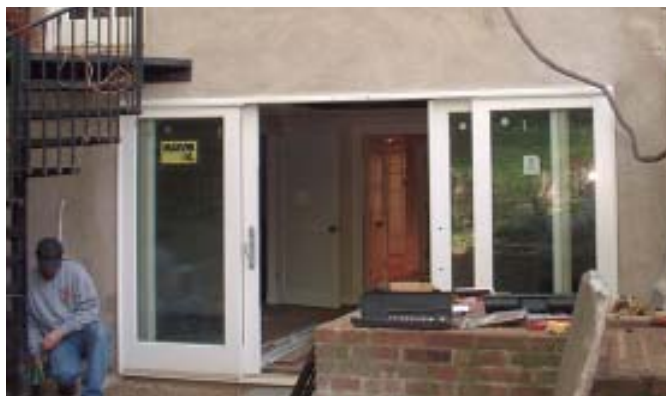
**Figure 9.** Because the masonry wall has a stucco finish, economical 12-inch block instead of brick was used to fill in above the new steel header (above left). The author's crew made sure each section of wall was well supported with block before removing the braces, one at a time (above). Mortar dye added to the stucco matches the new work to the existing wall (left).

With the door installed and the steel girders in place, we finished blocking up the opening. As we laid block, we removed one brace at a time and filled each pocket before removing the next. After each support was removed and the opening blocked, we padded out the steel web with plywood, then fastened wire mesh over the steel and block in preparation for the stucco. We experimented with mortar dyes to approximate the existing stucco color and did our best to blend the new with the old (Figure 9).

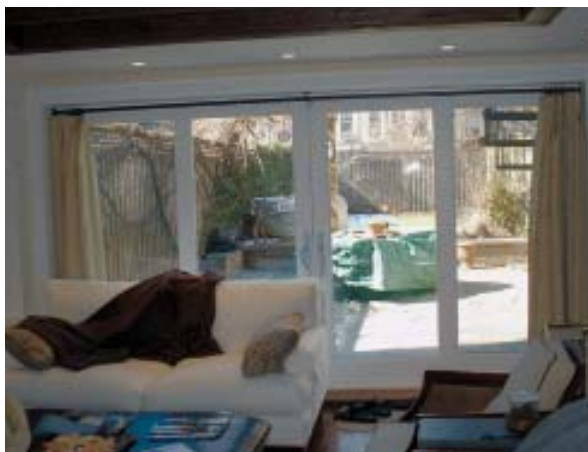
**Figure 10.** The wide glass door brings plenty of light into the new ground-level living space and offers easy access to the backyard.

the interior, but that wall of glass (Figure 10) never let us forget there was 1,600 pounds of steel that we had paid \$2,700 for sitting in the backyard. Because the only access to the backyard was through the house, we needed to get the steel out before turning our attention to the extensive interior finish work. After dis-
