Lifting Big Beams—the Easy Way

Curved Head Flashing

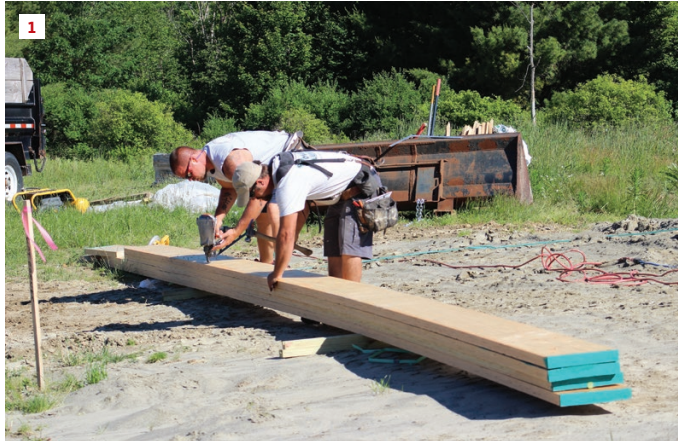
The 32-foot-long beam is built safely on the ground (1). The longer LVLs are chained to the telehandler's forks, ready to be moved (2). The telehandler lifts the partially built beam into place (3). The beam is guided into place via hand signals (4).

beam with 16d nails in a robust nailing pattern, keeping the pair aligned by toenailing as needed (1). While still on the ground, we cut the main beam's two shorter members and the support-beam LVLs to length.

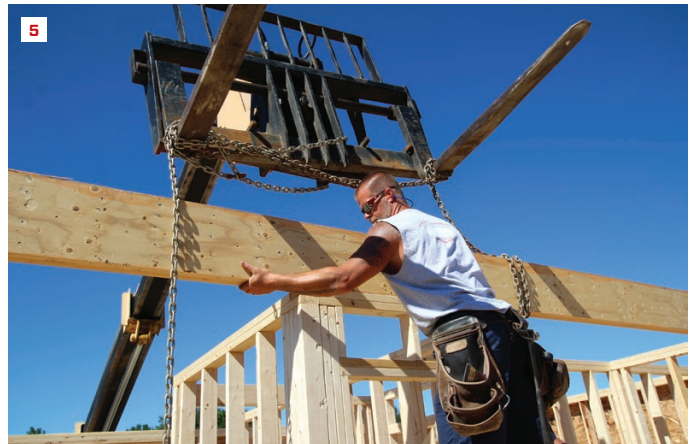
The author positions the first doubled LVL (5). Once these first pieces are nailed off, the telehandler becomes a work platform for laminating the third (6) and fourth layers (7). The telehandler supports the beam while end support is installed (8) and the structural assembly is secured with a beam hanger (9).

To hold the main beam's butted end in place, we nailed a temporary 2x6 block to the bottom of the support beam to serve as a seat. I further tweaked the main beam's position with the telehandler's articulating fork setup (tilting it side to side) to line it up with the location mark. Back on deck, I helped muscle the partial beam into its final position (5). Aaron end-nailed the butted end while I toenailed the beam to the top plate.

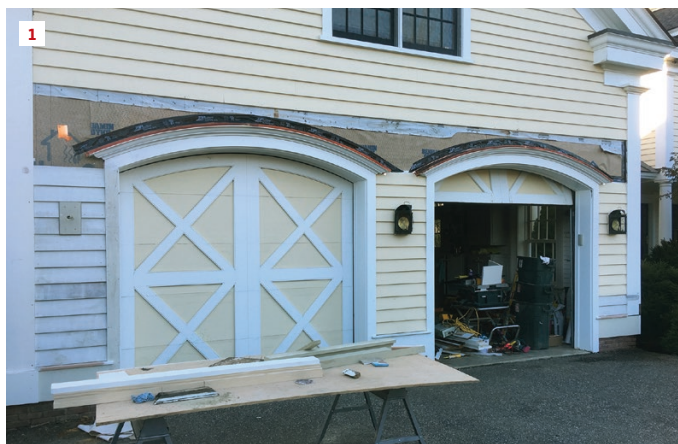
At top are the repaired carriage-house wall and arch-top garage doors (1). Water damage was due to a poorly flashed drip cap (2). The sloped drip cap made a tricky flashing job even trickier (3). The copper overhung the cap in the center when laid in place; the flat stock needed to be crescent-shaped to fit properly (4).

The cause of most of the problems was inappropriately installed drip-cap flashing. Some of the window and door heads were “flushed” with housewrap tape (the tape was adhered to the face of the WRB and run onto the exterior head trim). Over time, the tape lost its adhesion and failed, leading to repeated water intrusion into the home. Nowhere was this more apparent than with the garage doors on the carriage house (1).

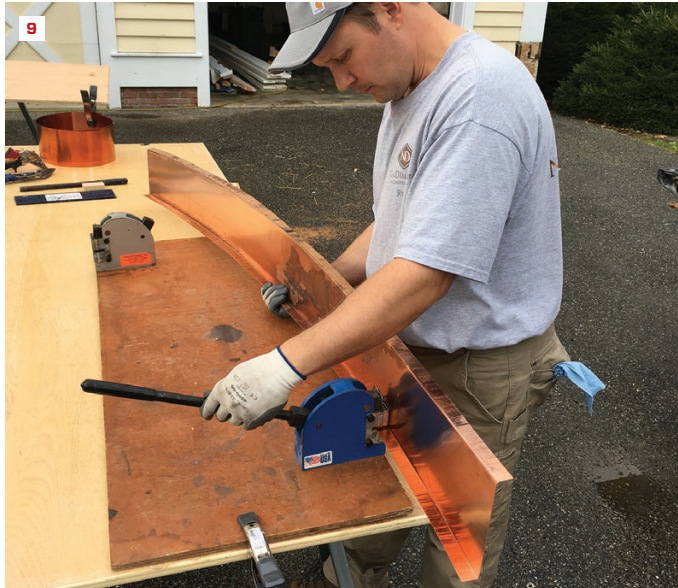
Flashing was shaped with Eastwood shrinker (blue) and stretcher (gray) tools (9). Flashing in the corners helps direct water away from the wall (10). Flashing was installed with minimal nailing; ends were folded down (11). The center seam was soldered (12).

Years ago, our company purchased a set of Eastwood sheet-metal shrinker and stretcher tools (largely used in autobody repair work; eastwood.com) after seeing a roofer using them on a jobsite. They operate on the same principle; both have little jaws that grab the metal and either contract it to form inside curves or expand it to form outside curves. When making curved flashing with both upturned (an expanded outside curve) and downturned (a contracted inside curve) vertical legs, you have to gradually form it into its final shape—you can't shrink or expand one side all in one shot.

The first piece. With the vertical legs bent, I began to shape the curve. First, I transferred half of the arch's profile onto a piece of plywood, then laid it on the table as a reference guide. Then, I started to curve the copper, alternating between the shrinker (blue) and the stretcher (gray) as needed (9). I lightly pulled the handle up to release the jaws, slid the flashing's vertical leg forward into the jaws, and lightly pressed the handle down. I was careful to advance the metal about an inch at a time (the tools shrink or expand the copper over a small area). After repeatedly checking the flashing against the reference and going up and down the ladder a few times to lay it in place, I finished one side of one arch top's flashing. Now that I knew what I was doing, I was able to form the second, third, and fourth pieces faster.
