Raising the Roof

BY ALAN SCHMIDT

Recently, we added a new master bedroom and bath to the upper level of the west wing of a vintage 150-year-old Vermont home, which had just been purchased by our clients. While the 22'-9" x 30' ell's foundation and first-floor framing were in fine condition, thanks to an extensive kitchen renovation project in 2009 (see “Replacing a Stone Foundation,” Mar/09), our clients had been instructed by their insurance agent to fix its slate roof when they had closed on the house. They also wanted to add shed dormers and move the knee walls out, thus increasing the footprint on the second floor and creating wall space for new windows for the master bedroom suite. All of the work would have to take place without disrupting the kitchen below.

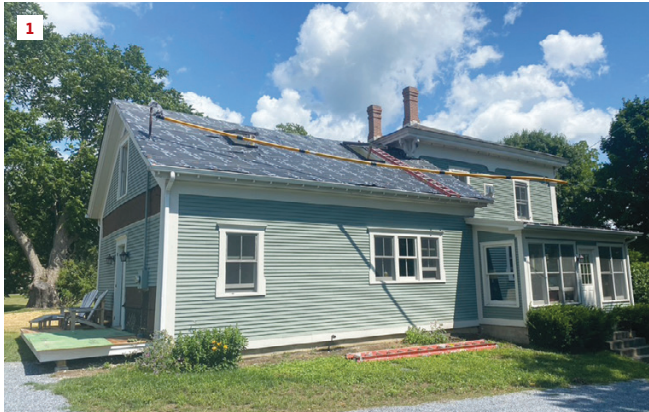
After stripping the old roofing, workers covered the roof deck with peel-and-stick membrane to keep the structure dry during the project (1). Workers reinforced 2x12 framing that had been sistered to the old rafters with rafter ties so the roof could safely be lifted with a crane (2). To provide a “foundation” for the new roof, they set up a braced and leveled LVL frame on the ground representing the tops of the structure’s walls (3).

Prepping the roof. The roof had been severely compromised due to the weight of slate sitting on roof framing that had been designed for cedar shakes. The slate had been installed directly over cedar shakes, in fact, so we started by removing both layers. Then we covered the roof sheathing with synthetic roofing underlayment to keep the space dry until we were ready to cut in the new shed dormers (1).

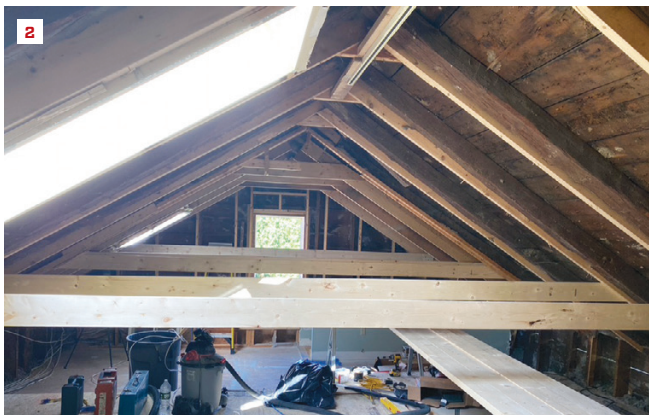
On the interior, we removed drywall and the dense-packed cellulose that had been used to insulate the walls and ceiling. This revealed hand-hewn 5x7 timber rafters, which had been reinforced at some point with sistered 2x12s. The rafters were pegged at the peak and nailed to the wall top plate on a roughly 3-foot-on-center layout (2). In order to cut in our clients’ proposed 21-foot-wide dormer on the south-facing side of the roof and 12-foot-wide dormer on the opposite, north-facing side, we would need to install a structural ridge to prevent the walls from bowing out even more than they already were.

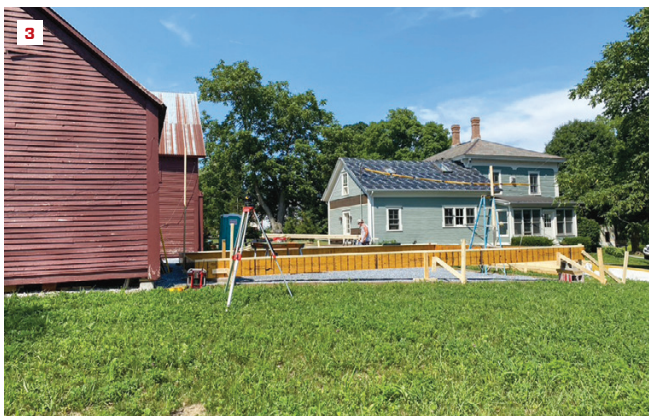
Next, we built a 22’-9” x 30’ frame out of LVLs in the parking area to represent the structure’s footprint (3), propping it up so that it was level. After squaring it up, we checked all four sides with a string line to make sure they were straight. Then we plated the two eaves walls of the LVL frame with 2x6s, which would eventually become the upper plate of the double top plate that we would install to cap the balloon-framed walls (4).

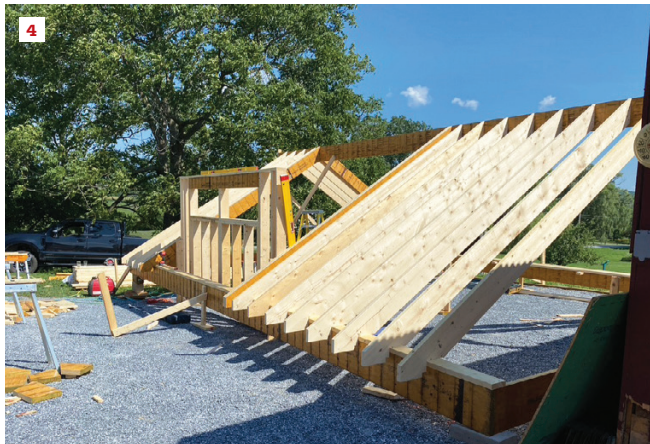
Workers tacked 2x6 plates to the LVLs and installed a double 1³/₄-inch-by-14-inch LVL structural ridge, then framed the new roof with 2x12 rafters (4). The dormer walls were framed with 2x6s (5). Zip panels were used to sheathe the walls and roof (6), while temporary T-shaped rafter ties were added to the framing to reinforce the roof system during the lift (7).

For the structural ridge, we specified double 1³/₄-inch-by-14-inch

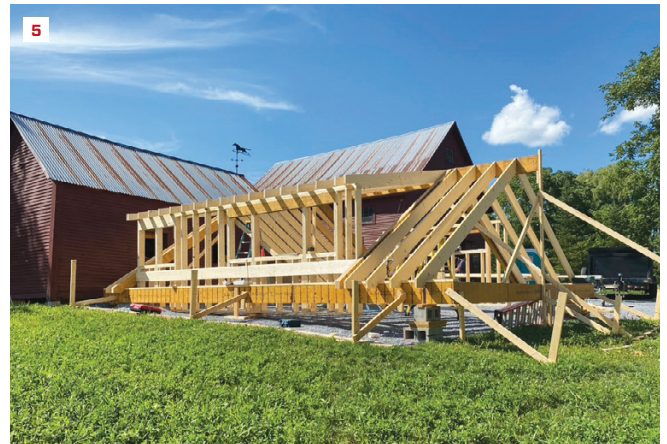
LVLS, with 2x12 rafters and roughly 7-foot-long collar ties to form the ceiling. We dropped the ceiling in the lower level to make room for a recessed cassette heat-pump head. The dormer walls were framed with 2x6s, with LVL headers in the window openings (5).

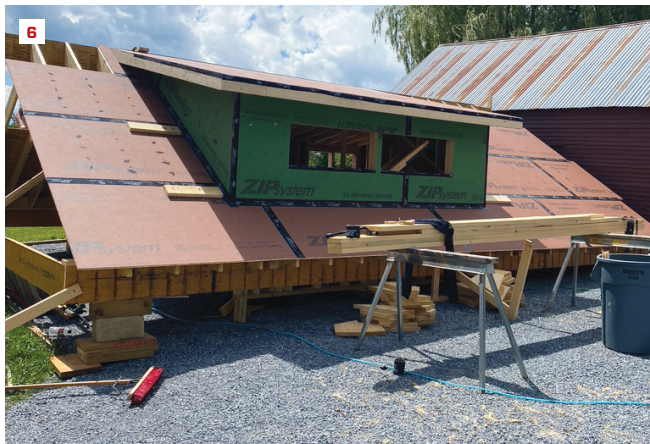
We sheathed the walls with 7/16-inch Zip System sheathing and used 5/8-inch Zip T&G panels to sheathe the roof (6). At the peak, we cut the final course of sheathing to size and Zip-taped the joints, but we fastened the panels to the framing with only a few screws in each panel. That allowed us to remove the screws and fold the panels back so that we could rig crane straps to the ridge.

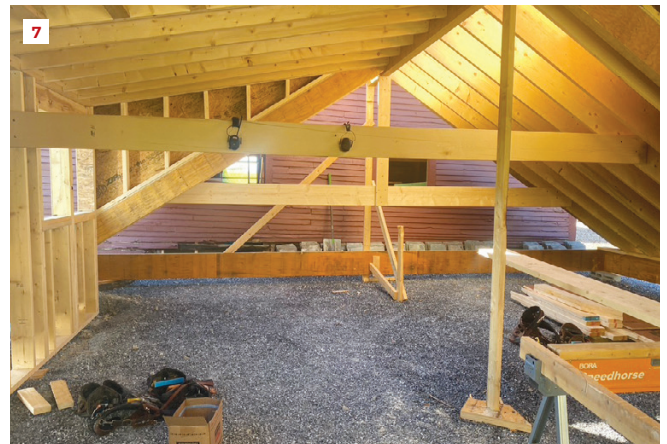
We had decided—with Cole's (the crane operator) input—that the roof system could be picked up from four points along the ridge. Since neither end of the structure would have a gable wall for support, we framed a series of 16-foot-long temporary strongback T-shaped 2x6 rafter ties, screwing them to the rafter pairs at the gable ends and to the rafter pairs flanking the short shed dormer. To reinforce the

assemblies, we posted each rafter tie up to the ridge and installed pairs of diagonals. Finally, to help resist the force of the walls and eaves wanting to fold inward during hoisting, we installed a full-width LVL fastened on each side to doubled window king studs, plating the LVL with 2x6s (7).

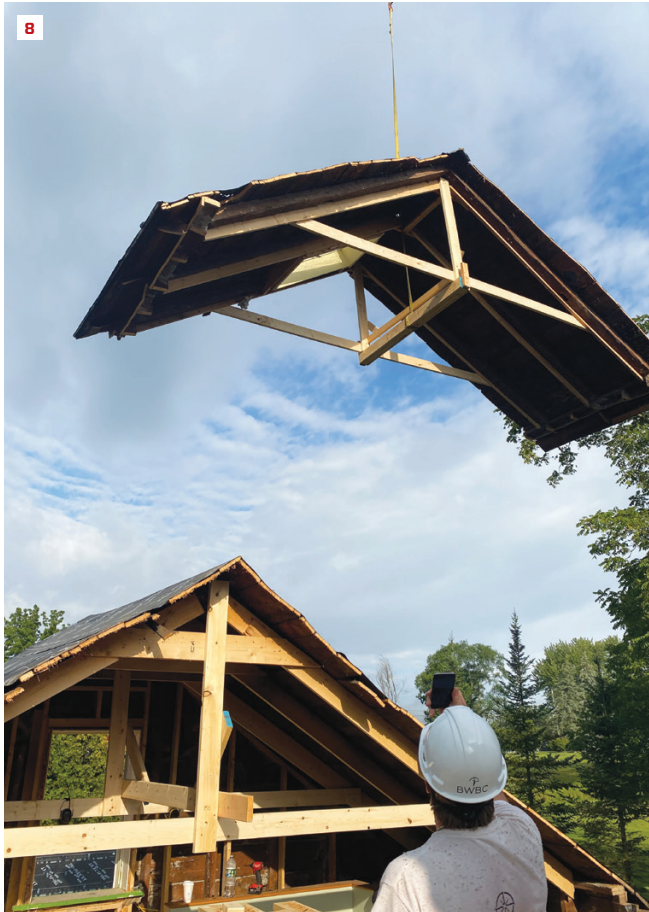
On the day of the lift, workers cut the old roof into three sections, which they had reinforced with truss-like framing prior to removal (8). The lifting straps were threaded through small openings cut into the roof sheathing at the ridge (9). With the roof removed and the balloon-framed gable end walls exposed, the structure was ready for its new roof (10).

Lifting day. To reinforce the old roof system, we had fastened rafter ties to roughly every other rafter pair with structural screws. These reinforced rafters become our lifting points, as the wooden pegs at the peaks offered minimal shear strength. With Cole's 70-ton crane on site, we divided the roof into three sections, cutting down the rafter bays from the peak all the way through the top plate with a reciprocating saw. Knowing that we would eventually have to remove 9½ inches of studs below the top plate, we also cut horizontally through the studs at the upper board sheathing break (8).

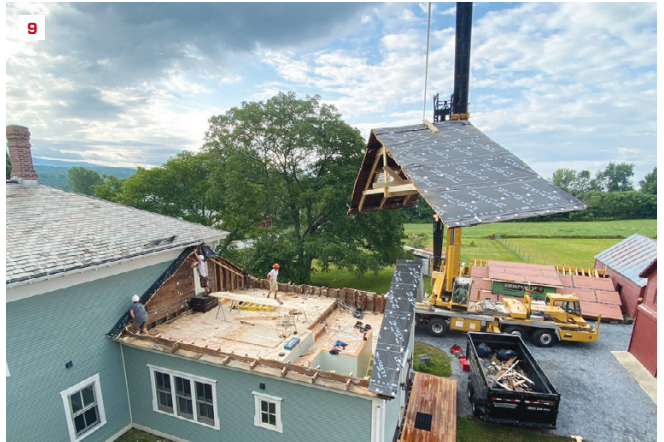
Next, we cut a small opening in the peak at the center of each section for the lifting strap to go through. Before lifting away each section, we installed a triple 2x6 beam underneath the section's supporting rafter ties. We also posted up from either end of the beam to the peak with 2x6s, effectively creating a pair of trusses that would support each roof section. Then we hooked the lifting strap to the beam and hoisted the roof away, section by section, relying on the small "windows" in the sheathing to guide the straps and keep the roof sections from rolling over (9).

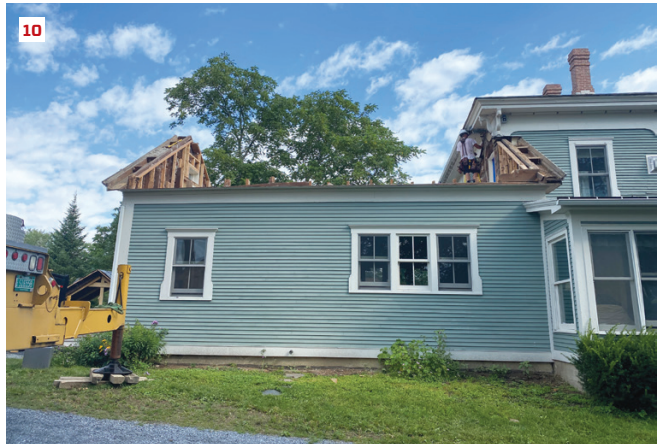
With the roof out of the way and the wall framing exposed, we shot a laser line around the building and snapped out the new height needed for the existing studs to set the new roof system level. Then we cut the studs to the line with a 10¼-inch circular saw, creating our new level plane. Finally, we snapped a line on the board sheathing that was slightly below the height of the studs and cut to the line with a reciprocating saw. When making the seat cuts on the new roof rafters, we had cut secondary notches 3 inches below the seat cut to accommodate the sheathing.

The west-facing gable wall was now free-standing, but because it was balloon-framed, we felt comfortable leaving it loose for the time being while we nailed off the lower of the two top plates to the tops of the studs in preparation for the new roof (10).

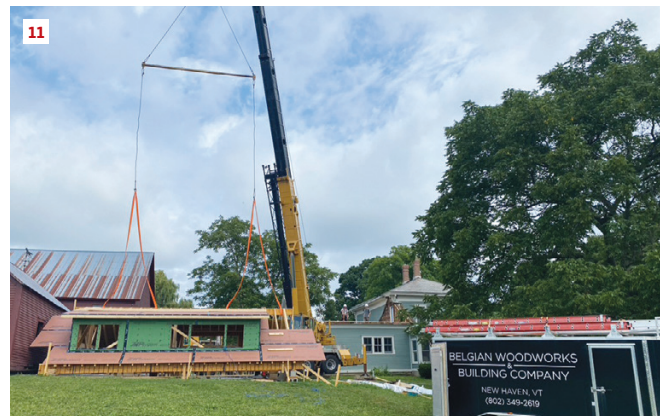
Flying in the new roof. While the crew and I reinforced the new roof structure for hoisting, Cole unscrewed and folded back the finish course of Zip sheathing to expose the ridge and begin rigging his lifting straps. He hung a spreader bar off the crane's main hook with two 20-foot steel cables, then choked 40-foot-long straps to the ridge. The longer the strap (and therefore the shallower the angle between the lifting points on the ridge and the hooks on the steel cables), the less likely the straps would slide inward towards each other under the weight (11).

Hung from a spreader bar, lifting straps were choked to the ridge at four reinforced locations (11). During the lift, a worker used a tag line to help position the suspended roof (12). A strap fastened to the large dormer and tensioned with a come-along kept the unbalanced structure level (13). Tucking the new roof's structural ridge under the main house eaves while fitting it into a beam pocket in the existing framing was tricky (14).

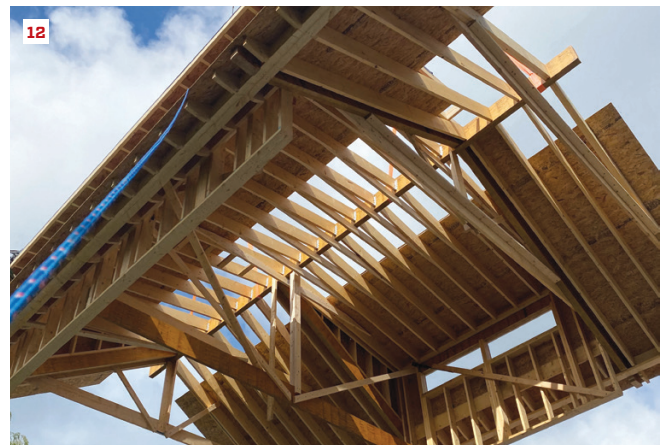
a test pick was performed, during which we used another strap hooked to the long dormer and a come-along to balance out the heavy side (12, 13). At the same time, we adjusted the lifting straps so that the east side—the side mating up to the existing house—would be slightly lower than the west side, providing the geometry needed to tuck the ridge under the eaves of the main house while clearing the free-standing gable wall at the other end (14).

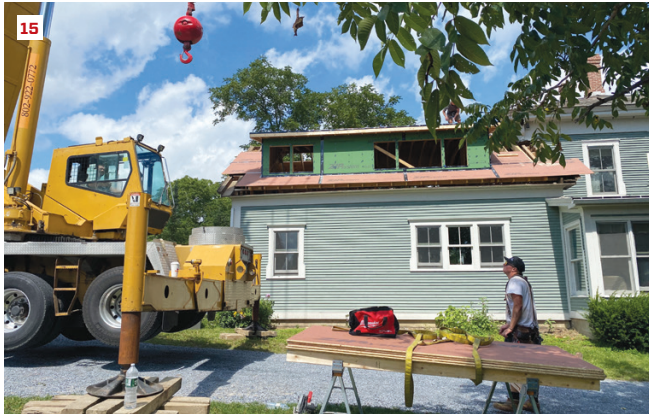
To match the new roof trim to the out-of-level ell, workers had to remove the existing soffit and fascia (15) and install a secondary frieze board molding detail, complete with new fascia, soffits, and crown molding (16, 17). The dormers were clad with gapped shiplap siding, and a new standing seam metal roof was installed (18). On the interior, new partitions were framed for closets and a master bathroom, and the wall cavities and rafter bays were sprayed with closed cell foam insulation (19).

On the east side, we had framed the LVL ridge 4 inches long to allow us to post up to the ridge inside the interior wall of the main house. Unfortunately, the extended ridge became a bit of a headache, as we didn't have enough clearance between the east strap near the end of the LVL and the eaves above to join up to the main house without the strap hitting the eaves. Because the east side was lower, we were able to set it down temporarily, taking just enough weight off the strap to be able to slide it over to the other side of the rafter bay that it was rigged to. Then we picked the structure back

up and slid it over into its final position on top of the new plates. Once we nailed the plates together, we unhooked the straps, cut the sheathing to length against the main house, folded the roof sheathing back into place, nailed everything off, and taped all the joints with Zip tape. It was a long day, but now we were watertight (15).

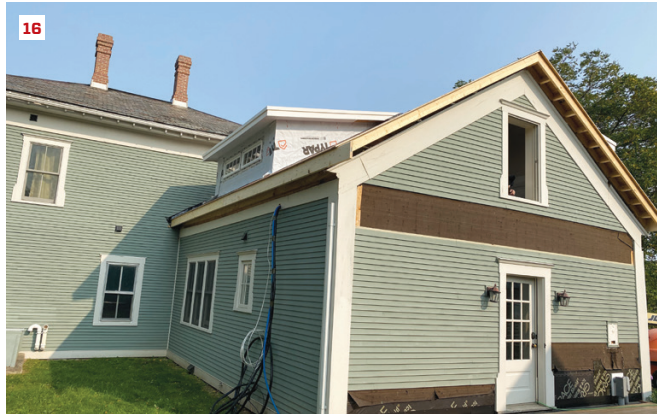
Stitching the pieces back together. Due to the ell's out-of-level condition, we had to remove the existing soffit and fascia. To match the new trim with the old and hide the problem, we installed a secondary frieze board molding detail, complete with new fascia, soffits, and crown molding, finished off with a new standing seam metal roof (16, 17, 18).

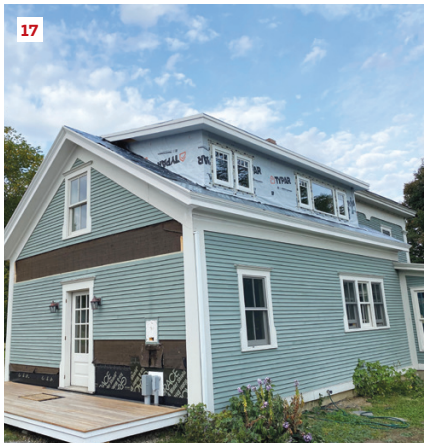
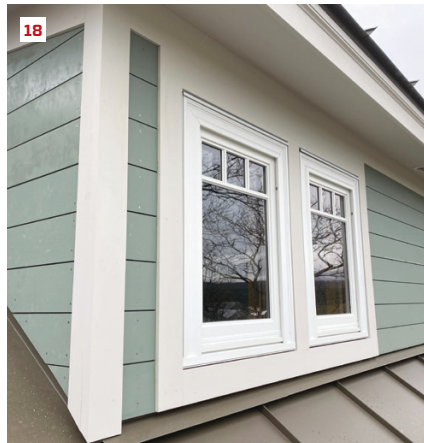
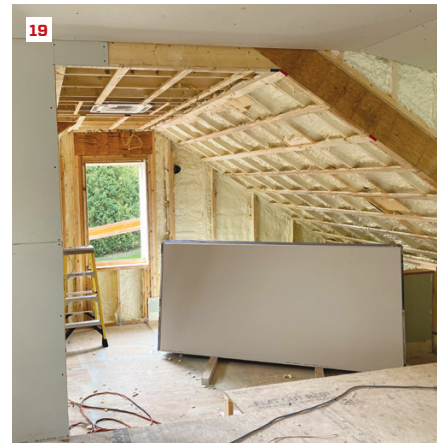
On the interior, after framing new interior partitions for closets and a master bath, we roughed-in new plumbing and electrical. Then we air-sealed and insulated the space with spray foam (19).
