Preserving a Stone Retaining Wall

BY GERRET WIKOFF

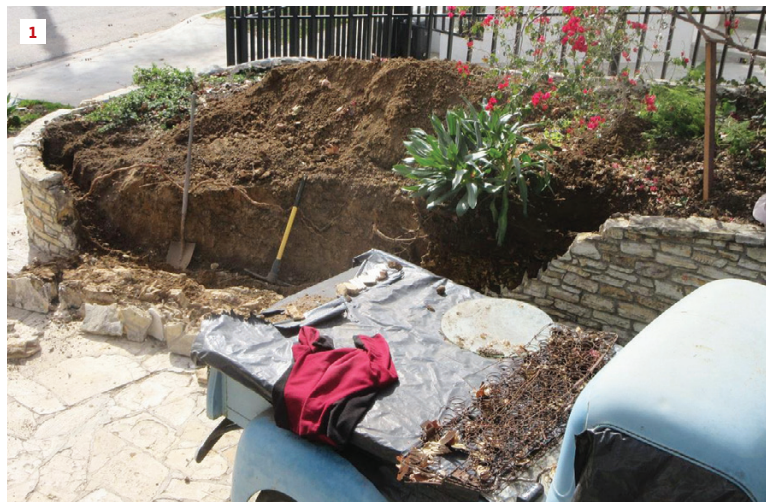
The middle third of a leaning, unreinforced stone retaining wall collapsed during excavation by the homeowner (1).

Last spring, a returning client asked me about repairing a leaning retaining wall for a large planter in his driveway. (The year before, I had repaired the porch on his late 1920s Storybook-style bungalow home in Los Angeles; see “Repairing a Bungalow Balcony,” Feb/21). I suggested if he were to dig the soil out from behind the stone wall, we could add rebar, push it plumb, pump in some concrete to bond it together, and Bob’s your uncle. Possessing a shovel and the gumption to use it, the homeowner started excavating behind the wall. A few days into the project, the middle section collapsed; he thought that the clay soil must have been holding it in place, but I suspected otherwise (1).

I investigated the collapsed section and found that it was an unreinforced wall with no rebar connecting the stone to its concrete footing and that the site’s expansive clay soil had managed to push the stone wall beyond the edge of its footing. Over the years, the clay soil would get saturated, push the wall a little, and then contract, with the remaining gap eventually filling in; the cycle had repeated itself to the point that the wall had nearly sheared off its footing, particularly in the area where it collapsed.

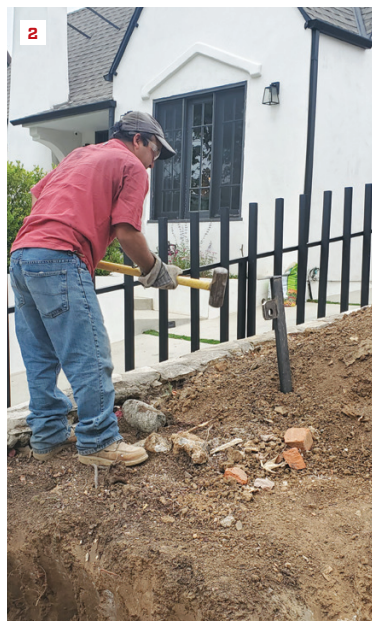
At the street-adjacent curved section of wall, a steel anchor post was driven into undisturbed soil (2). A come-along attached to the steel anchor and a 4-by wall brace pulled the wall back to plumb. Workers reset the 2x4 angled bracing after plumbing up the wall (3).

large Titan concrete screws to the sidewalk and driveway on the outside of the shorter curved wall. We then braced the wall to the interior side with horizontal 2x4s to keep the wall from falling inward. With excavation complete on the short wall, we drove a steel anchor fabricated by a welder into undisturbed soil **(2)**. We used a come-along attached to the steel anchor and a 4-by wall brace to pull the wall back to plumb, then reset the 2x4 angled bracing **(3)**. Because the short wall was broken into two large sections, we forced the second one into position after moving the first.

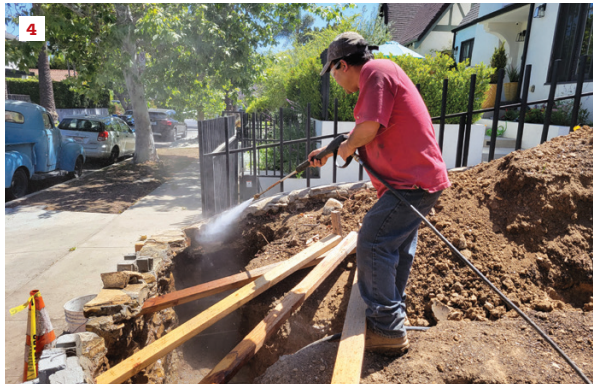
After the interior side of the standing wall sections were pressure-washed (4), the rebar was placed and the footing was poured using 3,000-psi pea-gravel concrete (5). Horizontal wall rebar was installed, and perforated drainage piping was dry-fit (6). Hex-head concrete screws set into the stones help bond the new concrete to the stone (7).

Given the greater mass of the upper 4-foot-high wall, we braced the wall with 4-by lumber taller than the wall, then sledge-hammered two steel anchors into the soil. Next, we hooked up three come-alongs with chain wrapped around the top of the 4-by wall braces and pulled the wall gradually back to plumb. We then braced the inside of the wall against the soil embankment to keep it locked in place. The next step was to rent a pressure washer and clean the interior side of the standing wall sections of soil and debris **(4)**.

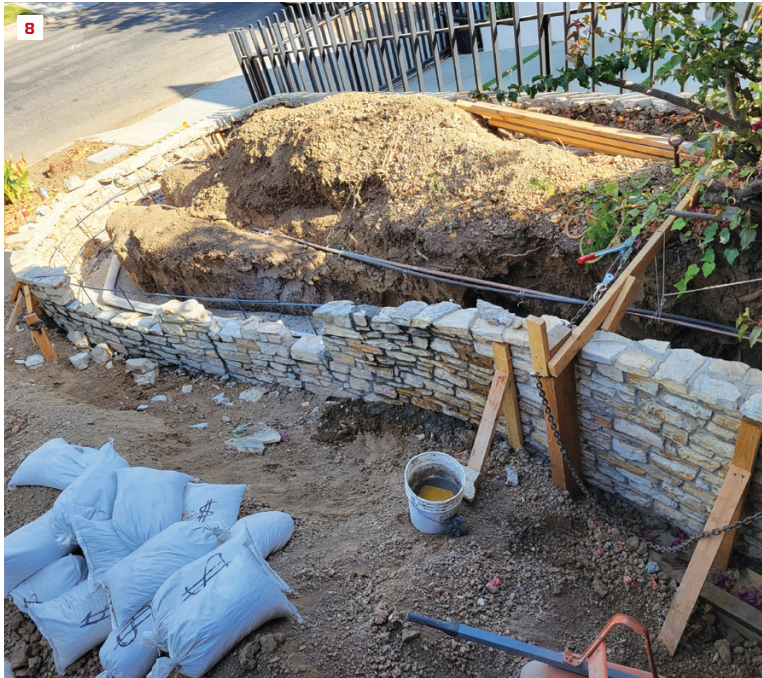
The collapsed portion of the wall was rebuilt using salvaged and new stone **(8)**. Sheets of 1/4-inch-thick Masonite, 2x4 horizontal blocks, and sandbags were used as wall forms on the shorter curved wall sections **(9)**.

The next step was to rebuild the fallen-down portion of the wall. I was able to buy a few hundred pounds of similar stones, and we mortared the wall back together with Spec Mix mortar, trying to match the original style as much as possible (8).

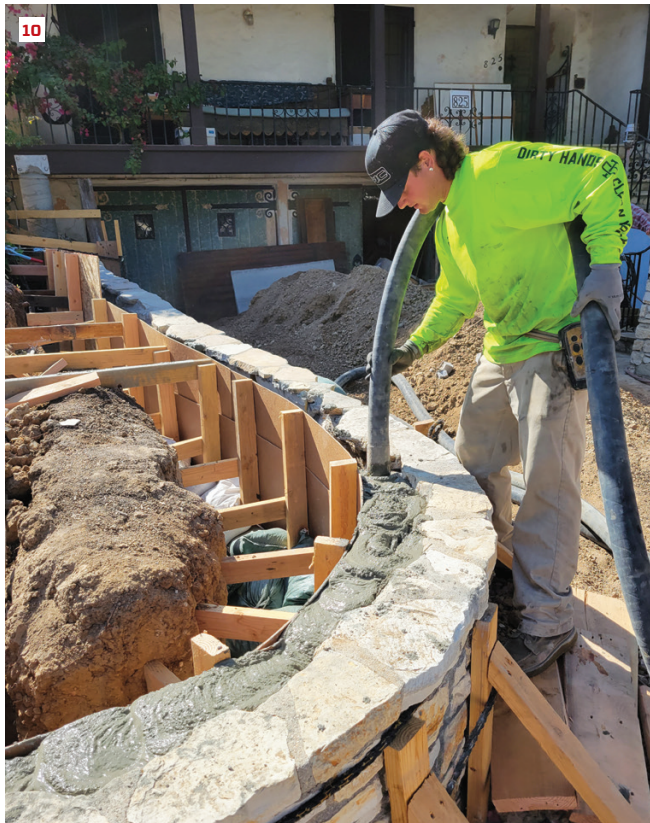
The walls were poured without any blow-outs (10). The author's crew finished off the top of the wall, working around the irregularly shaped capstone (11). The completed retaining wall (12).

Next, we worked on the wall forms. Due to the pandemic, plywood had tripled in cost, so I wanted a cost-effective alternative. This idea, Mickey Mouse as it was, worked surprisingly well: We placed 2x4 vertical ribs approximately 2 feet on-center and braced them with sandbags at the bottom and with 2x4 horizontal blocks to the side of the excavation (9). This was to hold 1/4-inch Masonite in place around the curves. In the 4-foot-tall section, we placed 7/16-inch OSB and braced the forms similarly. We poured the walls without any blow-outs (10), and our crew finished off the top of the wall, working around the irregularly shaped capstone (11).
