Better Porch Stairs

With pattern-routed stringers and rot-resistant details, this porch was built to last

by Emanuel Silva

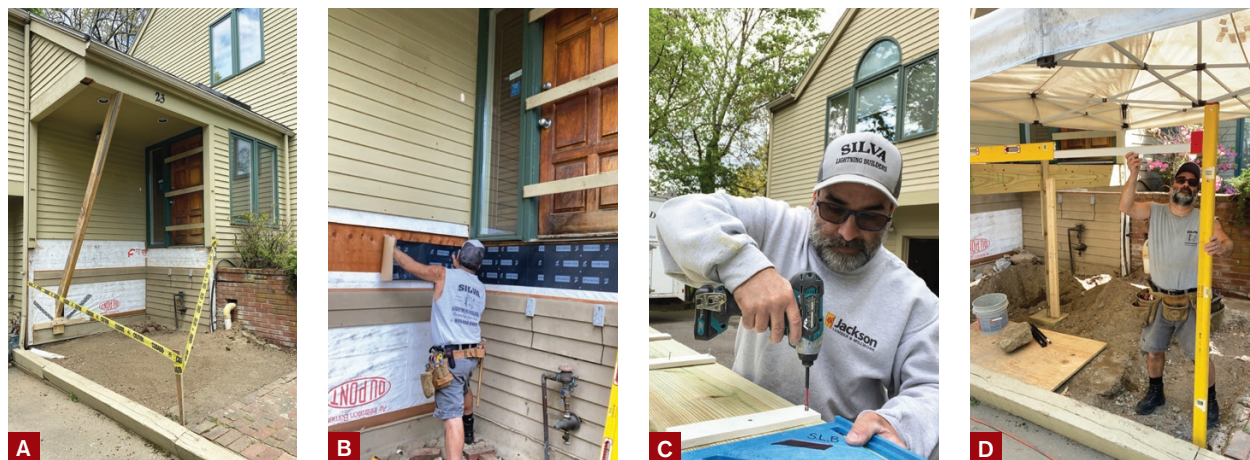
Figure 1. The new porch and stairs had to fit the existing footprint (A). The author covered the wall sheathing with a peel-and-stick flashing membrane (B) and screwed PVC shims to the ledger (C) before installing it. After framing the new porch on temporary supports, the author determined the landing slab's location and elevation (D).

Per the building permit, the new porch had to exactly match the footprint of the existing one. After marking the locations of the new landing and footing but before pouring any concrete, I installed a new ledger for the porch framing. To prevent moisture damage at this critical location, I cut away the existing housewrap and replaced it with Vycor Plus self-adhering membrane (Figure 1).

Before installing the new ledger over the membrane, I screwed 1/2-inch-thick PVC shims to the back of the ledger

16 inches on-center to match the locations of the lag screws I would use to fasten it to the house framing. For drainage, I also installed shims between the doubled rim joist and end joist, which had been temporarily propped up into position as I rebuilt the porch framing and installed the floor joists.

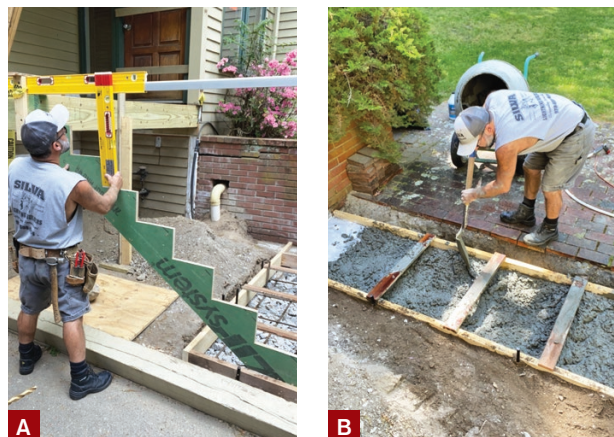
Figure 2. The author used a plywood template he made to cut the stair stringers to confirm the location of the landing slab, which he reinforced with rebar (A). The concrete needed to fill the form was mixed on site (B).

Landing. I had to remove a couple of courses of the brick walkway to build a form for pouring the new landing. For good drainage, I built the formwork over a base of stone and broken-up concrete from the existing slab, and to reinforce the slab, I wired together a rebar grid. In addition, I drilled short rebar dowels into the concrete footing supporting a brick planter next to the stairs.

Prior to filling the form with about 15 80-pound bags of concrete mix that I mixed up on site, I used a stringer template (more on this below), which I had cut for the new stairs, to fine-tune the position of the landing. This allowed me to pinpoint the landing's elevation so that all the risers would be exactly equal, with the outside edge of the landing slab perfectly aligned with the front edge of the stringers (Figure 2).

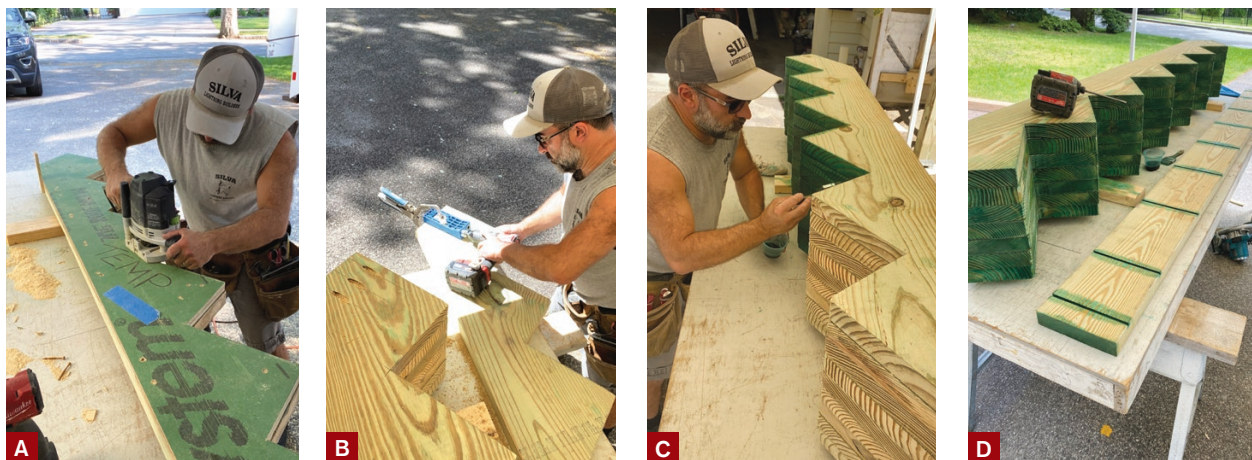
Figure 3. Using a template cut from a double layer of 7/16-inch Zip sheathing, the author pattern-routed the stringers (A). He used a Kreg jig to make pocket holes for mounting screws (B), then screwed the cut stringers together to prevent warping. To prevent rot, he applied preservative to the cuts and notches on the stringers (C) and the landing plate (D).

Usually, I cut out the sawtooth shape of open stringers using a track saw. On this job, however, I made a template out of scrap 7/16-inch Zip System sheathing, then used it to pattern-route the nine identical stringers needed for the 8-foot-wide staircase. My hope was that cutting the stringers production style instead of individually would result in uniform sizing that would eliminate the shimming

of treads and risers that would be otherwise necessary (**Figure 3**).

First, I ripped the sheathing to match the width of the 2x12 pressure treated stringer stock. Using a track saw, I carefully cut the treads and risers following the layout I had preserved from the original staircase. After finishing up the corners with a handsaw, I smoothed out the cuts with a sander so that the sheathing could be used to guide the bearing of the router bit. This is the template that I used to fine-tune the position of the landing.

stringer template was a little floppy, I doubled up the sheathing to reinforce it. This had the added benefit of allowing me to fine-tune my pattern-routing technique, as I traced the second length of sheathing to the template, cut slightly off the line with the track saw, screwed the two lengths of sheathing together, then trimmed the second piece to the first with the router.

I used the same approach when cutting out the pressure treated stringers. First, I traced the cuts onto the 2-by stock, then cut within about 1/8 inch of the line with

the track saw. Next, I screwed the template to the stringer and finished the cuts with the router. This was tedious going, as wet, 1 1/2-inch-thick pressure treated stock doesn't cut easily with a router, so I worked slowly and made a careful second pass with the router to clean up the edges. When I was done routing, I unscrewed the template and used a handsaw to carefully square up the rounded corners left by the router bearing.

the result: perfectly identical stringers. To keep them that way—since pressure treated stock has a bad habit of moving around once it's been cut and notched—I screwed each stringer to the previous one as I completed it before moving on to the next. Then, before leaving for the day, I gave all the cuts a couple of coats of copper naphthenate preservative.

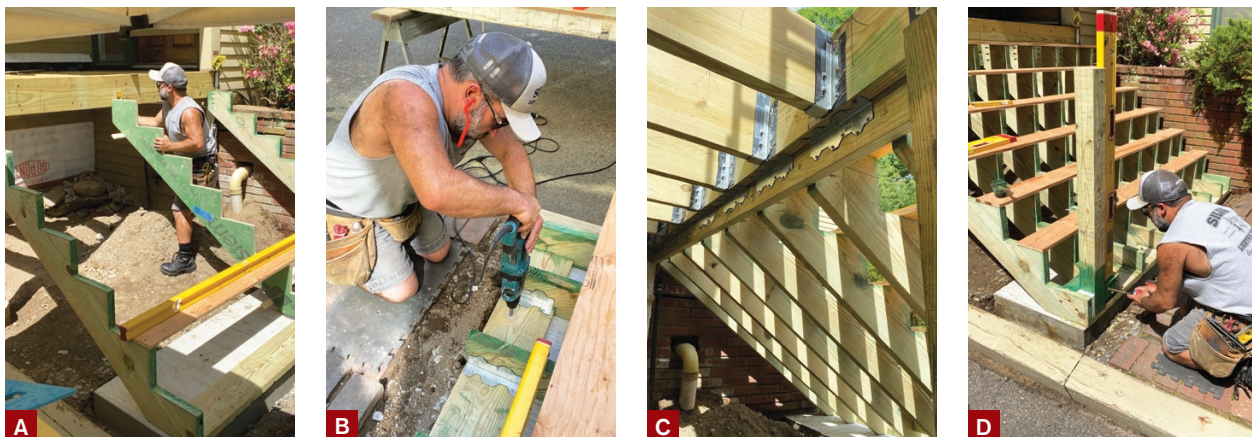
Figure 4. The author installed the end stringers first, then used the template to fine-tune the position of the remaining ones (A). The author used wedge anchors to fasten the plate to the slab (B), and metal angles to attach the dropped header for the stringers to the framing (C). Plenty of blocking was used to reinforce the landing post connection (D).

The stringers connect to the landing via a 2x8 pressure treated plate cut to match the width of the stairs, less 3 inches to account for the end stringers. For better drainage and rot protection, I incised the bottom of the plate with 1/4-inch-wide by 1/4-inch-deep notches, which I then saturated with preservative (**Figure 4**).

screwed structural screws through the sides of the two end stringers into the ends of the plate; the remaining seven stringers were notched to fit over the plate. To fasten the stringers to the deck framing, I drove structural screws through pocket holes into the rim joist. I also fastened a dropped header to the rim joist with metal angles and drove screws through the header into the stringers. After installing the stringers, I anchored the plate to the slab with wedge bolts.

To provide a solid connection between the landing newel post and the framing, I used plenty of structural screws and 2x4 and 4x4 blocking that I'd notched to fit. After cutting the pieces to fit, I saturated all the cuts and end grain prior to assembly to improve their resistance to rot.

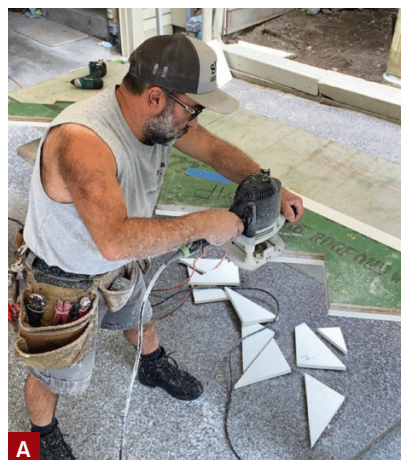
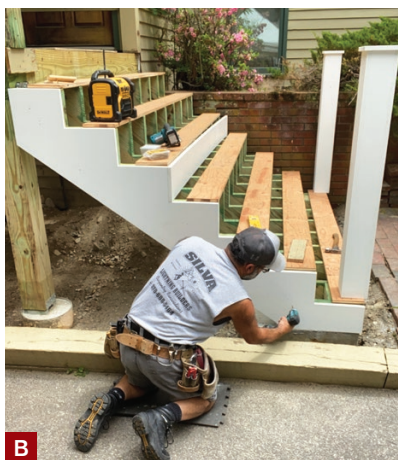
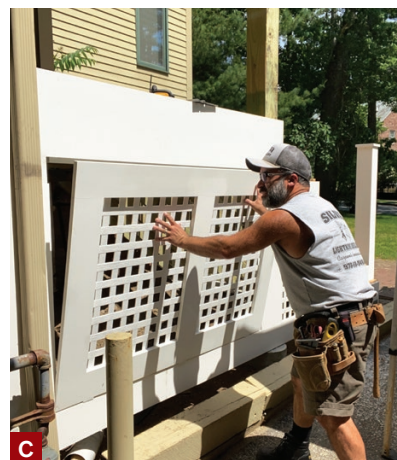
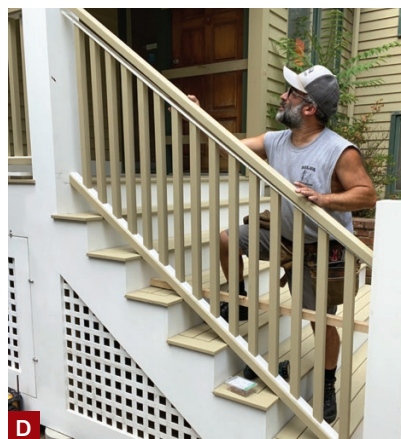
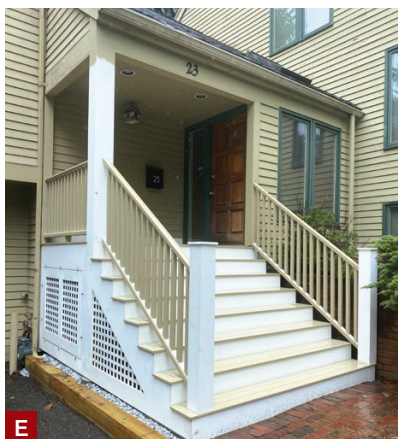
Figure 5. The author used the template that he had made to fabricate the stringers to pattern-route the PVC stringer trim (A), which resulted in a very accurate fit (B). The author also fabricated the post sleeves, stair risers, access door (C), and other porch trim from PVC stock. Along with the 1x4 decking, the railings, balusters, and stair treads were all fabricated from vertical-grain fir that the author prefinished on all four sides with a solid stain (D, E).

To match the appearance of the original porch, the homeowner specced clear vertical-grain fir for the railing, decking, and treads, which I prefinished on all four sides with a solid stain. I emphasized that this choice would require regular maintenance but was able to talk him into PVC post sleeves and stair risers. I also covered the stringers with PVC trim, using my template to accurately lay out and cut the stringer trim (**Figure 5**).
