CINCHING UP AN OLD SCHOOLHOUSE

Remodelers counteract earth movement with cable compression and a concrete grade beam

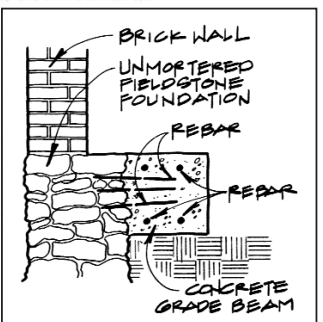
Figure 4. The grade beam was poured on all sides of the perimeter of the building. Rebar tied it to the ground and the fieldstone foundation wall.

The schoolhouse had been missing its one door and six windows for years, so there wasn't much problem getting the concrete chute inside. But an additional wooden trough helped get to the far wall so the truck didn't have to move (see Figure 4). After the concrete cured, missing bricks in the lower section of the walls were replaced and the cables were removed. I guess that old school house got a passing grade beam. ■
