EIFS Performance Review

For a durable EIFS exterior, follow installation details to the letter
and avoid the use of gypsum sheathing

by Richard Piper and Russell Kenney

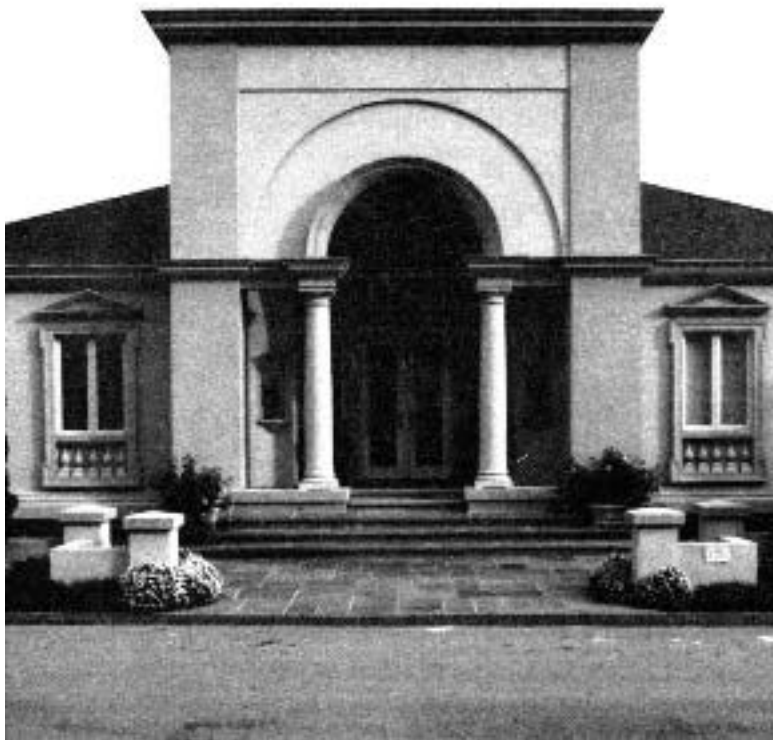
Courtesy of Russell Building Co., Birmingham, Ala.

Soft-coat synthetic stucco gives designers a lot of flexibility with colors and architectural details.
