BY KYLE DIAMOND

## Fixing a Poorly Flashed Cupola

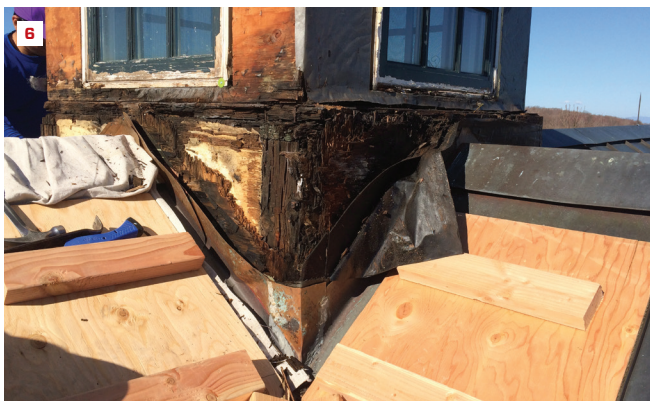
We began our investigation by removing the outer, plywood-clad finish base of the cupola (3). The copper roof-to-wall flashing had been reverse-flashed, with the copper placed on the outer surface of peel-and-stick—the previous builder had omitted the housewrap, which could have easily lapped the vertical leg of the roof-to-wall flashing. Another red flag was that sheathing behind the peel-and-stick at the top of the base felt spongy, which led us to remove the cedar corner boards and wrap-around sill (4). We then discovered that where the cupola's upper portion transitioned to its wider, lower base, there was no flashing; the upper portion's Tytar drainage plane dumped onto the 2-inch-wide, exposed plywood strip at the stepped-out base (5).

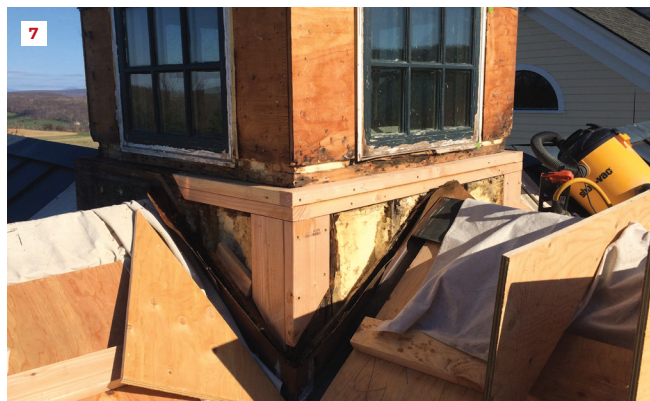
workmanship on the cupola was a whole bowl of “wrong.” There should have been either pan flashing installed under the existing cedar wrap-around sill or a metal cap installed over it. Without such details, this handsome architectural feature had become a conduit for water.

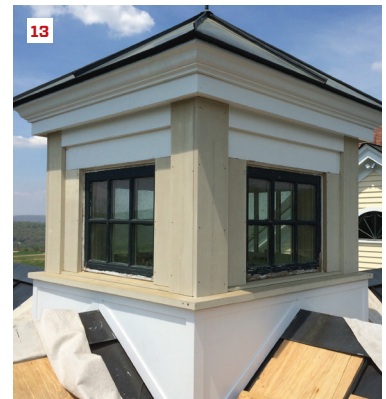
The existing windows didn't need to be replaced. The damage was confined to the frame's outer, factory-applied wood sill. The seam between the protruding, factory sill and the trim had held water and caused

them to rot, while most of the framed sill, which concealed the awning's operable hardware, was not damaged (8). This saved us from having to do any interior trim or drywall work. We managed to remove the rotted portion of the sill, then pulled the sashes and began waterproofing the base.
