RESILIENT BUILDINGS

A Texas Tornado: Lessons Learned Stronger Connections Could Have Saved Homes

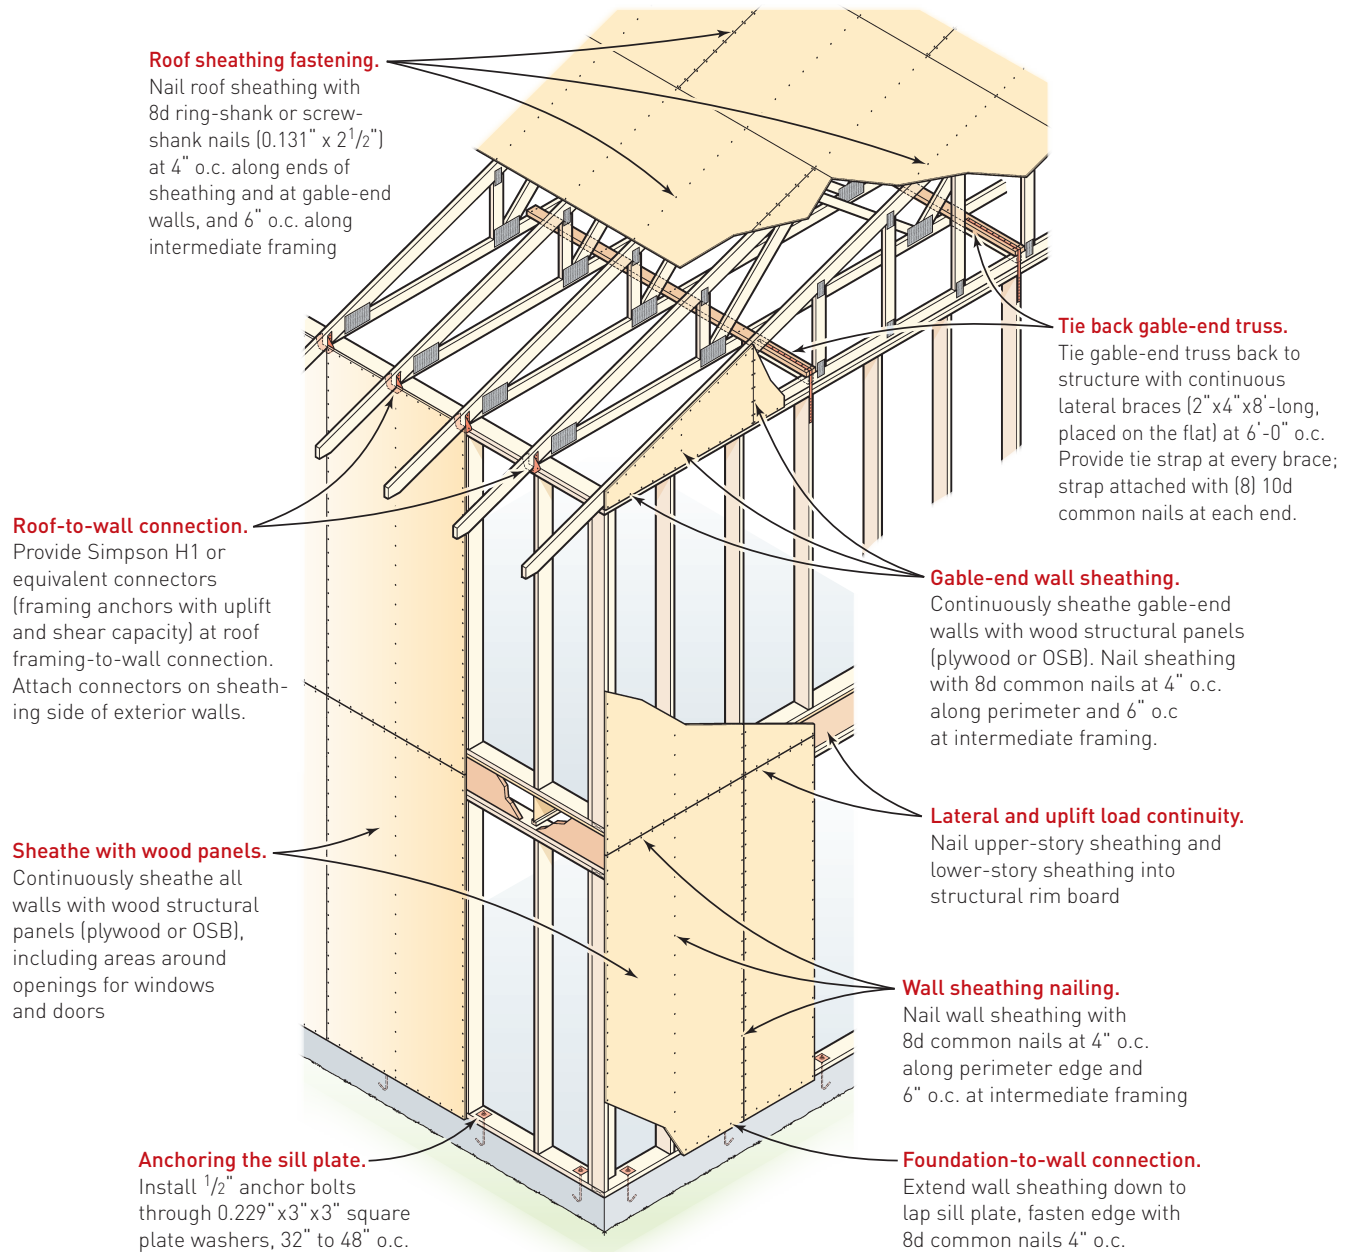
Improving Tornado and Hurricane Resistance of Wood-Frame Buildings

After inspecting hundreds of damaged or destroyed homes in multiple storm events in many different locations in the United States, APA engineers have concluded that a systematic upgrade of the component and assembly connections, designed to create a functioning load path for wind resistance throughout the structure, could save many homes at a reasonable cost.

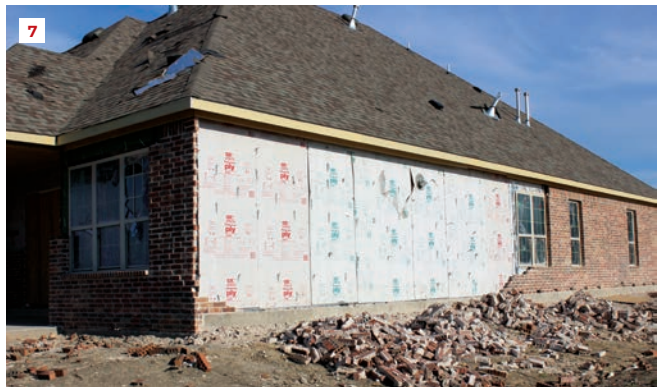
Failure of brick veneer exposed to relatively moderate wind speeds was common on the fringes of the tornado's track. Vertical cracking in the brick at the corners of buildings (4, 5) was a typical failure—the result of lateral displacement, or “drift,” of stud walls built without sufficient bracing. In one case (6), brick veneer and foil-faced foam sheathing were both blown off the gable wall—possibly after the wind breached the garage door. In another example (7), portions of a brick wall collapsed. “Lateral flexibility within these structures is incompatible with rigid and brittle brick-veneer wall coverings,” notes the APA report.

Images 4 and 5 (above) show big cracks at wall corners. “We saw this repeated over and over again in Texas,” says Uher. “We think

that it is due to lateral displacement. Brick is really brittle, and the lack of flexibility of brick can be a problem in these high wind speeds.” Structural wall bracing is important to maintain stiffness so that inflexible components such as brick cladding, doors, and windows will not be damaged by “drift” of the wall structure.

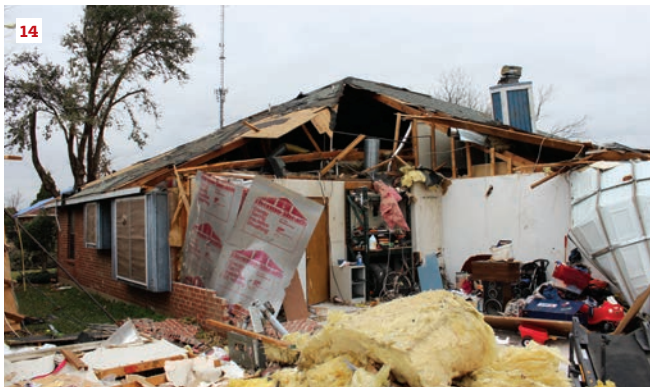
This garage door opening (12) shows a classic racking failure that is also commonly seen in earthquakes. Image (13) shows similar racking of another garage door frame, plus catastrophic failure of the adjacent walls and roof—likely a result of the sudden pressurization of the building when the garage door was lost. In images (14) and (15), pressurization of the garage apparently contributed sufficient force to cause the loss of roof sheathing in nearby areas of the main house roof.

One code-allowed solution is to use a “portal frame” as prescribed in the International Residential Code (IRC), with a continuous header across the large opening, and heavily nailed wood structural panels tying the wall framing to the header—plus metal anchors tying the wall base to the foundation.

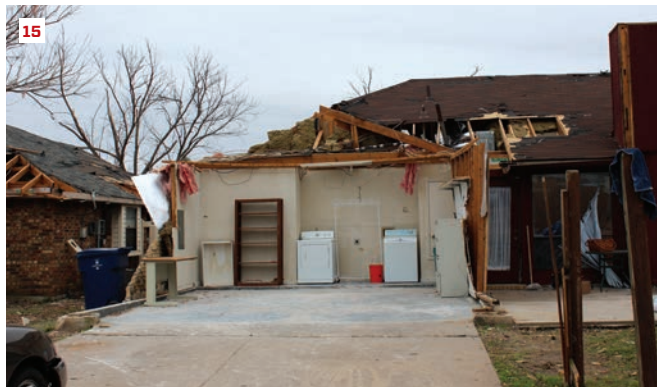
But the garage door itself can also be a weak point. “Failure of a garage door pressurizes the inside of the house,” explains Uher. “Once the garage doors go, the wind is now not only on the outside of your house, but inside. You have suction on the roof, plus pressure from underneath. The pressures double, essentially—and then it’s typically a sudden failure of the roof.” One weak link can be the connection of the wall to the roof. “If that fails,” Uher says, “it allows both your walls to fall out and your roof to blow off.”
