# STRUCTURE

## Deep Structural Retrofit Rotted framing called for a complete rework of the load path

BY JAKE LEWANDOWSKI

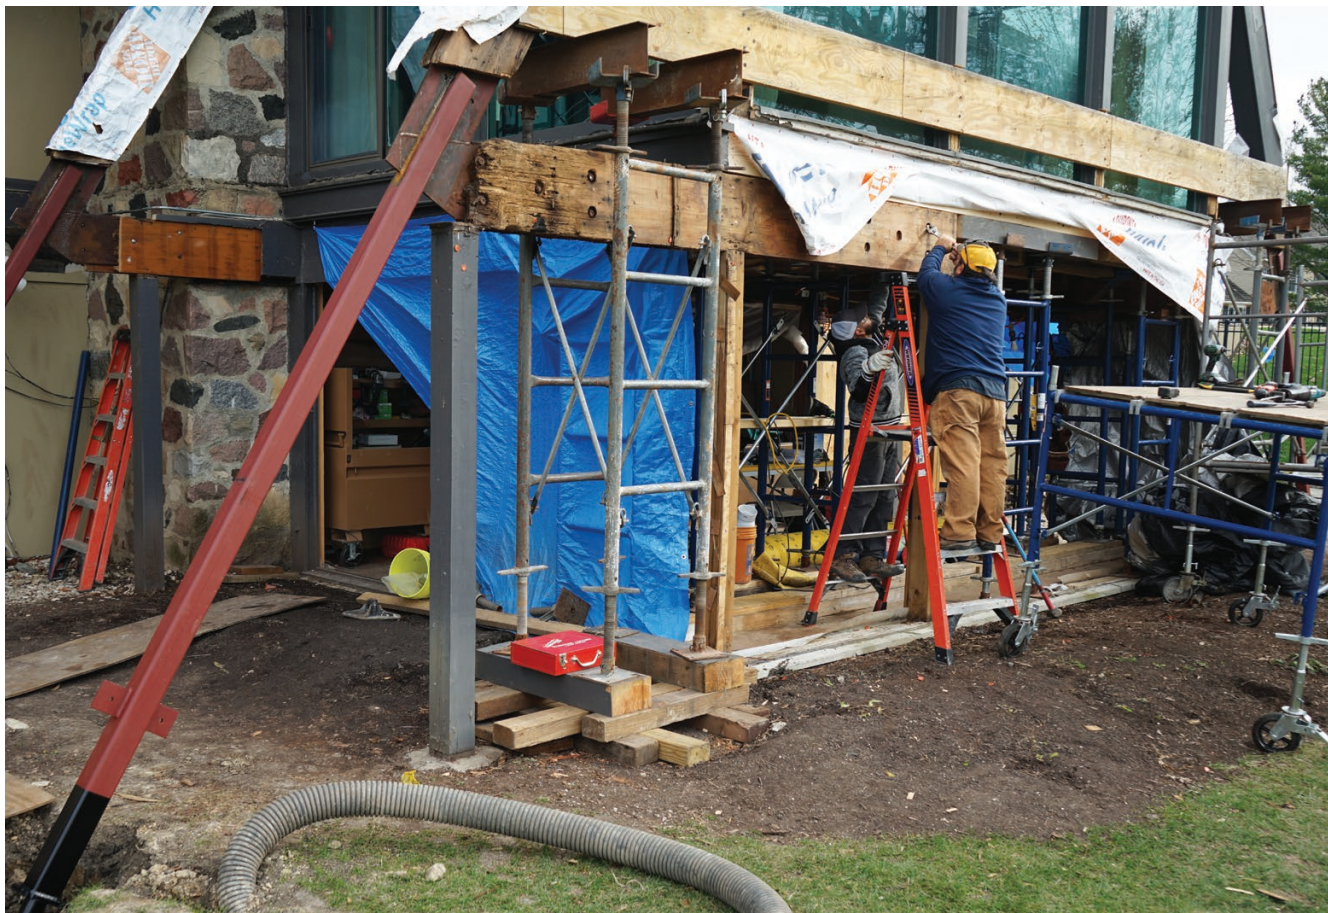
Our company, which specializes in structural repairs, was recently called to an expensive residence outside of Chicago. A number of contractors had been to this house to bid on replacing a large wrap-around deck, but they had concerns; extensive rot of the ledger board signaled deeper structural problems that exceeded their expertise. Our inspection revealed numerous places where poor flashing had led to extensive water intrusion problems. The worst was at the base of large banks of windows on the A-frame-style wing that the deck wrapped around. Water running off the large expanses of glass had leaked for years through the base of the window walls, jeopardizing not just the deck ledger but the entire floor-system supports, which

served to tie together the A-frame rafters. The house was on a hill and exposed, resulting in significant lateral wind loads on the steep roof, so a rotting floor system put this entire A-frame at risk of collapse.

The original structure appeared to be built with clad, heavy timber rafters that continued past the roof overhang and tied into a clad, horizontal timber beam, which completed a triangle. After we removed the cladding from the rafters, though, we discovered they were constructed from two roughly 3-by-14-inch boards sandwiching a 1/2-inch steel flitch plate welded to a flitch plate in the horizontal member. The floor system sat above this horizontal beam. This design may have worked while the wood framing was sound, but

once the wood rotted out, the integrity of the bolted assembly was severely compromised. Rather than try to reproduce this triangular load path, we worked with our engineer on a repair that redefined the load path: By driving helical piers at the same angle as the slope of the roof, the thrust of the rafters would be supported in-line with the rafters. We also supported the floor system with laminated veneer lumber (LVL) beams and completely reframed the supporting walls to create a robust structure with redundant support paths.

Given the tenuous condition of the existing structure and the possibility of the roof spreading as we unraveled the load path, we had to thoroughly shore up the home during the repair. This involved shoring under the entire A-frame floor, as well as erecting shoring towers on the right and left flanks of the A-frame where the main house roof extended over the deck. We also installed a temporary LVL beam across the face of the windows at the base of the triangular gable end.
