# Q&A

## Q. Fixing a Noisy Condo

I'm renovating a condominium that shares a wall with the adjoining unit. Sound from the neighboring unit — the ringing telephone, the dishwasher, and especially the TV — travels right through the double 2x4 common wall, which has fire-rated drywall sheathing on one of the interior surfaces. Only the neighboring wall has fiberglass batt insulation, and as far as I know, the two walls do not touch. The condo is on a slab foundation. Is there any way to reduce the sound transmission through this wall?

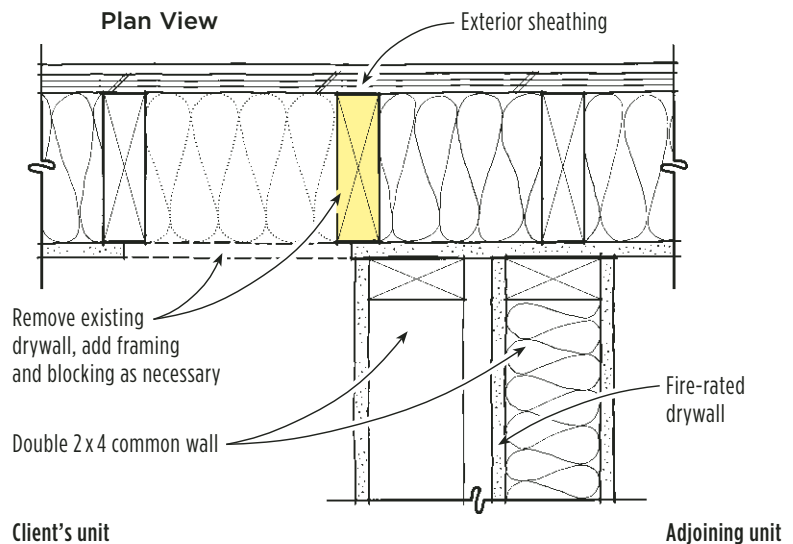
### Add Blocking at Improperly Built Corners

Next, check the sidewalls for “flanking paths” that allow sound to come through the corners. Improperly built corners transmit noise, and the solution involves removing drywall and adding framing and blocking as necessary so that the wall goes through the adjacent corners to the exterior sheathing. Check the attic or ceiling, too. Sound travels around these joints when they’re built improperly.

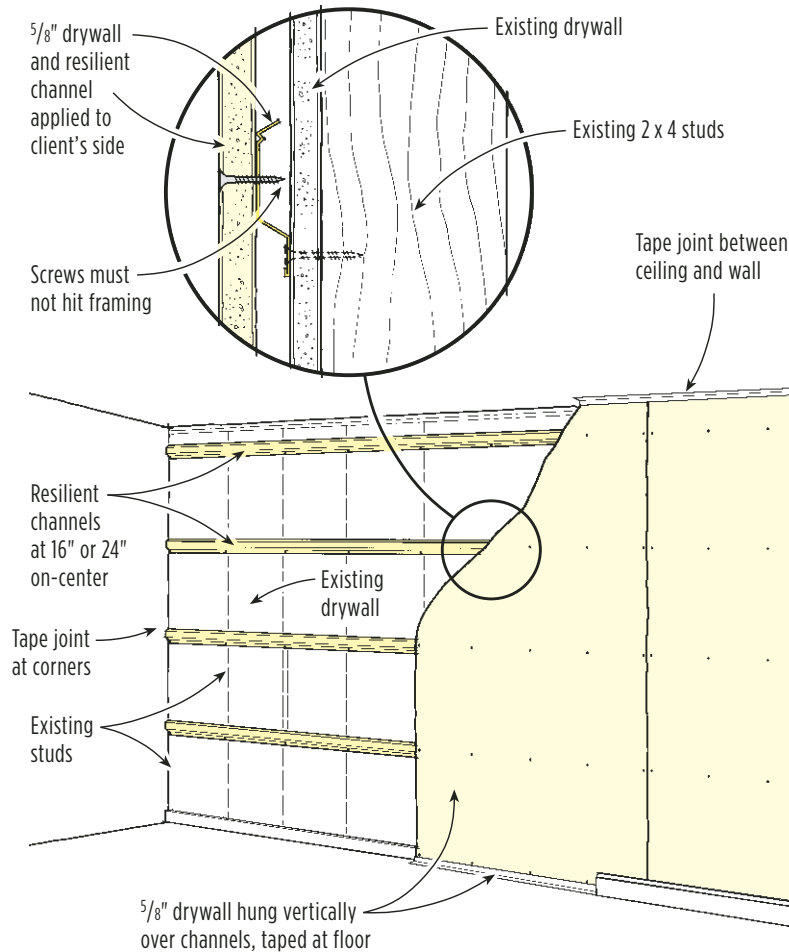
### Add Resilient Channel and Drywall

If all of these steps fail to reduce sound levels adequately, you can buy resilient

channel at the drywall supply shop and apply it horizontally to your wall at 16- or 24-inch centers. Then hang  $\frac{5}{8}$ -inch drywall vertically over the channels, making sure your screws do not go all the way through the channel into the framing, since this would defeat the spring action provided by the channel. Also, be sure to tape the new drywall to the ceilings, adjacent walls, and floor, which will help seal the leaks that permit sound transmission. Of course, it would be even better if you could get the neighbor to take the same steps.
