Preventing Early Deck Framing Failures

by Frank Woeste

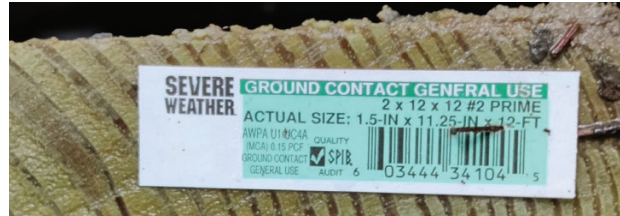
Preservative treatment lumber tag on one end gives the size of the 2x12, along with the AWP UC4A level that indicates it is suitable for “Ground Contact.”

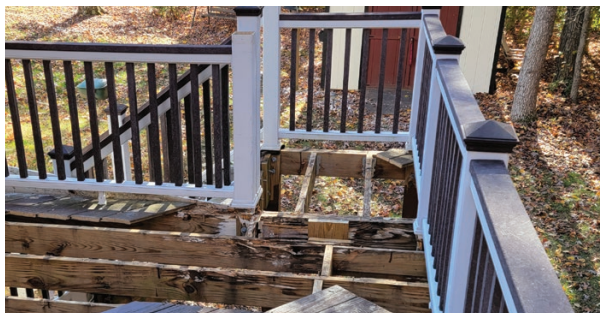
Central Virginia deck after 10 years in service. The bulk of decay damage is where the top edges of joists are in contact with the decking. Such water-trapping joints accumulate water by gravity and capillary action and are slow to dry after a rainstorm since the top edge of the joist is not exposed to natural ventilation.

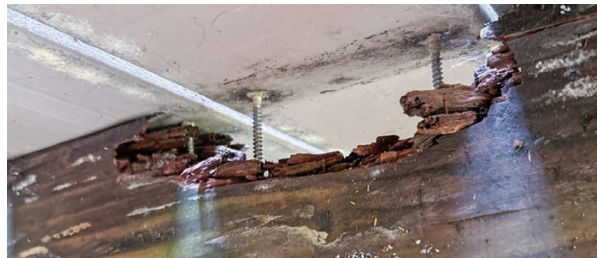
Constructed in coastal New Jersey, a deck joist in-service about 10 years was preservative treated to the "Above Ground" AWPAs U1 Use Category.

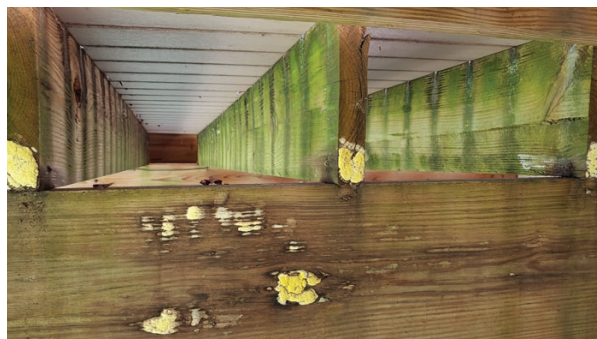
Advanced decay of joists and beam treated to "Above Ground" based on an available treatment tag. The tag did not indicate an AWPAs Use Category System.

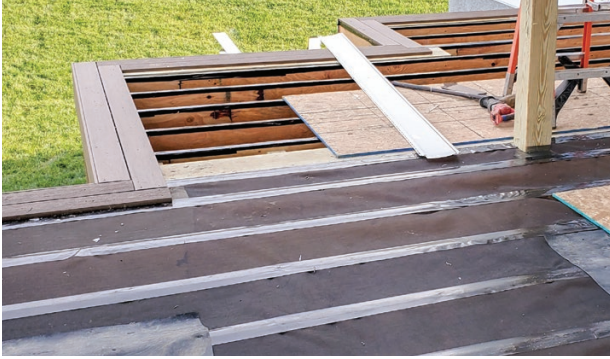
The PWT preservative-treated LVL framing has been flashed for additional protection.

Built-up beams are especially vulnerable to water collecting in the gaps between members, which can be avoided by flashing the top of the beams. At least one manufacturer, PWT, which offers a preservative-treated LVL, has a requirement to flash all framing. Flashing for 2-by joists should be a minimum of 2 1/2 inches wide to ensure good coverage. Built-up nail-laminated beams (two, three, and four plies) should be flashed with a single width that is adequately sized to cover the entire assembly.

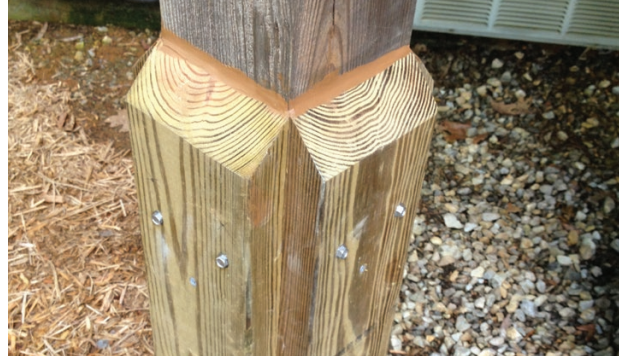
This UC4A-treated 6x6 southern pine post has been repaired using UC4B-treated 2x6 cleats and 1/4-inch-by-3-inch structural fasteners. Note that the cleats (as well as the concrete, not shown) have been sloped to shed water.

For UC4A or UC4B structural deck posts attached to a concrete slab or pier, a post-base connector that separates the post end-grain at least one inch from the concrete or standing water should be used. UC4B may not be available in retail outlets and require a special order. Note that with UC4B lumber, stainless steel hardware is recommended to avoid premature corrosion.

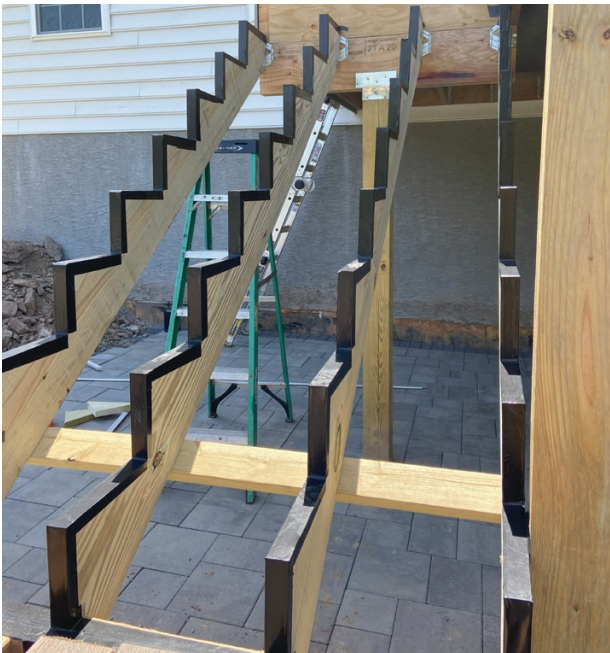
Cutting a stringer creates “end grain” at each stair tread and riser. End grain absorbs water up to 100 times faster than the sides of the lumber do. As such, cut edges of the 2x12 preservative-treated southern pine stringers are flashed.

These recommendations are in addition to IRC requirements, which call for field-cut ends, notches, and drilled holes in preservative-treated wood to be treated in the field in accordance with AWPAs M4. According to the *Forest Products Laboratory Handbook*, sealing all end-grain surfaces to prevent liquid water from entering the wood “is probably the single most valuable improvement that can be made in standard construction practice to improve the performance of wood exposed to water. The end grain is so important because liquid water can enter wood through the end grain so quickly—100 times faster than from the sides is not unusual.”
