# Identifying Poria Fungus

**Q.** While renovating a home in New Jersey, I found a fungus-like growth a few inches long growing between the tile floor and the base molding in the bathroom. The house is on a concrete slab. Is there anywhere I can have this growth tested to see if it is poria?

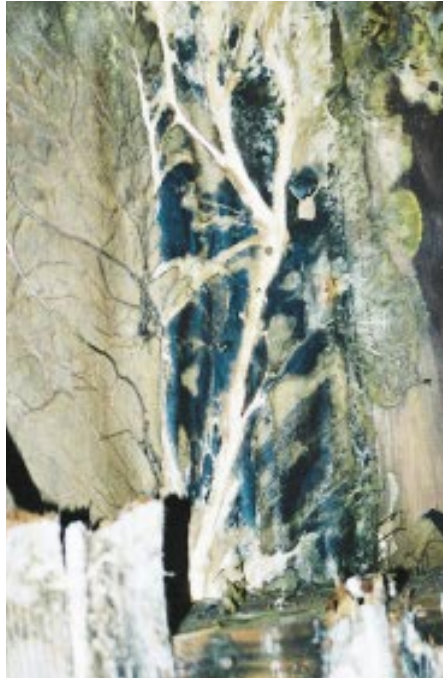
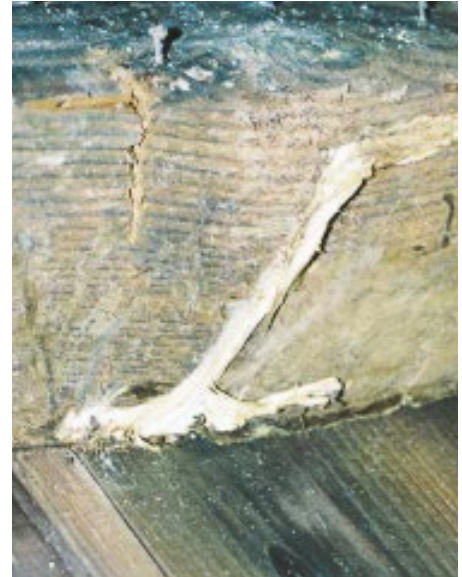
**Figure 1.** The rhizomorph of the poria fungus is a rootlike tube.

Because the laboratory procedure can take a month or longer to complete, it may be safer for you to diagnose it in the field. *Meruliporia incrassata* (the recently changed scientific name for poria) can be identified by the presence of the water-conducting rootlike tube called a rhizomorph and by the appearance of the fruiting body and the dark colored spores it produces. The rhizomorph looks like a barkless root and smells like a mushroom if broken open.

non-water-conducting decay fungi, you have to find the source of liquid water that is making the wood wet enough for decay to occur, and stop it. With poria, the rhizomorphs supply the water, and therefore they all need to be found and severed. Severing the rhizomorphs will eliminate the water source and kill the fungus.

Finding and cutting the rhizomorphs can be difficult, particularly with slab-on-grade construction. The rhizomorphs can move through some very tight openings, such as plumbing penetrations and cold joints between two concrete pours. To prevent poria from infecting the house again, you need to change the construction detail that allowed the rhizomorph to get to the house without drying out (for example, by providing an adequate air gap between wood and soil).

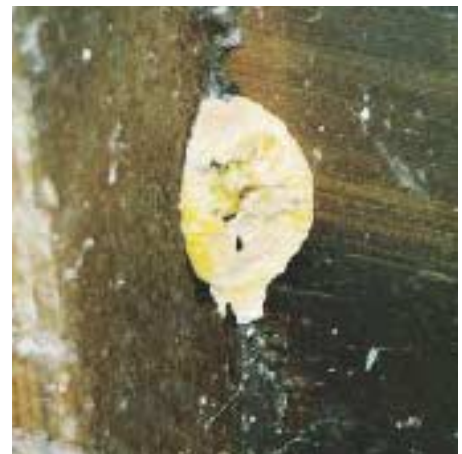
**Figure 2.** One identifier of *Meruliporia incrassata* is its fruiting body.
