# SITE WORK

## Roughing Out Site Work Lessons learned taming a difficult site

BY ANDREW BORGESE

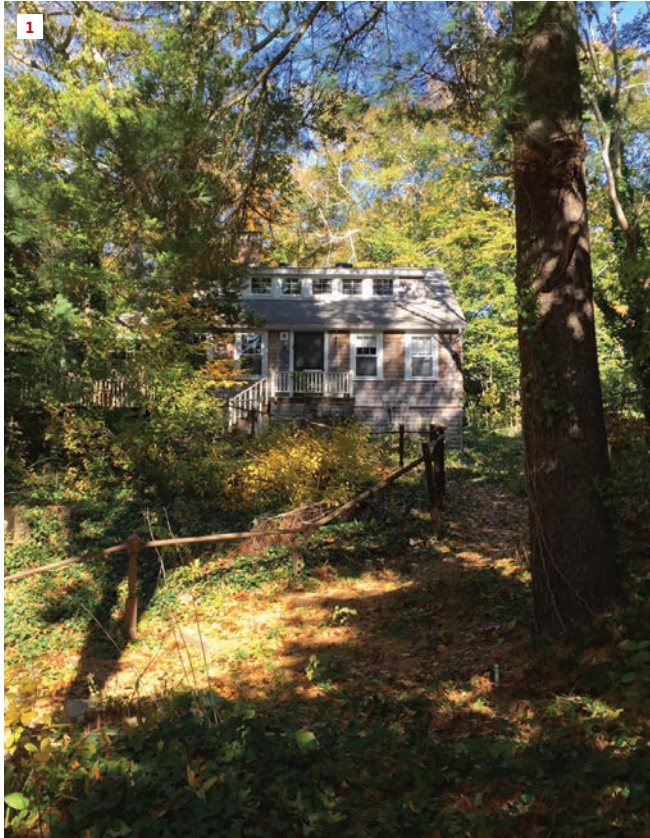
the scope of the work. On this Cape Cod project, the clients owned a small cottage that sat in the back of a narrow, overgrown lot (1). Built in the 1940s, the existing house was so far from being code compliant that demolishing it and salvaging materials from it was more financially feasible than trying to renovate it.

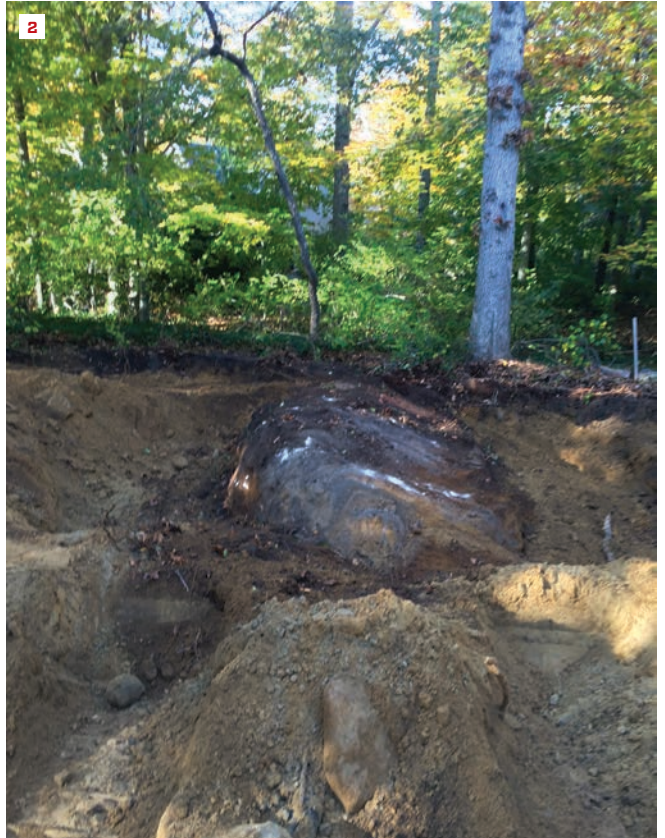
When I first visited the property, I noticed that the back corner of the house sat on what appeared to be a large boulder (2). But with no other such outcroppings visible as the site sloped downhill, I wasn't overly concerned and didn't feel that my observation justified spending thousands of additional dollars to do soil borings throughout the lot to investigate what obstructions, if any, might lie beneath the surface. My excavation contractor had done extensive digging in the nearby area and although he had encountered some poor soil and rocks, he wasn't too concerned either.

However, as a precaution, we decided early in the design phase to locate the new house closer to the road (and farther away from the visible outcropping of stone). We also designed the rear uphill portion of the house to sit over a crawlspace with a shallower foundation; a full foundation would have required a much deeper excavation in that area.

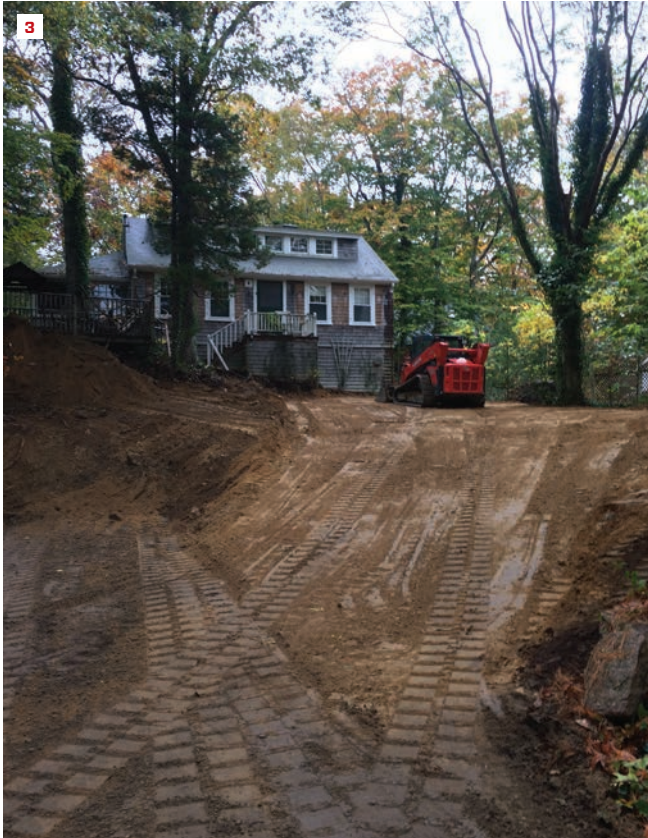
The rough site work began with clearing any trees and vegetation located within the footprint of the new structure and in the access path of construction vehicles (3). In this case, that meant getting the site ready for the equipment that would raze the house and remove the debris.

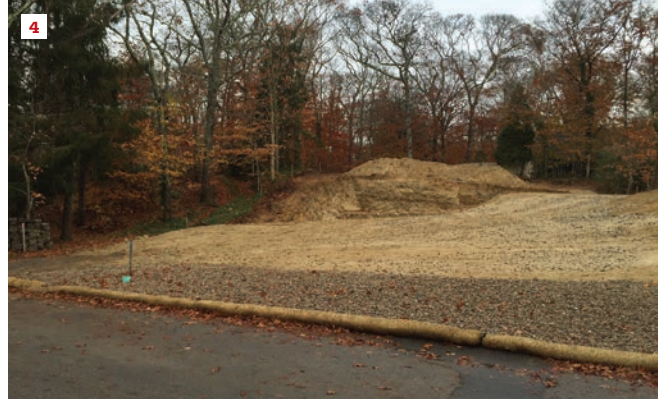
**Mud mat.** One of George's first tasks was scooping out a 12-foot-wide by 10-inch-deep area along the length of the property where it abutted the street (which was also the lowest elevation of our sloping lot). He filled the resulting wide, shallow trench with crushed stone to create a large "mud mat" to filter runoff from the site and to help remove dirt from the tires of construction vehicles.

**Straw wattle.** As an additional measure, we placed a straw wattle along the edge of the crushed-stone mat, parallel with the roadway. This wattle is a biodegradable woven tube filled with absorbent fiber designed to collect any silt or debris that might get past the mat,

and requires no special removal after it begins to break down from wheel traffic. The combination of mud mat and straw wattle was incredibly effective in keeping the roadway clean despite several days of heavy downpours during the excavation (4).

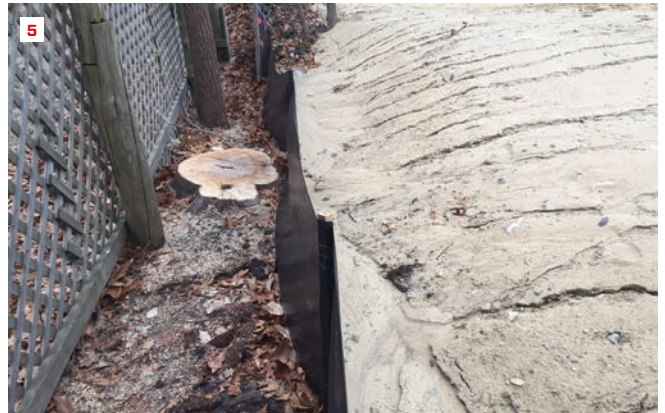
**Silt fence.** To keep mud and debris from washing off the site onto neighboring properties on both sides, we installed a silt fence made from a plastic fabric that holds back soil while allowing water to pass through. We buried the bottom 6 inches of the fence in the ground, and it, too, was quite effective in keeping the excavated soil contained on site (5).

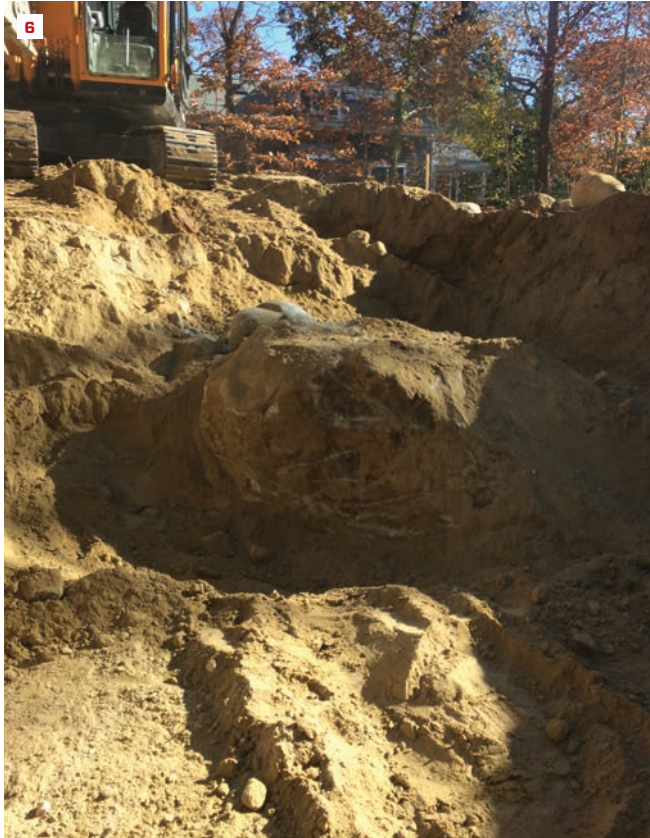
**Rock bottom.** After removing 967 yards of clay and silt (George kept close tabs), we thought that we had exhausted our bad luck and had hit rock bottom. That is, until we actually hit rock. About 18 inches above our designed slab elevation for the crawlspace area, we hit glacial till. George found a "rock" that kept getting bigger as he tried to dig under and around it (6). It was not to be moved.

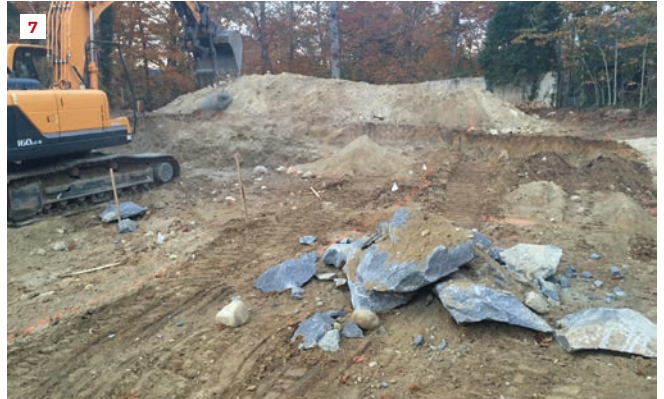
The densely developed neighborhood where this property was located was definitely not a "blast-friendly" zone, so breaking up the rock with explosives was not an option. Breaking it up with a pneumatic impact drill was also ruled out as being too noisy. Instead, George chipped away at the stone protrusion by repeatedly dropping a one-ton steel-alloy weight (appropriately nicknamed "the head-

ache ball") from the bucket of his excavator (7). Eventually he broke the rock down to the desired elevation for the slab.

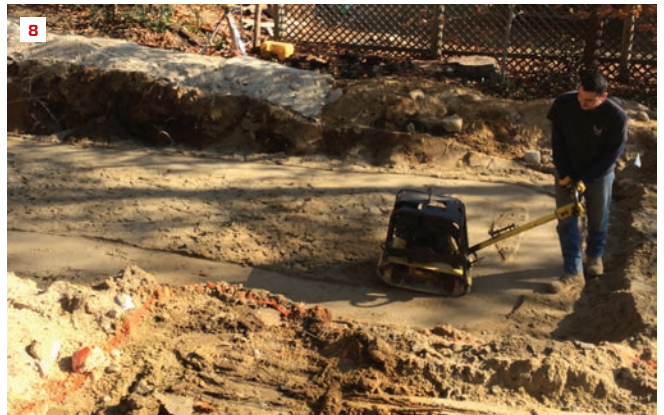
**Driveway base.** Part of the excavation process was preparing the driveway area for the heavy construction vehicles, including the concrete pump truck, that would need to drive up the hill. A good driveway that would provide access to the main floor of the house was also a crucial part of the plan. George excavated the poor soils from the driveway area and brought in clean, structural fill that he installed in 6-inch lifts, compacting each layer before placing the next one (8).

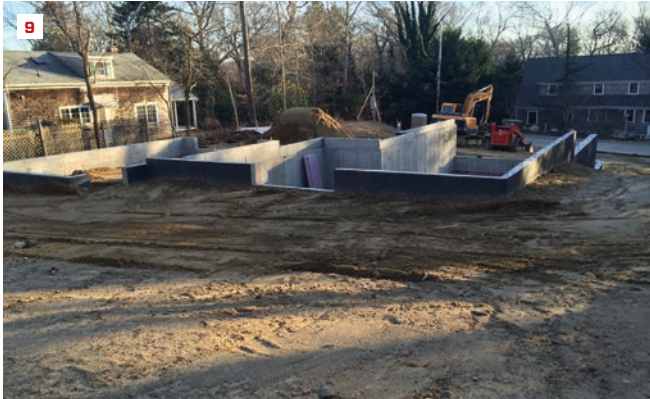
**The footings and foundation** for the house and garage went in smoothly. To put the main floor of the house at an accessible level, the foundation contractors formed a shelf in the upper part of the walls. It would support an I-joint floor that would be at the same

level as the grade at the driveway and garage floor. On two sides of the house, the foundation walls extend almost two feet above the shelf to allow the grade next to the foundation to be higher than the floor and then slope away from the house properly **(9)**.

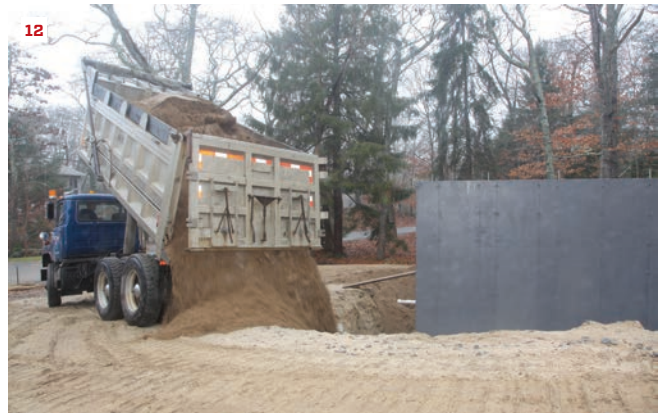
**Backfill.** Now it was up to the excavator to backfill the foundation and finish the rough grade for the driveway to bring it all together. Using the bucket on his excavator, as well as his skid steer, George backfilled around the foundation at the back and sides of the house with excavated material that had been piled behind the house **(10)**. He also used the bucket to fill the foundation of the garage with clean material, which he compacted using the bucket and a hand-operated compactor **(11)**. To make up for the materials that had been hauled off site, George brought in 400 yards of screened and structural fill material to finish backfilling the sides of the foundation and to fill the rest of the garage foundation as a base for the slab **(12)**.

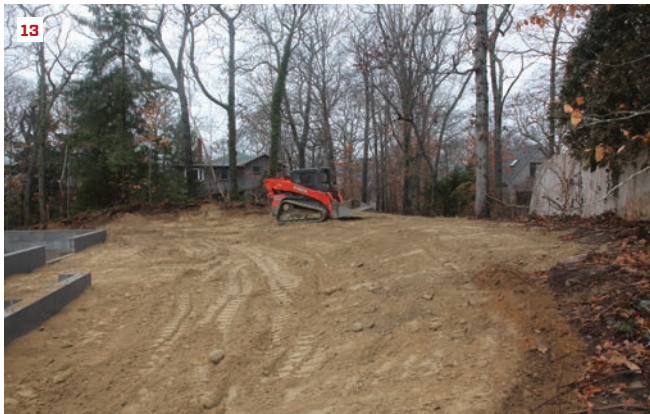
the only area that would work was behind the house. But the topography there continued to slope uphill, so our original design called for cutting into the grade and containing the patio area with 3-foot-high retaining walls. After backfilling the foundation, George began roughing out the ground behind the house. Sculpting and smoothing the grade with the blade of his skid-steer machine, he was able to carve out the area needed for the patio and then gently slope the grade up to meet the natural topography, eliminating the need for thousands of dollars worth of retaining walls (13). Those savings at least put a dent in the unforeseen excavation expenses.

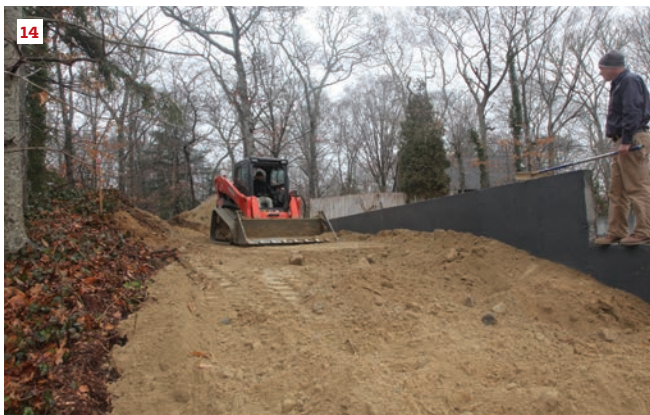
One of the last steps in the rough grading was making the site safe and ready for the framers. This involved smoothing the ground with the skid steer after the backfill was placed (14), and hand-grading the area immediately beside the foundation to get rid of what George called “ankle breakers”—chunky soil that when frozen can be dangerous underfoot (15). Ideally, this last step would have been completed after the septic system (located

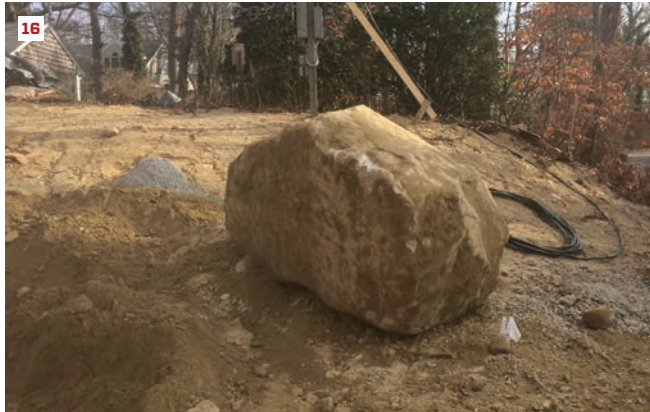
Unfortunately perc tests don't reflect all of the conditions below grade, and excavation for the septic system uncovered the same clay and silt mixture that we'd found earlier. It wasn't until we reached a depth of 25 feet below grade that we discovered suitable sandy material. To excavate for the septic system, George dug out some huge boulders (16) and ended up removing 1,121 yards of material, more than twice what we'd estimated based on the perc test. Within a few days, George was able to complete the septic system (17).

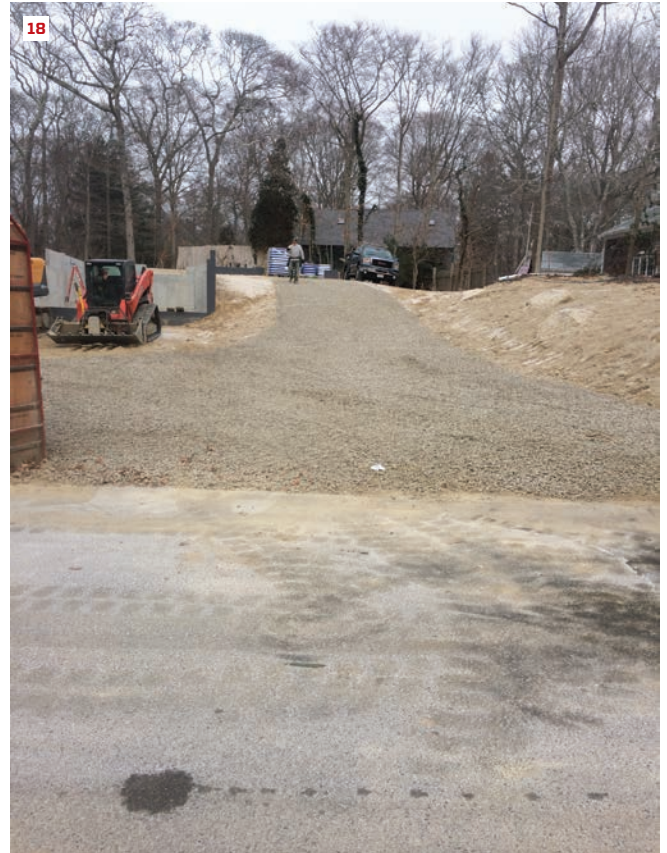
Before packing up his equipment and leaving, George put down a layer of crushed stone on the driveway (18). The stone will help keep the ground from turning into a soupy mess during freeze/thaw cycles as work progresses into the spring. The stone also created a clean, even surface for staging materials throughout all phases of construction that followed.
