# Hurricane-Resistant Concrete Homes

*A builder's search for a new wall system leads to a more hurricane-resistant home*

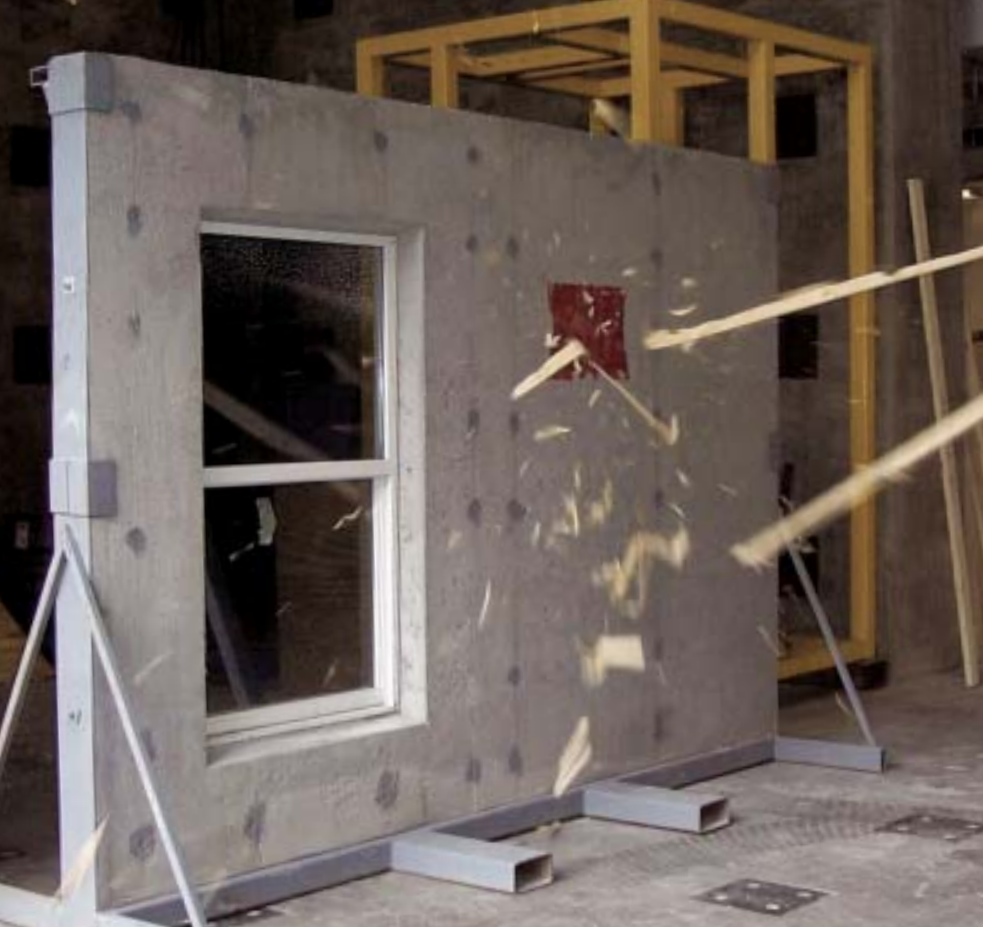
The 2x4 used in the “large missile test,” which has become the standard measure for impact resistance, completely shatters upon impact with solid concrete, causing no damage whatsoever to the advanced wall system developed by Mercedes Homes and the Department of Energy’s Building America program.

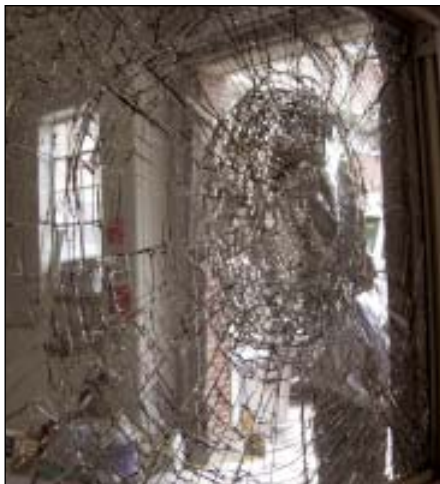
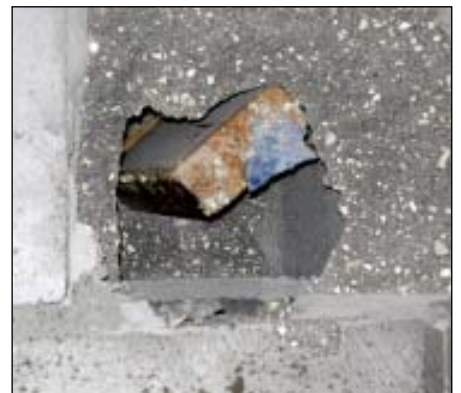
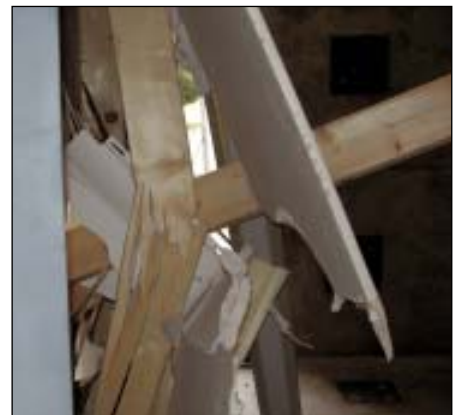
FIGURE 1. Windows that meet the ASTM E 1886 and ASTM E 1996 impact standards shatter but do not present an opening that will either pressurize the interior or allow undue amounts of water into the home (above). However, most conventional wall systems do not fare as well under the same test. A typical vinyl-sided wood-frame wall is obliterated by the large missile test (right). A concrete block wall performs a bit better but still allows a sizable hole for wind and water to penetrate (top right).

In much of Florida, the typical single-family home is built with CMU walls. Although stronger and more durable than standard frame construction when subjected to a tropical storm, these homes are still susceptible to lateral and uplift wind-load failures as well as to penetration damage caused by wind-blown debris (“missiles”). The Mercedes SWS cast-in-place concrete wall developed with the help of the Building America program performs better than a CMU wall (and monumentally better than a wood-framed wall) at resisting these forces (Figure 1).

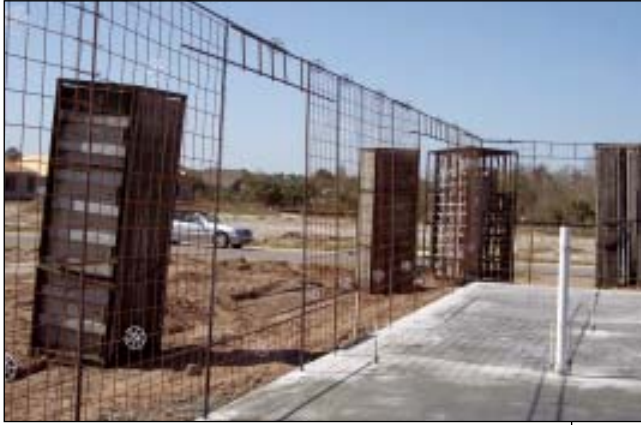
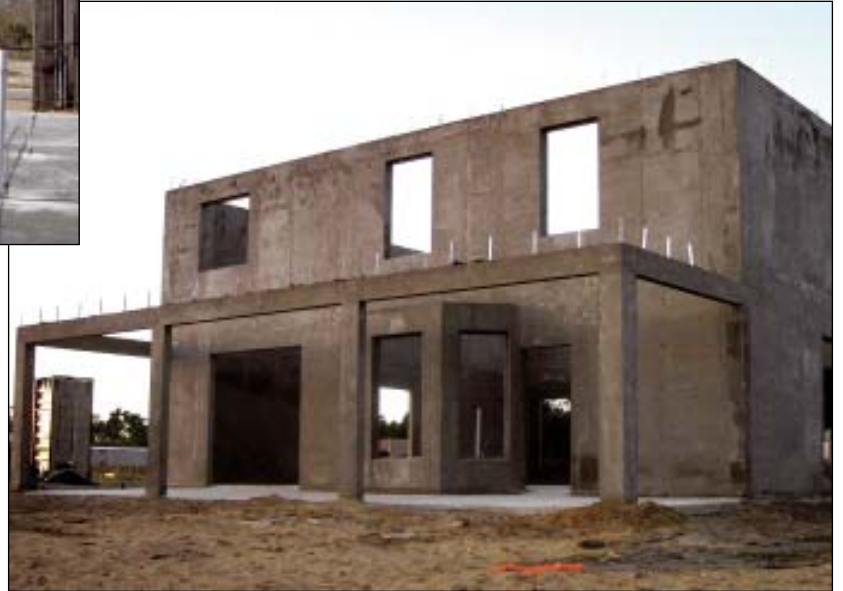
FIGURE 2. The heart of the Solid Wall System (SWS) is a steel reinforcing cage of 6x6x1/8-inch "road mesh" combined with vertical 5/8-inch reinforcing bars placed at 4-foot intervals (above). The cage is specifically designed to evenly distribute lateral wind loads and minimize point stresses imposed by missile impacts, which can lead to failure. The steel cage also connects to steel in the footings. Wet-set tiedowns (hurricane straps) are embedded every 2 feet in the concrete as the walls are poured, providing a continuous path to resist uplift.

**The science of SWS.** The SWS system uses 3,500-psi concrete placed in modular aluminum forms to create its 6-inch walls. The concrete encloses a steel reinforcing cage of 6x6x1/8-inch "road mesh" combined with vertical 5/8-inch reinforcing bars placed at 4-foot intervals (Figure 2).

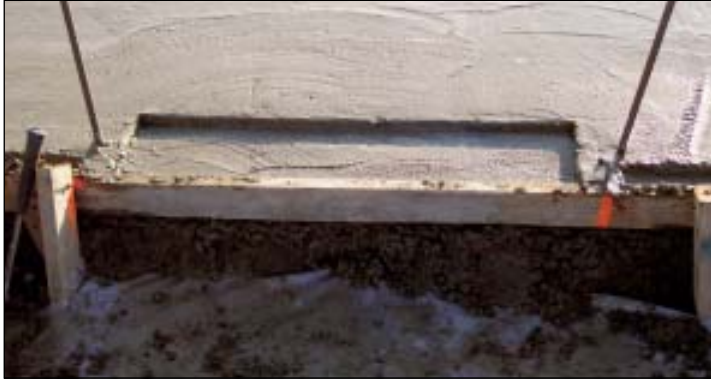
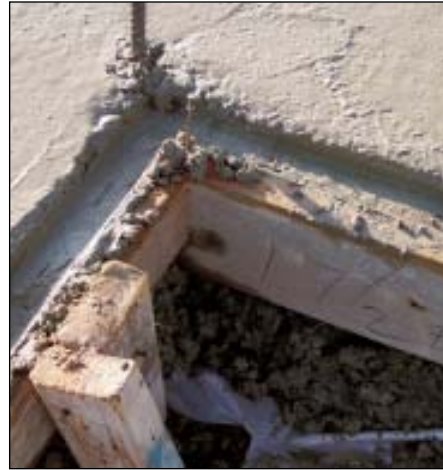
FIGURE 3. During the 2004 hurricanes, wind-driven rain and excessive ground-level runoff leaked under exterior doors and through the cold joint at the base of CMU walls. Mercedes Homes solved these issues during slab forming: A recess formed in the slab, in conjunction with out-swing doors, limits water intrusion beneath doors (above). At the perimeter of the slab, a recessed step provides a key for the poured walls that effectively cuts off a direct pathway for ground-level water (right).

Ground-level water intrusion can be mitigated by creating shallow indentations or recessed seats in the foundation slab to

prevent rain from being driven or sucked into the home under the exterior doors and walls (Figure 3). The recessed seats work well in conjunction with out-swing entry doors — a somewhat unconventional but practical solution to a common source of damage. For additional protection for openings, the builder also offers removable hurricane shutters as an option to all home buyers.

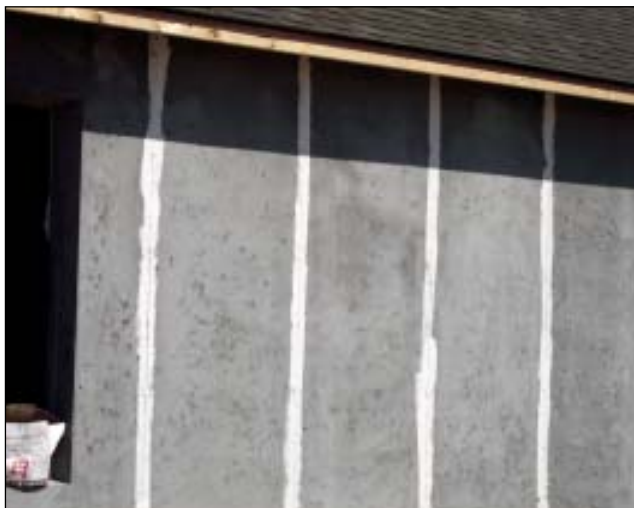
FIGURE 4. Form joints and snap ties are possible water entry points for wind-driven moisture. Applying sealant to these potential pathways is a simple, effective way to prevent water damage to the interior.

**Sealing walls.** Although concrete is poured continuously across multiple forms, the change in texture at vertical form joints and tie connections creates a vulnerability to water infiltration. To eliminate this potential pathway for water intrusion, the exterior wall surfaces of the Mercedes SWS are protected with elastomeric sealant at form joints and at the concrete form snap-tie locations (Figure 4).

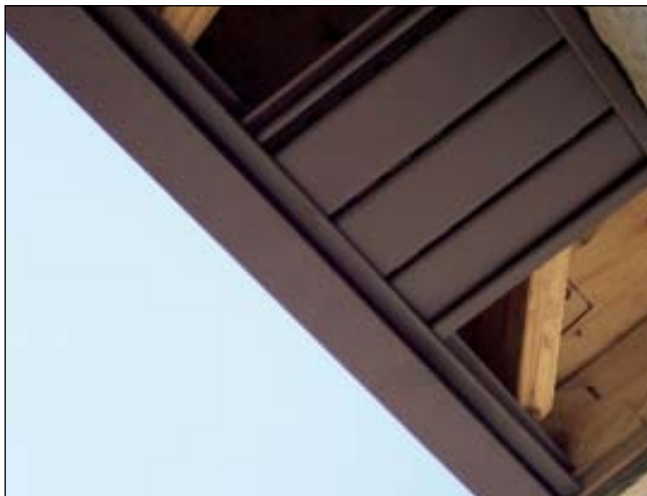
FIGURE 5. The perforations in Alcoa Hidden Vent are recessed in the panel grooves. The manufacturer claims this design provides plenty of ventilation airflow, but when combined with a fascia that extends a full inch below the soffit, the potential for water sheeting off the roof and getting driven by wind or surface tension into the vent openings is greatly reduced as well.

In another frequent envelope failure, water sheeting off the roof spills down the fascia board and is driven by wind or surface tension into the soffit vent openings. To alleviate this mode of water entry, a redesigned fascia extends an inch below the soffit to form a drip edge, directing water down and away. A perforated soffit panel by Alcoa (www.alcoa.com), with recessed rather than surface openings, limits water intrusion while encouraging greater air circulation and faster drying within the eaves assembly (Figure 5). A simple change to baffled ridge and roof vents is also used to mitigate a common, and often significant, water-entry mechanism.
