## Problem Joint spalls

Spalls that occur adjacent to joints in floors, slabs, or pavements.

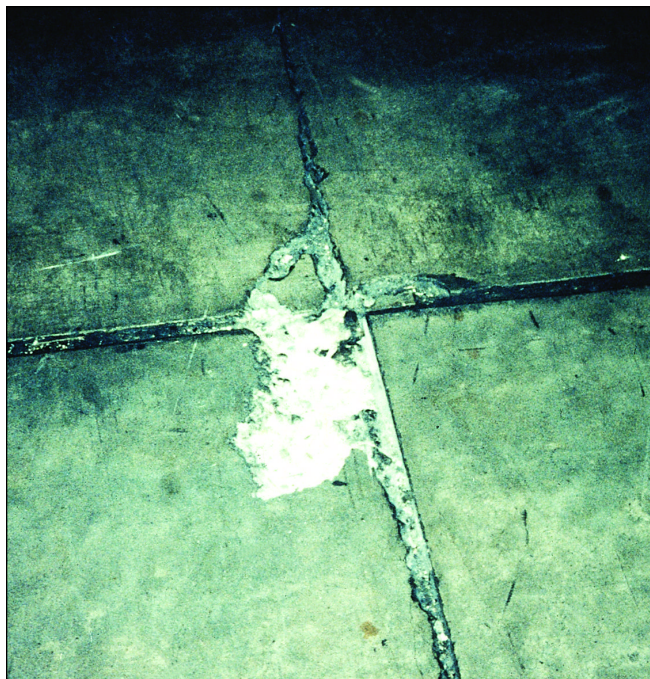
Joint fillers are too soft to support traffic across joints in industrial floors.

- Elastomeric joint fillers. While elastomeric joint fillers may do an excellent job of keeping water out of joints (if the fillers remain bonded), they are too soft to support traffic across the joint. When the joint is loaded, the sealer compresses and there is nothing to support the face of the concrete in the joint.
