BY WILL WALLACE-GUSAKOV

Helping Rebuild Notre Dame

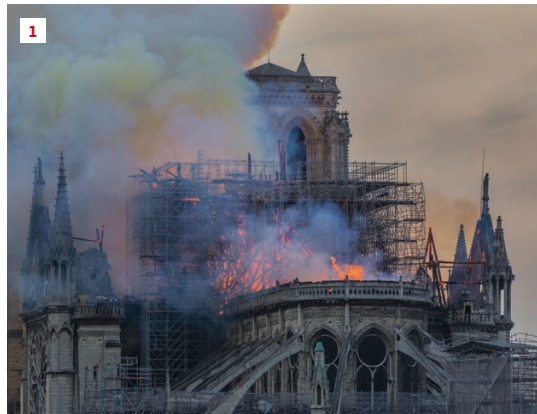
On the evening of April 15, 2019, a fire broke out in the attic of Notre Dame cathedral during a maintenance project (1). The blaze would go on to destroy the entirety of the Gothic church's roof, including its iconic 19th-century spire. A majority of the estimated 400 tons of lead roofing and cladding vaporized from the high temperatures, and the underlying oak timber framing, most of which dated back to the 12th and 13th centuries, was destroyed. Hours later, after the fire was contained, French President Emmanuel Macron set a five-year deadline to restore the sacred structure in the heart of Paris.

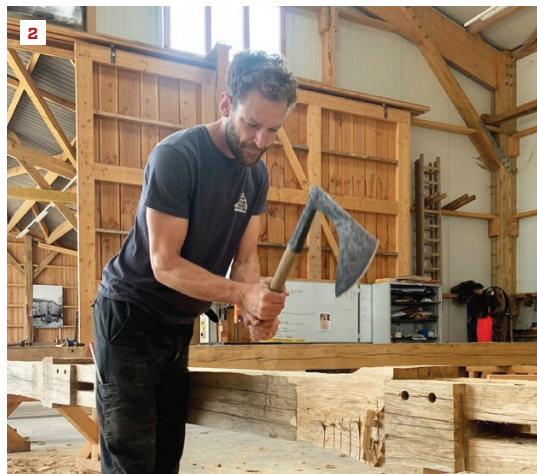
An accurate replica. Last year, French colleagues associated with Charpentiers sans Frontières (Carpenters Without Borders, of which I'm a member) contacted me because their company, Ateliers Desmonts, had won the contract to rebuild the timber-framed roof over the cathedral's nave and choir areas. They hired me to help create an accurate replica of the medieval timber frame, down to individual details in each truss and framing member destroyed by the fire. Starting this past January, I spent six months working in Normandy, a few hours outside of Paris, hand-hewing oak beams with a Gothic-style broad-axe (2) and laying out and cutting wood joinery.

An important concern was the hand-tooled finish of the oak timbers used (timbers "hand hewn with a broad-axe" was written into the spec of this big government job—a watershed moment for traditional hand-tool carpenters). We researched historical sources and tool marks in extant contemporary frames and set criteria for the hewing axes to be used. We studied historical photographs and experimented with axes, adzes, and chisels to create full-scale prototypes of joinery and sculptural details, which were then reviewed by the project architects. Every effort was made to reproduce the famous medieval roof frame (affectionately known as *la forêt*—"the forest") both in detail and in spirit.

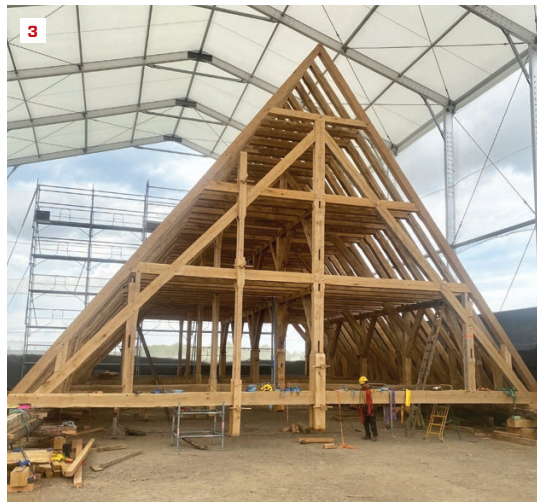
The nave frame. I worked mainly on the principal roof trusses over the cathedral's nave. To help re-create the nave's 11 principal trusses and 46 secondary trusses, we drew from Point Cloud scans, archival photographs, and technical documents from the architectural team. We used traditional *piquage* (French plumb line scribe) methods to lay out the frame. Joinery was cut using modern tools such as chain mortisers and circular saws as well as hand tools like chisels, planes, drawknives, and side axes. To verify everything fit together, we raised the full-scale nave frame at the Normandy worksite. The completed nave frame measured 46 feet wide by 33 feet high by 115 feet long (the 11 principal trusses are spaced roughly 12 feet apart) (3).

I returned home in July just as the nave frame was beginning to be disassembled bay by bay and transported piecemeal to Paris. Because of jobsite constraints, the trusses are being reassembled one at a time on site and hoisted into place. This methodical, bay-by-bay truss installation over the nave and choir areas will take roughly six months.
