Backfill

Reconstructing the Past

by Noah Woodruff

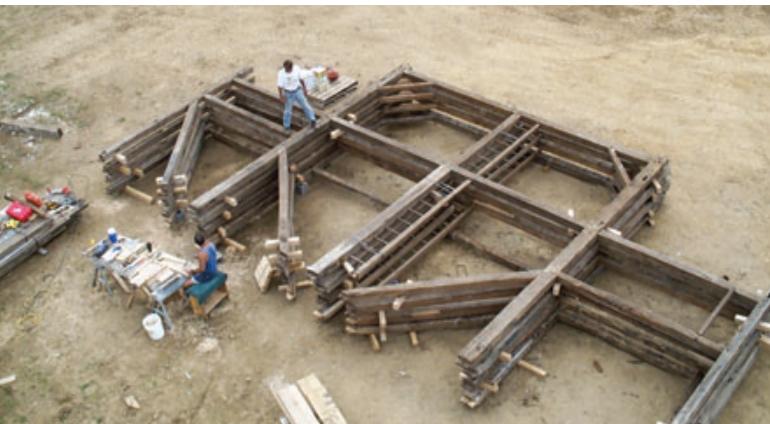
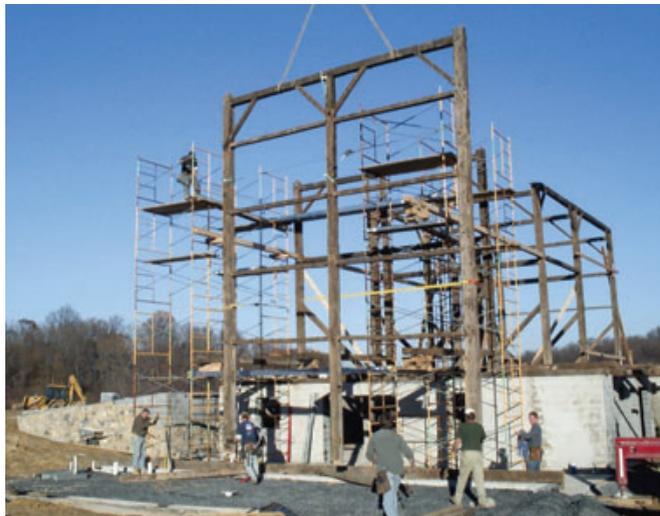
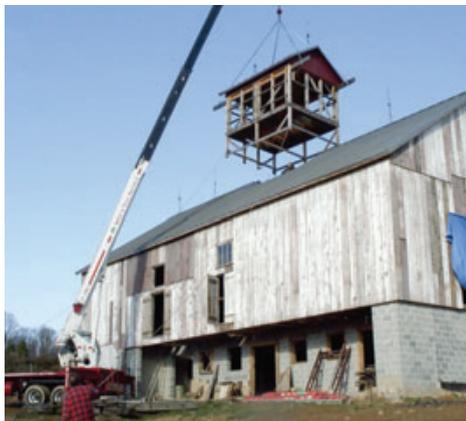
Original barn timbers were re-assembled into bents at the job site. Replacement parts were cut and shaped from locally milled lumber as needed, and surfaced with an adze to remove saw-blade marks (top). After original hand-hewn plates were laid atop the new block foundation, bents were craned into position one at a time. Strategically positioned pipe staging simplified reassembly of the many mortise and tenon joints and installation of the top plates (above). Tenons on each of the four “legs” of the cupola fit into corresponding mortises in the roof framing. Despite the close tolerances, the cupola fit into position on the first try (right).
